**MILESTONE INSPECTION – PHASE I**

**SOUTHPOINT OF DAYTONA CONDOMINIUM**  
4453 S ATLANTIC AVE.  
PONCE INLET, FLORIDA 32127

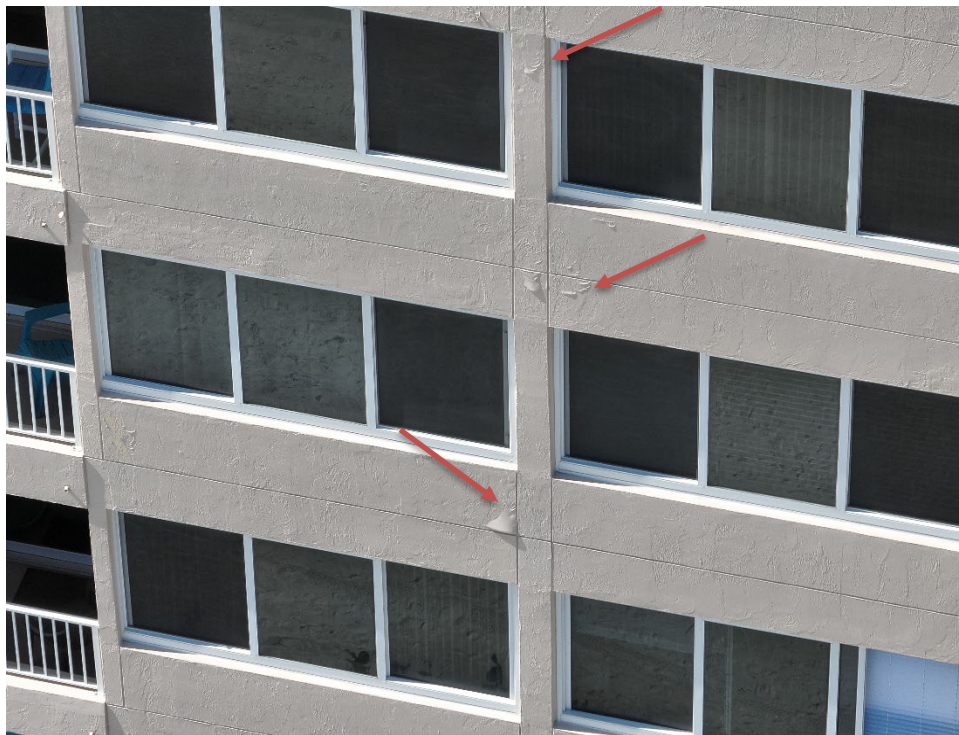
12. View of the areas of the northeast wall at floor 4 and 5 where water infiltration is occurring.

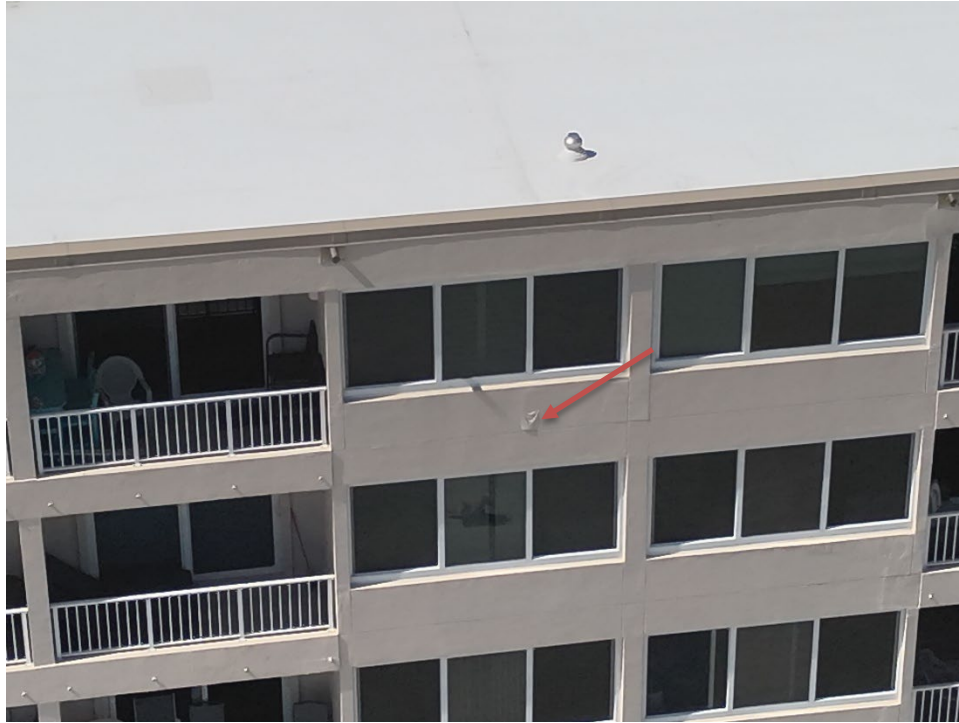
13. View of the additional area of the northeast wall at floor 7 where water infiltration is occurring.

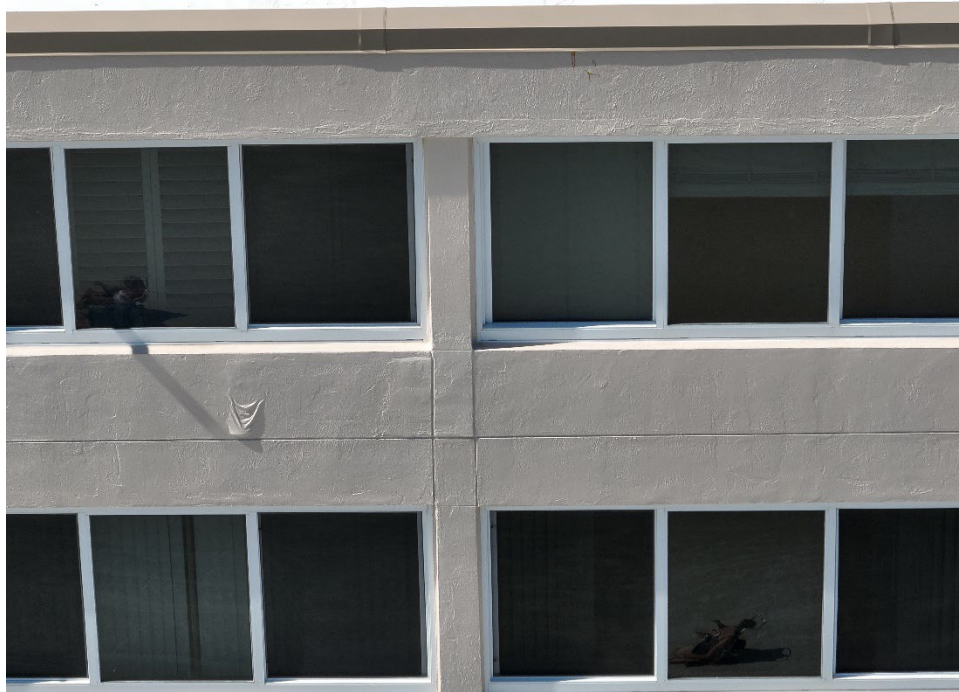
14. View of the additional area of the northeast wall at floor 7 where water infiltration is occurring.

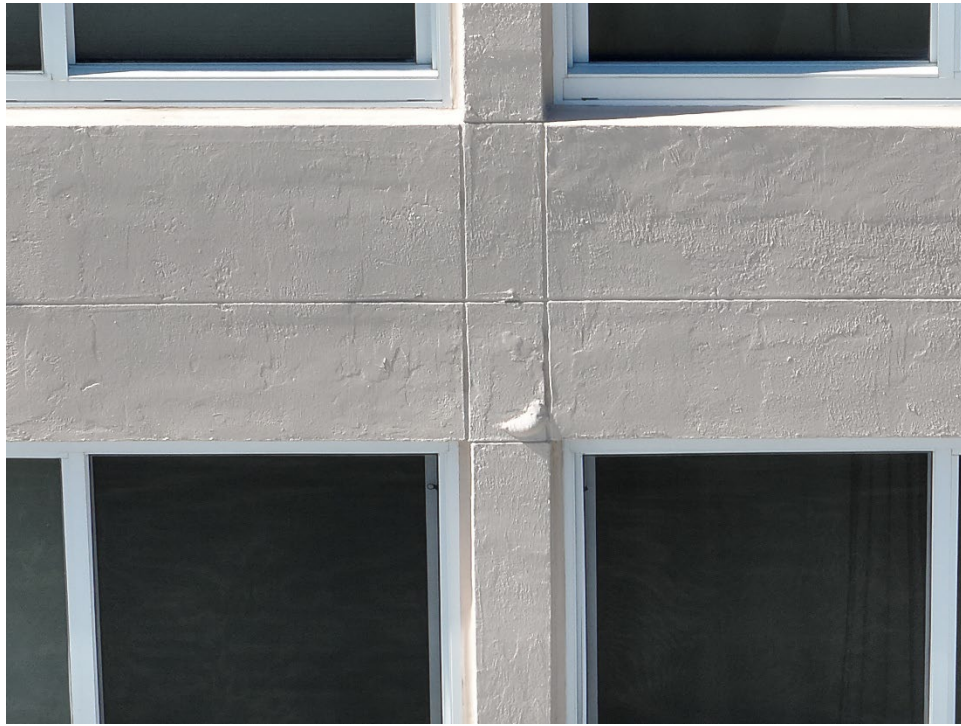
15. View of the additional area of the northeast wall at floor 6 where water infiltration is occurring.

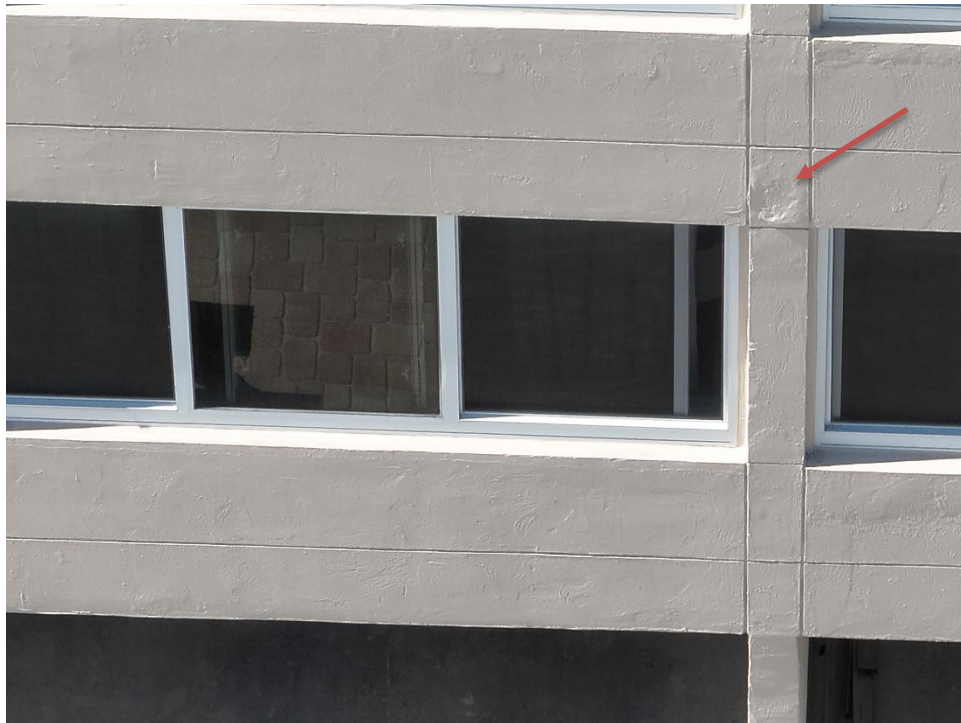
16. View of the additional area of the northeast wall at floor 1 where possible water infiltration is occurring.

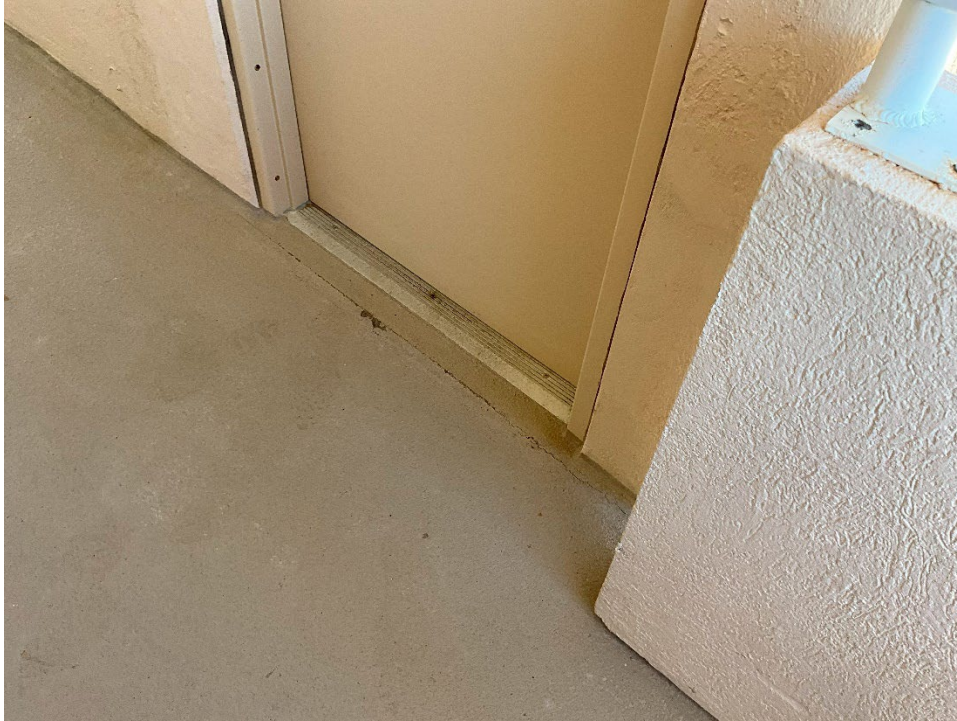
17. View of the cracks occurring along control joint in front of the door to the Elevator equipment room on the 7<sup>th</sup> floor.

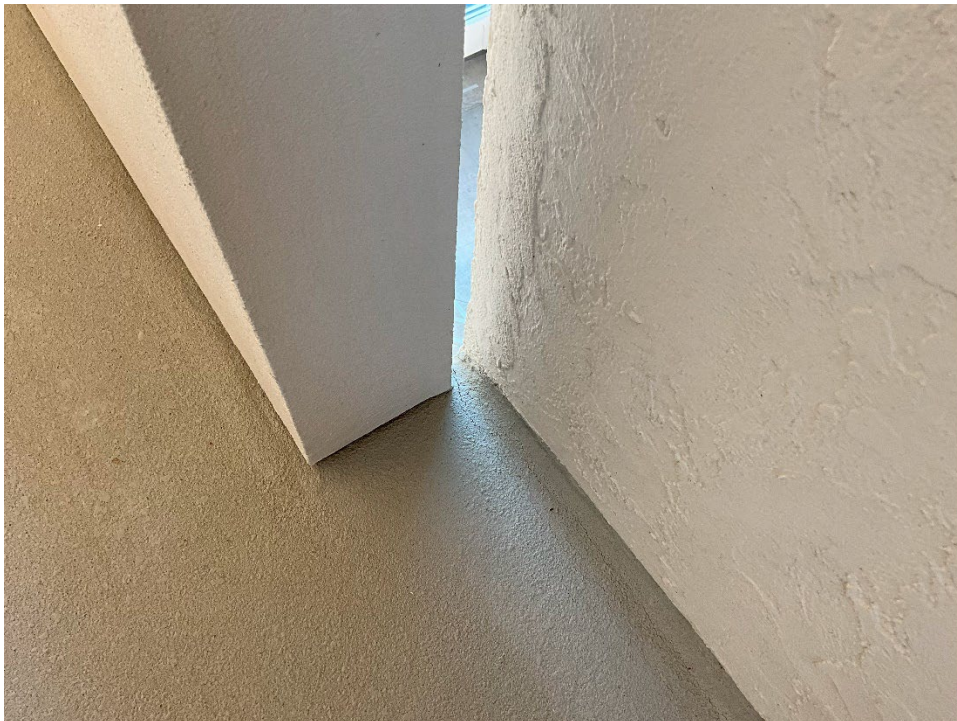
18. View of the cracks occurring along the control joint in the corner where the Breezeway wall meets the Elevator Tower on the 7<sup>th</sup> floor, outside of Unit 501.

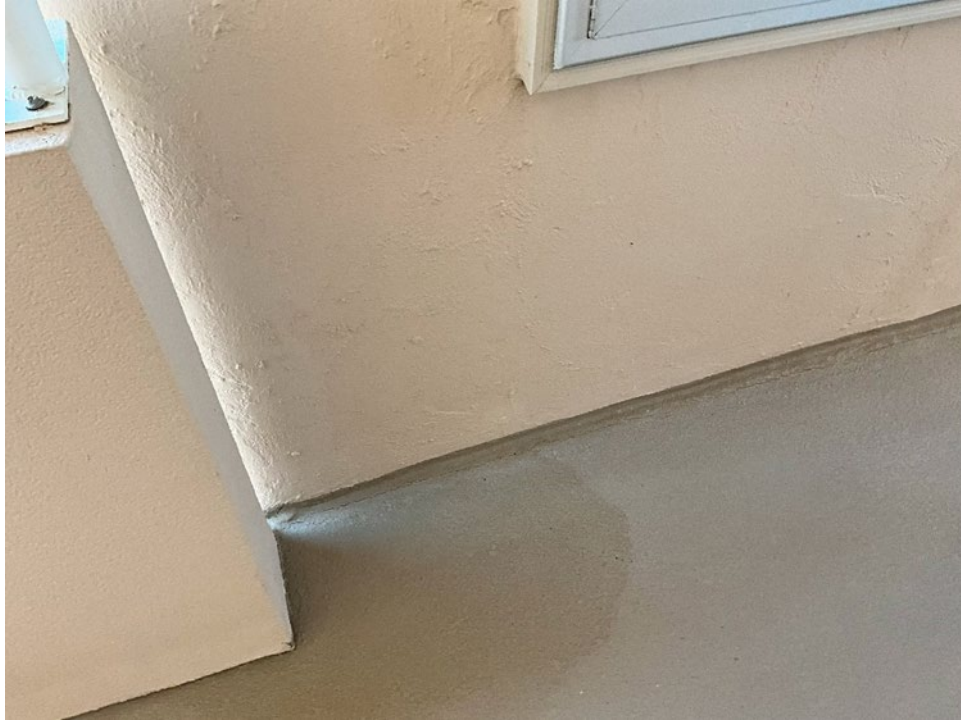
19. View of the cracks along the joints between the floor and the wall outside of Unit 501.

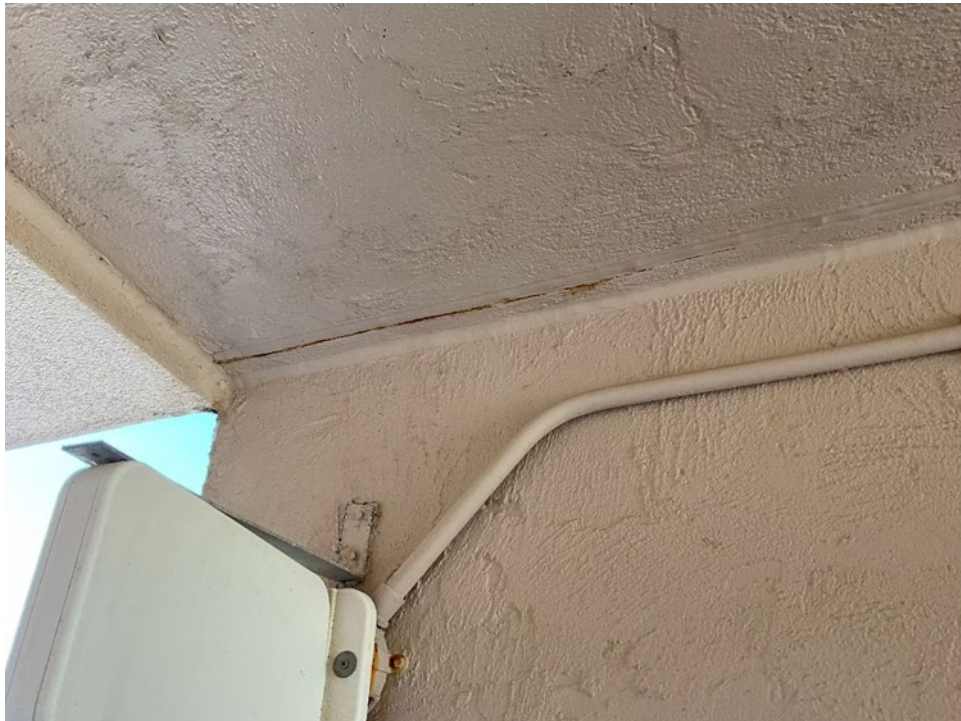
20. View of the cracks along the joint between the wall and the ceiling outside of Unit 501.

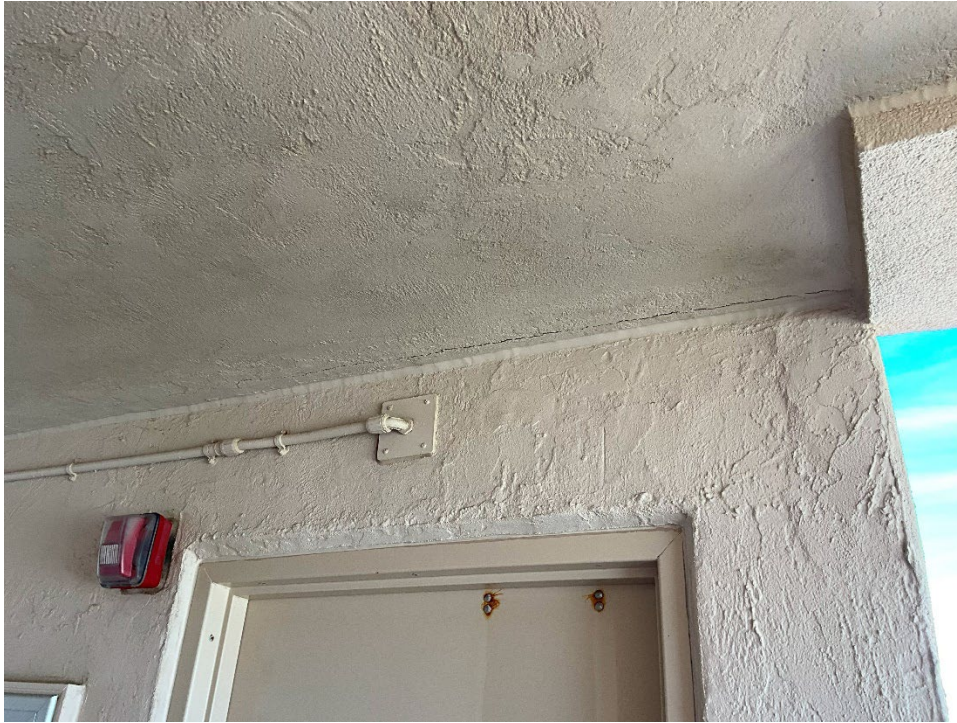
21. View of cracking along the joint between the ceiling and the wall outside of Unit 301.

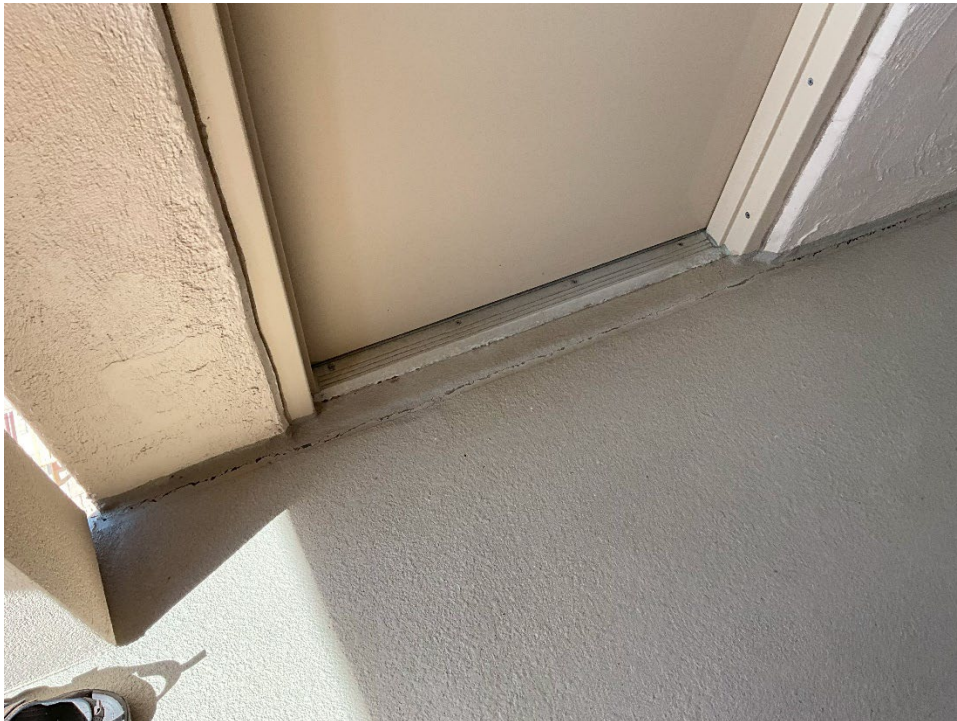
22. View of cracking along the joint between the floor and the wall outside of Unit 211.

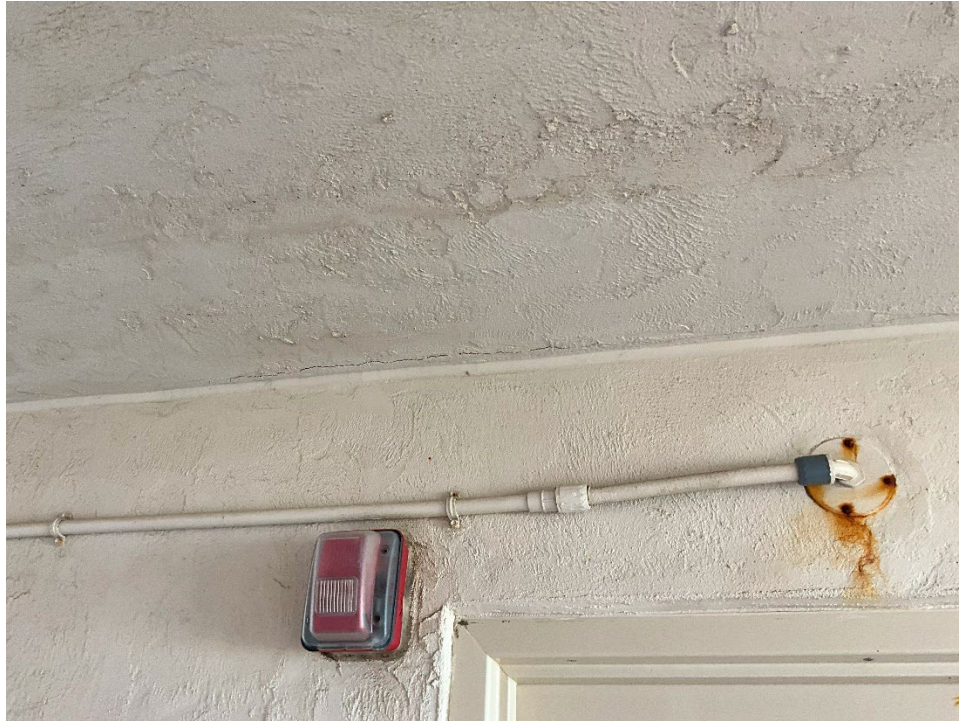
23. View of cracking along the joint between the ceiling and the wall outside of Unit 101.

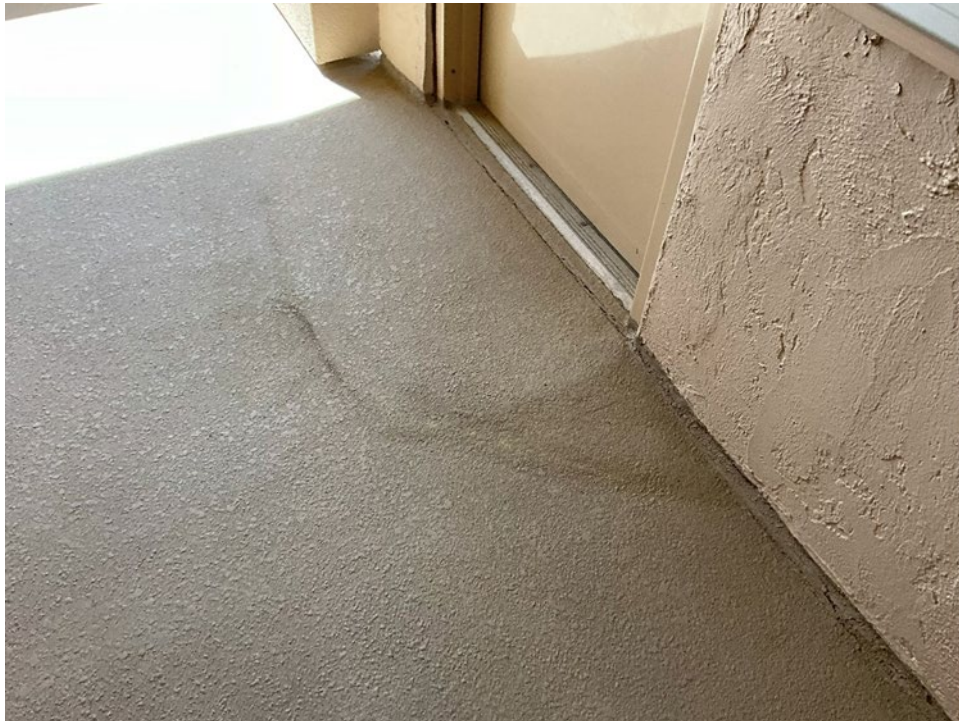
24. View of cracks and staining from water ponding on the slab in the Breezeway outside of Unit 110.

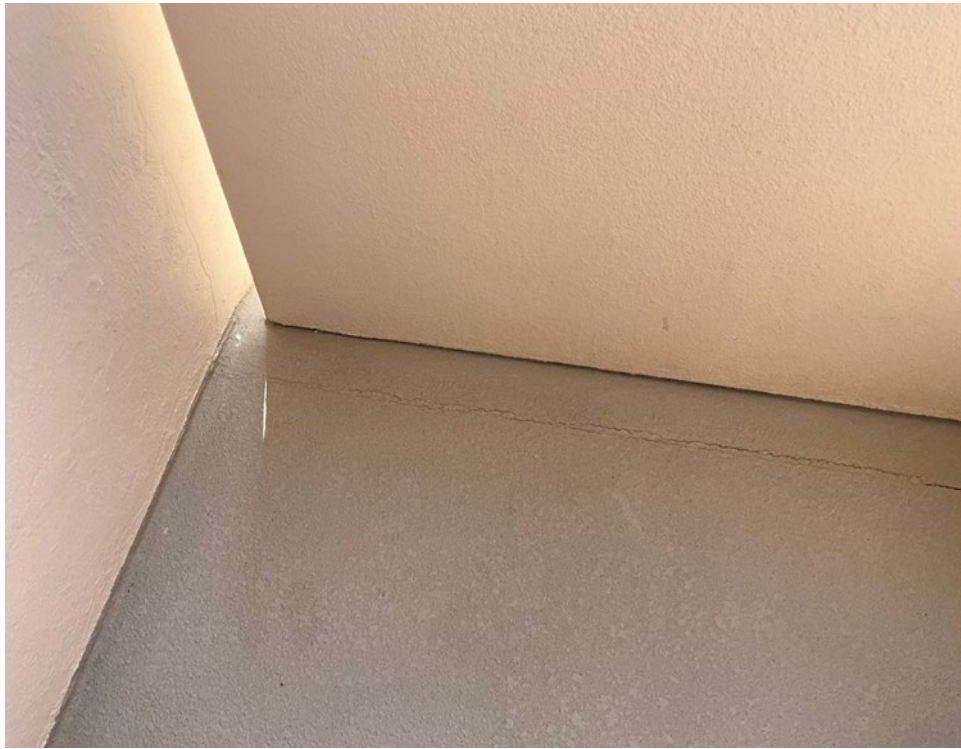
25. View of a crack along the control joint in front of the Breezeway safety wall near Unit 111.

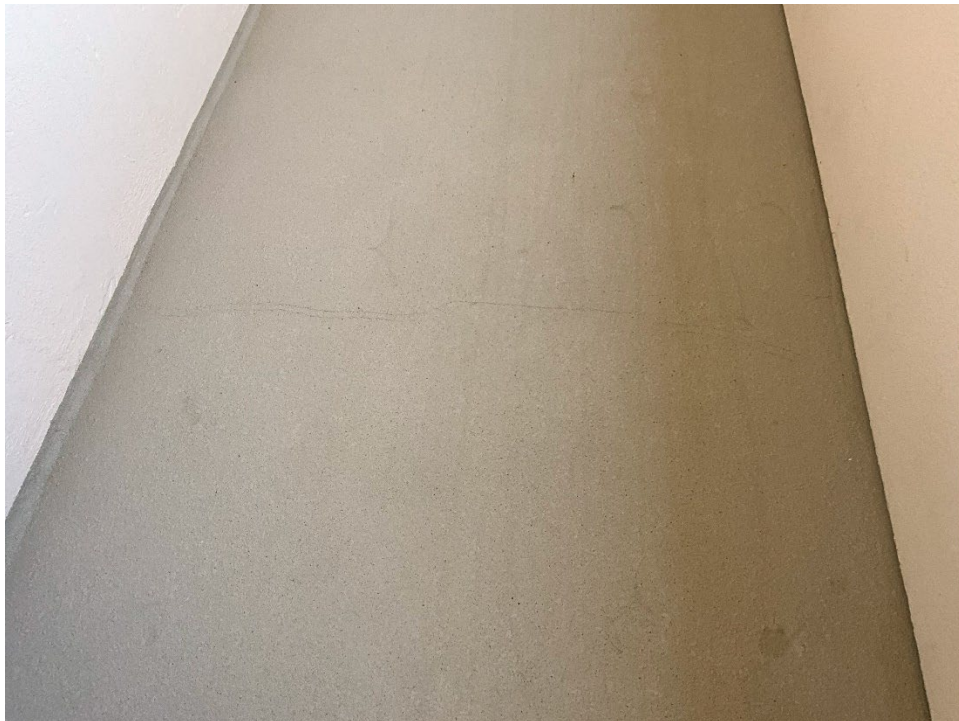
26. View of the cracks along the missing control joints in the breezeway along the hallways of each floor.

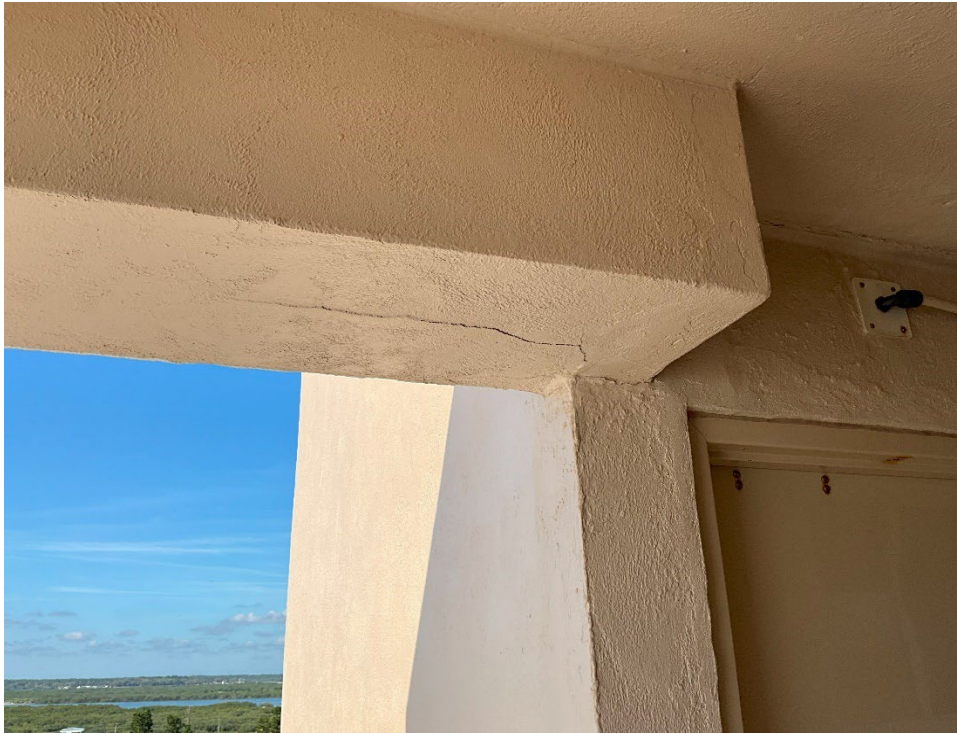
**27. View of the Visible cracks along bottom of beam outside of Unit 710. The paint and stucco will need to be removed to expose the beam for Phase II.**

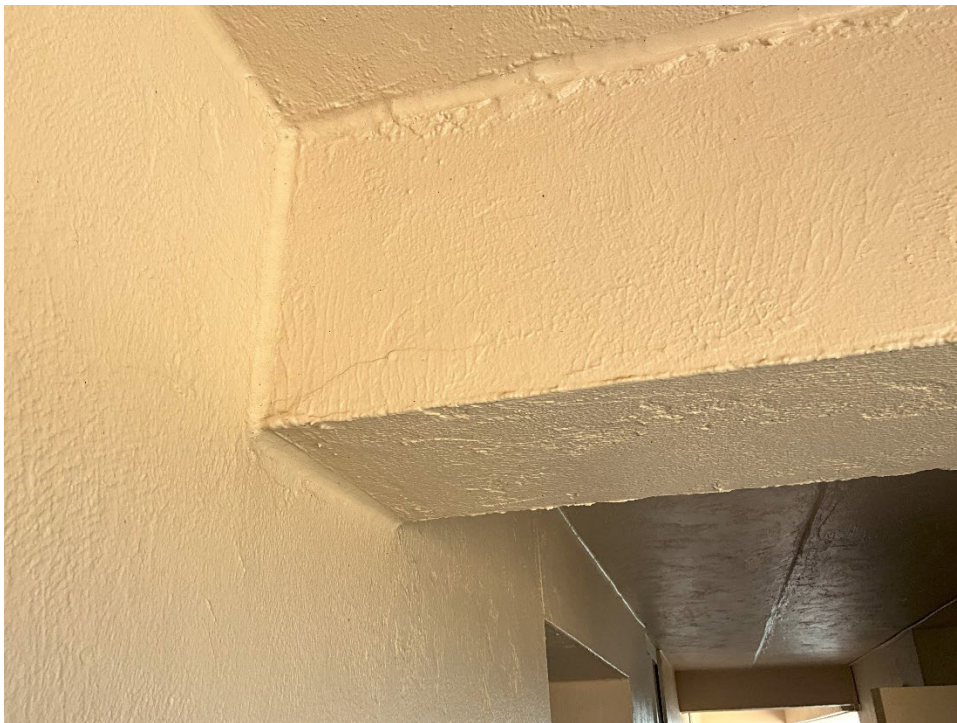
**28. A tensile crack is shown running along the bottom of the beam outside of Unit 704.**

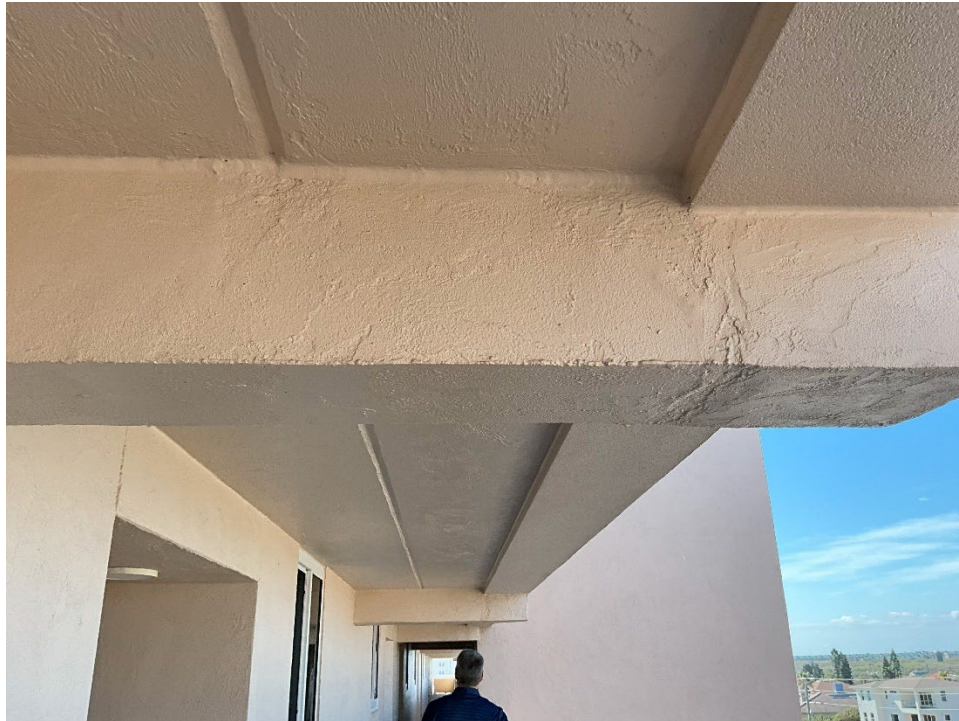
29. View of the previously patched beam outside of Unit 503.

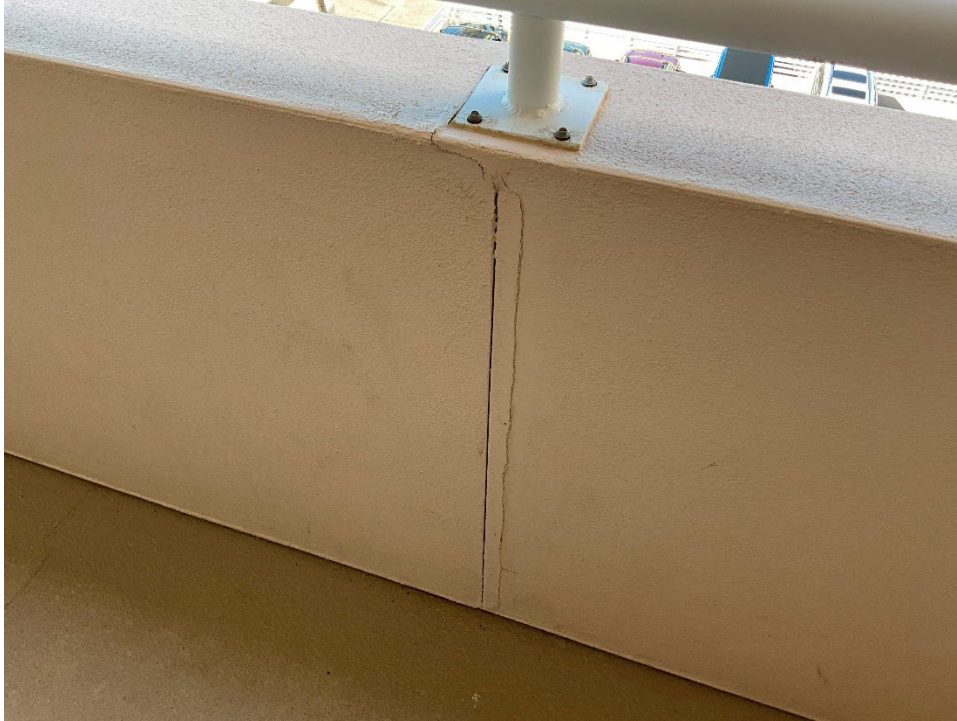
31. View of the crack in the parapet wall next to the control joint outside of Unit 507.

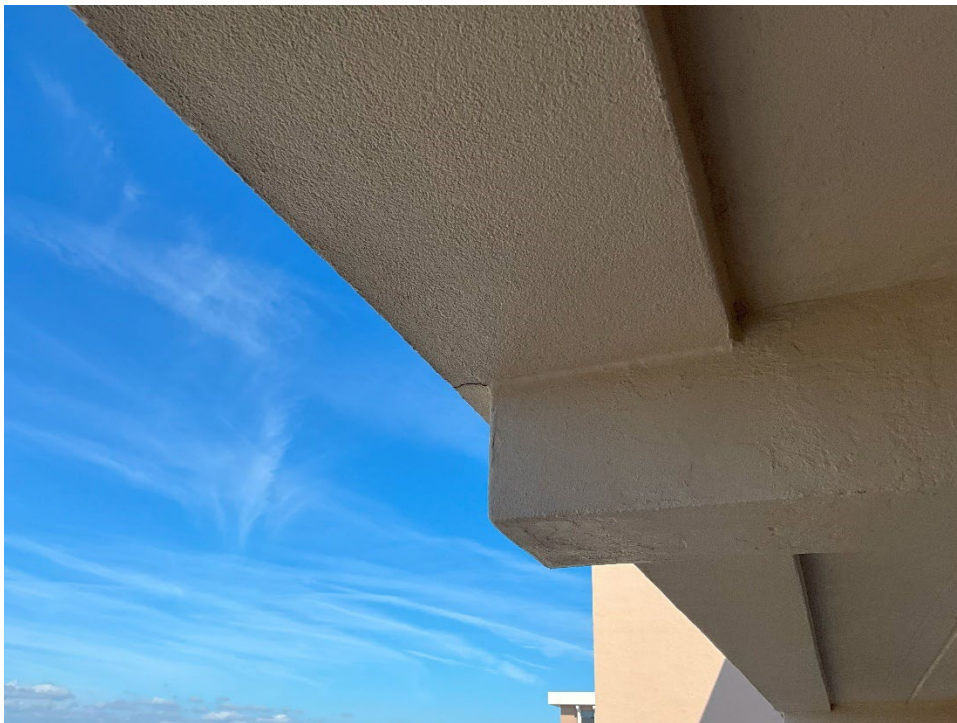
32. View of the crack in the underside of the Breezeway slab outside of Unit 509 and 410.

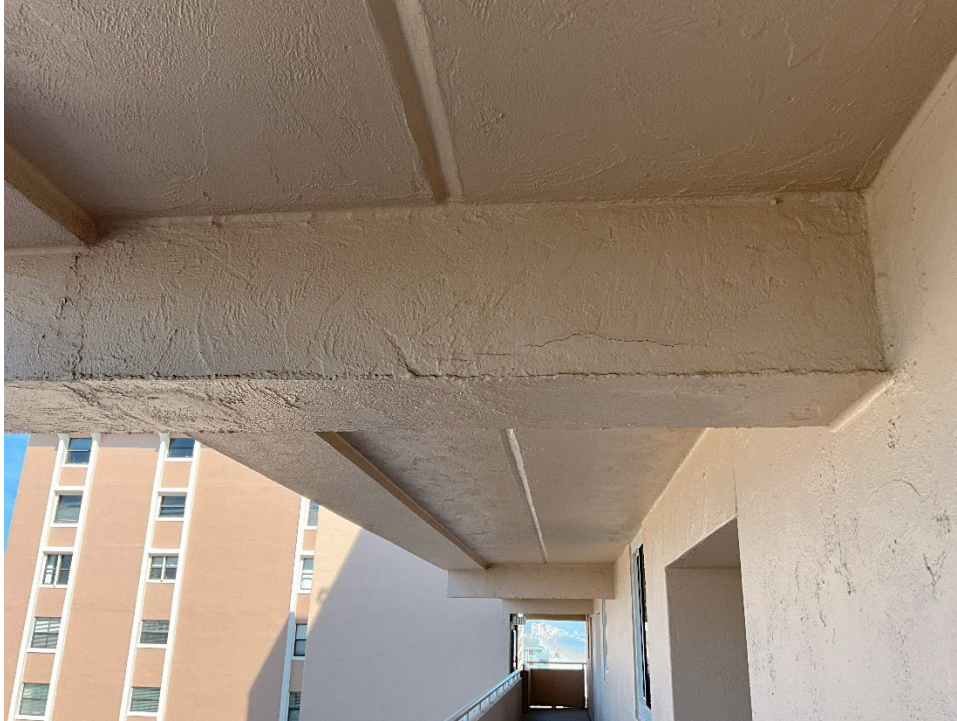
**33. Tensile crack along bottom of beam outside of Unit 404.**  
**The paint and stucco will need to be removed to expose the beam for Phase II.**

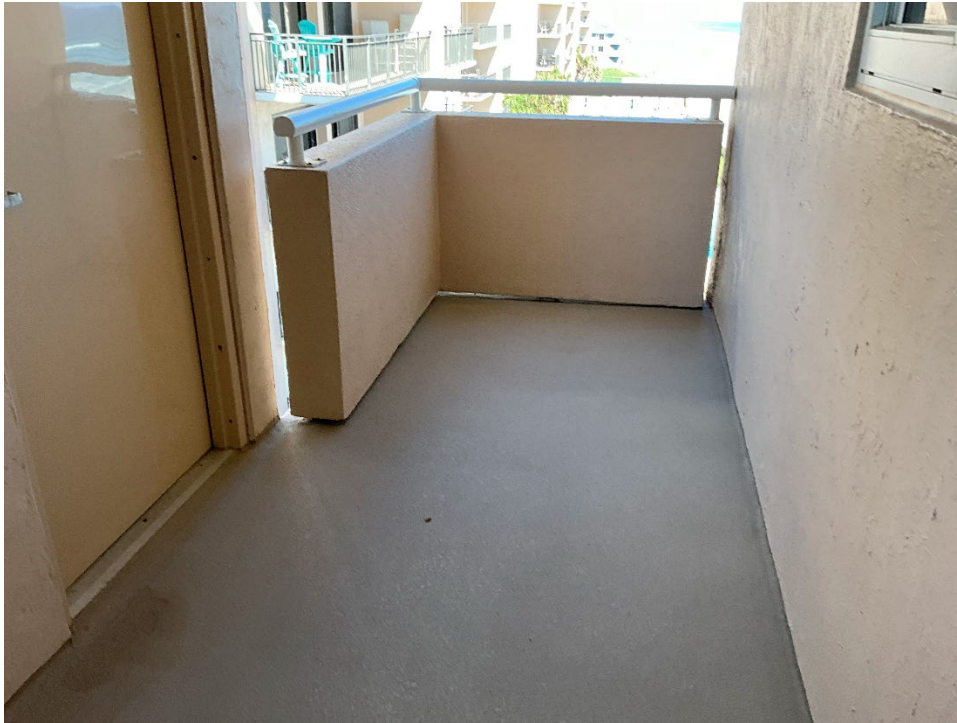
34. View of the parapet wall constructed out of plane with a sloped Breezeway outside of Unit 401.

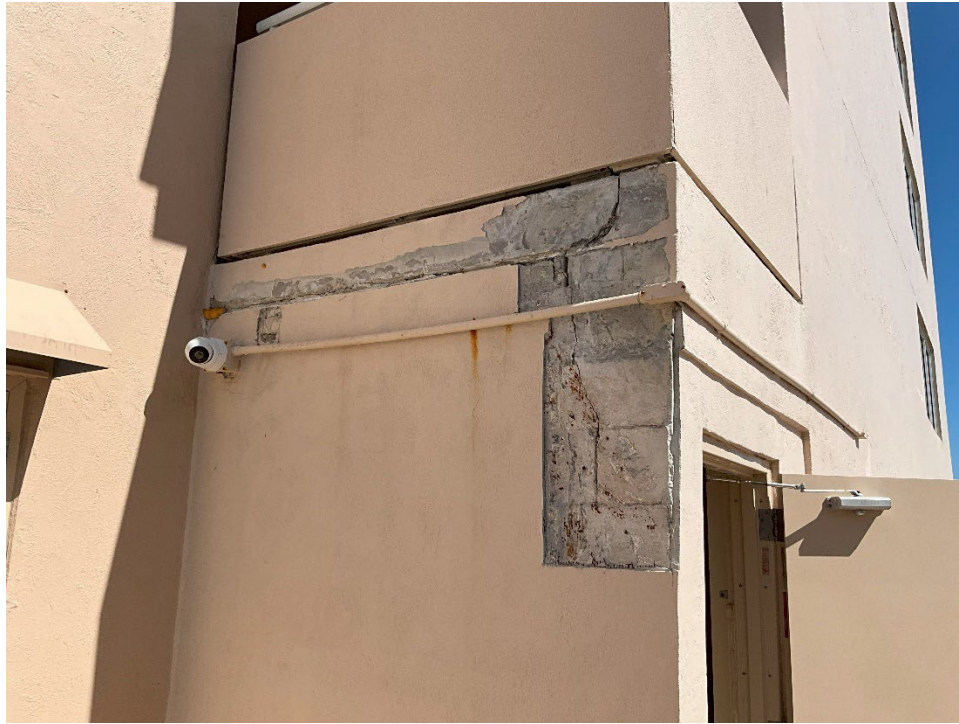
**41. Exterior shear crack in CMU wall with removed EIFS system. Perform Geotechnical testing to investigate evidence of settlement for Phase II.**

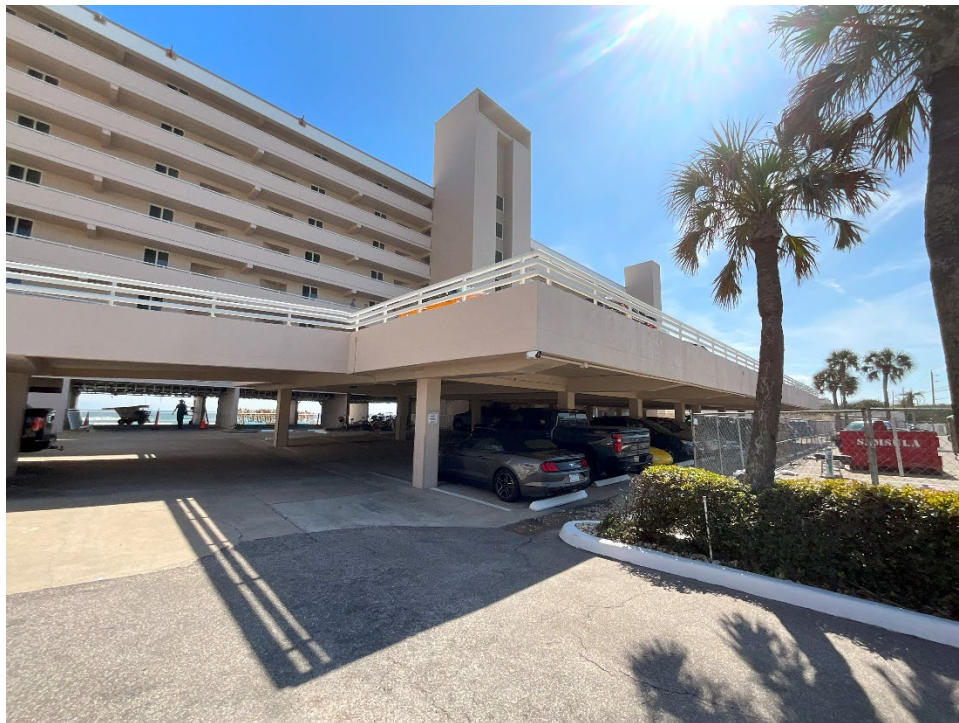
42. View of the Parking Deck.

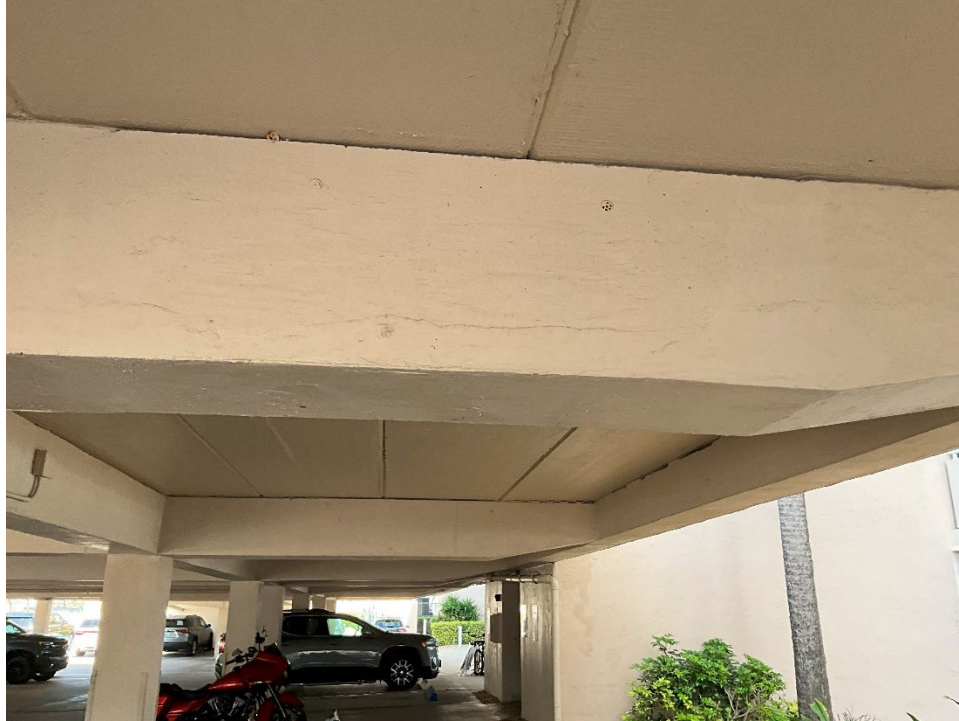
**45. Tensile crack in beam under Parking Deck.**  
**The paint and stucco will need to be removed to expose the beam for Phase II.**

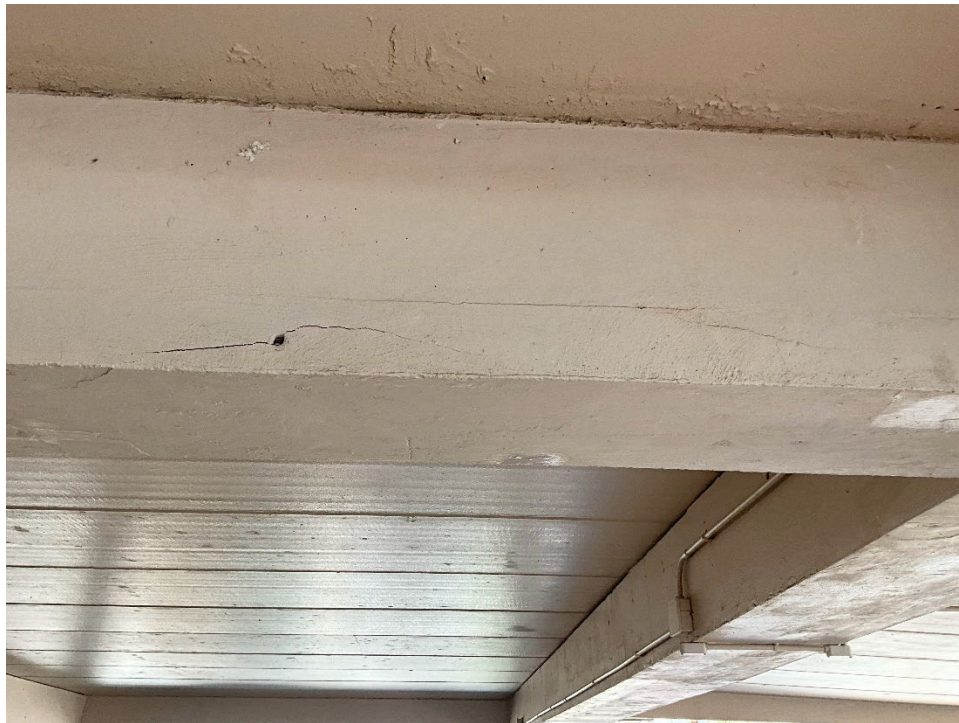
**46. Additional tensile cracks along beams in Parking Deck.**  
**The paint and stucco will need to be removed to expose the beam for Phase II.**

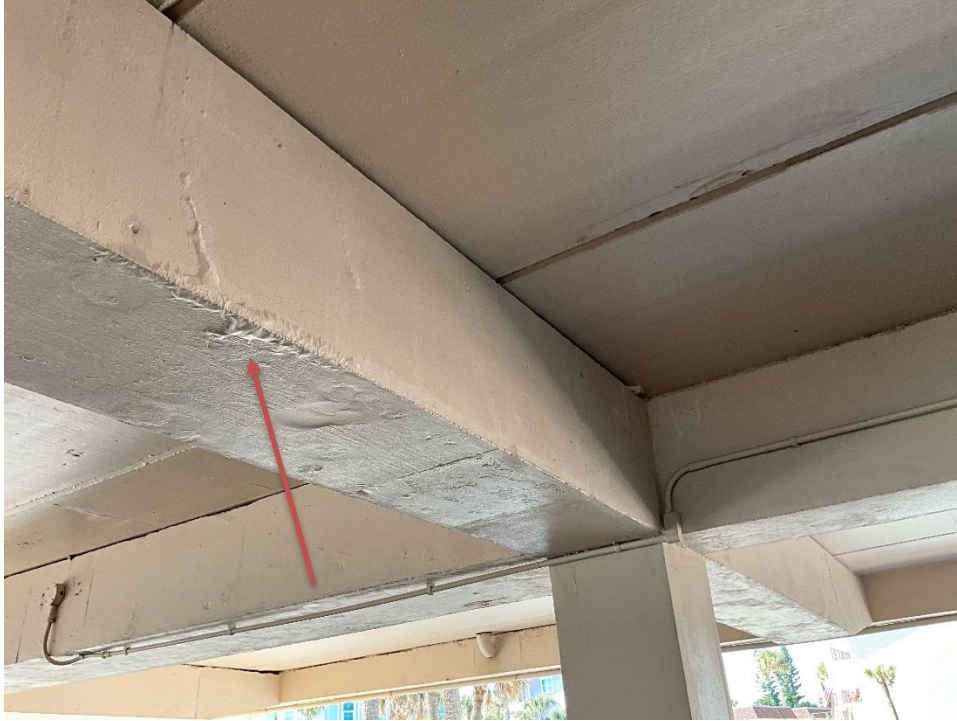
47. View of water intrusion along the beam under the parking deck.

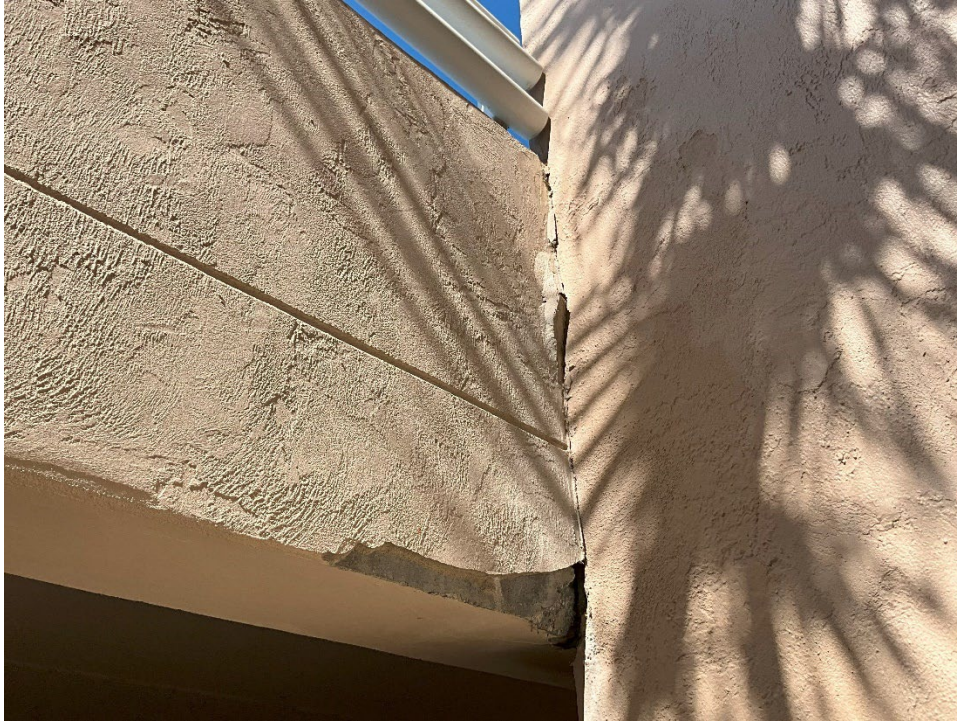
52. The portion of beam where the Parking Deck intersects with the Elevator Tower wall is spalled and EIFS system is cracking off at the joint due to water intrusion.

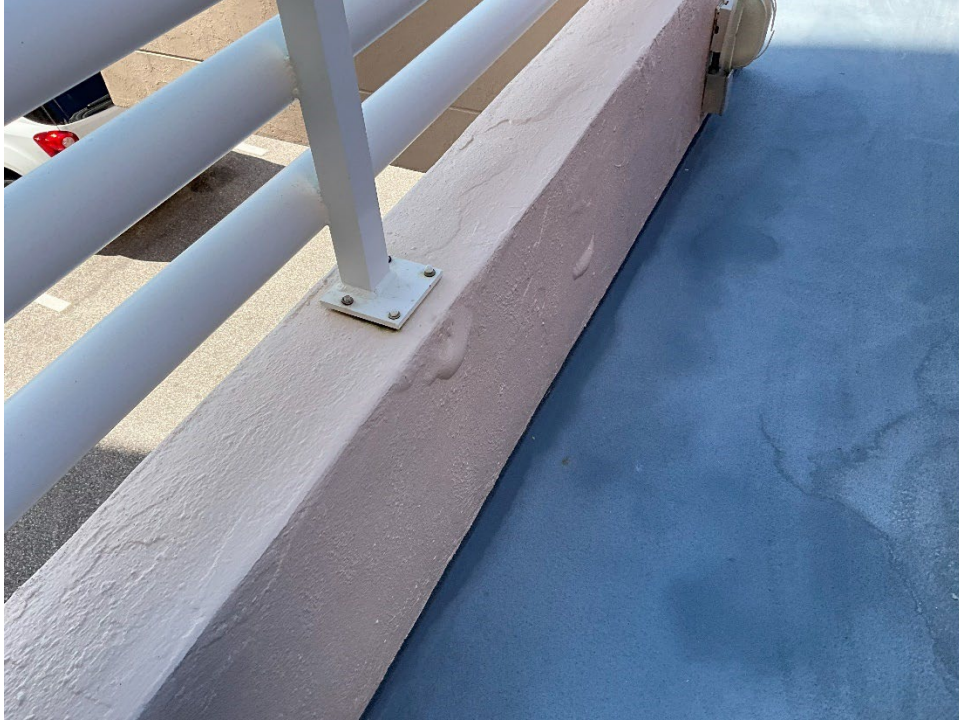
53. View of water intrusions showing in the wall of the Parking Deck.

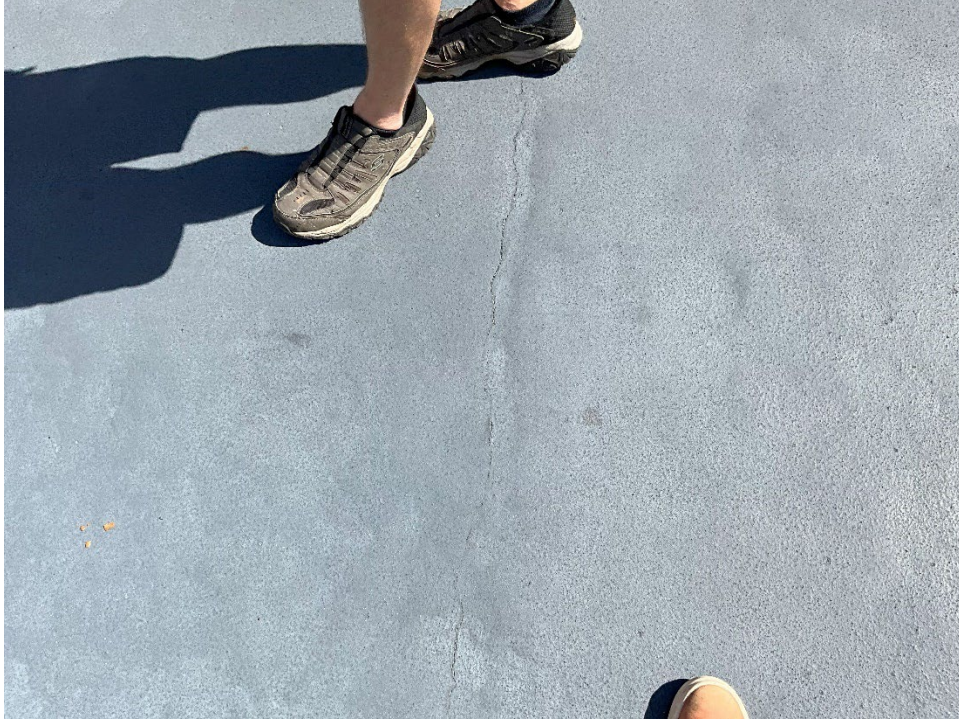
55. Cracks along the expansion joints in the Parking Deck.

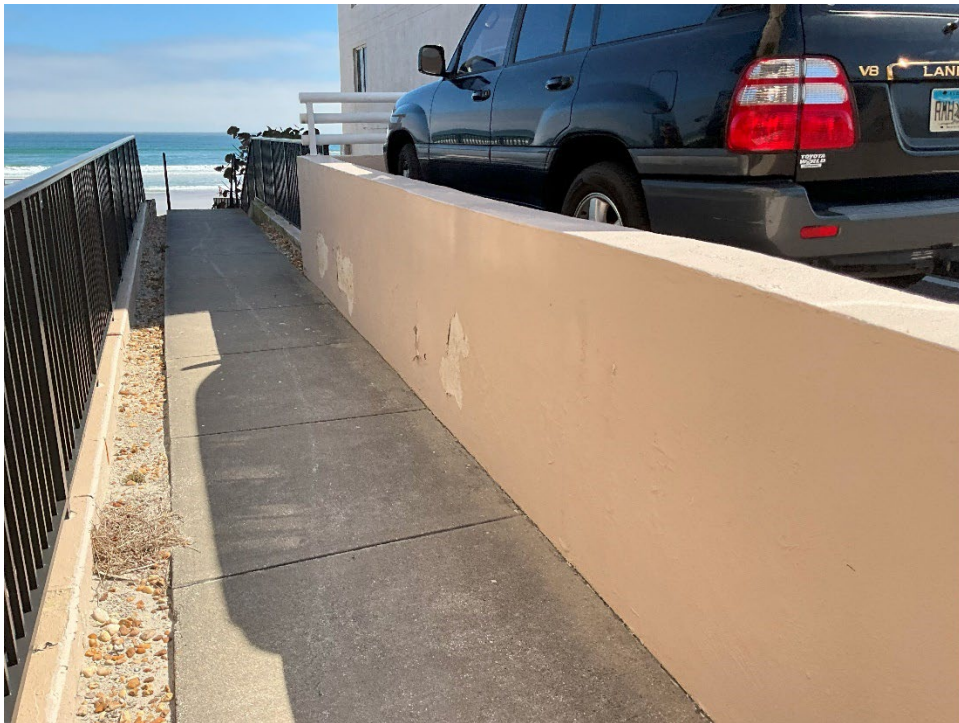
56. Paint delamination noted along the wall next to the beach access sidewalk.

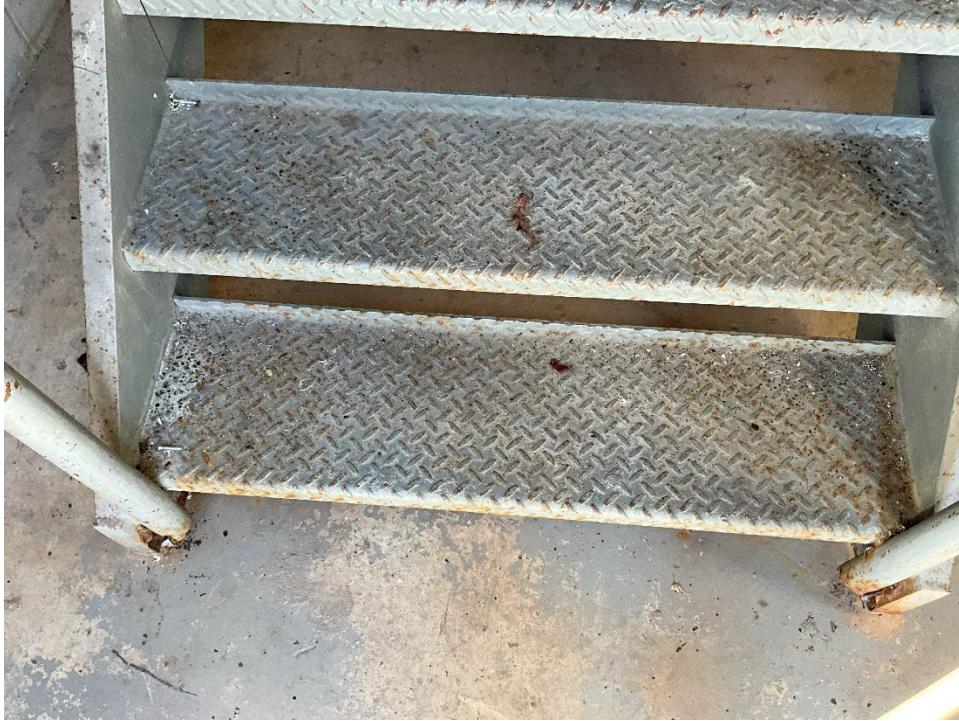
57. View of the bottom of the stairs, located in the Elevator Tower, are showing signs of corrosion.
