**MILESTONE INSPECTION – PHASE I**

**SOUTHPOINT OF DAYTONA CONDOMINIUM**  
4453 S ATLANTIC AVE.  
PONCE INLET, FLORIDA 32127

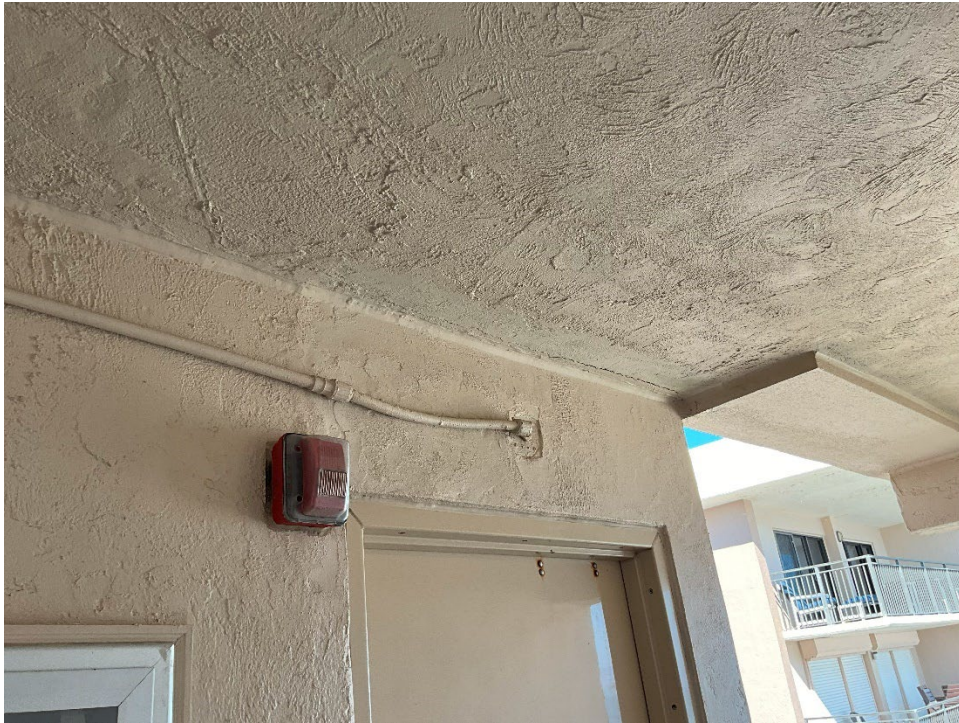
58. Typical example of the fire safety equipment installed.

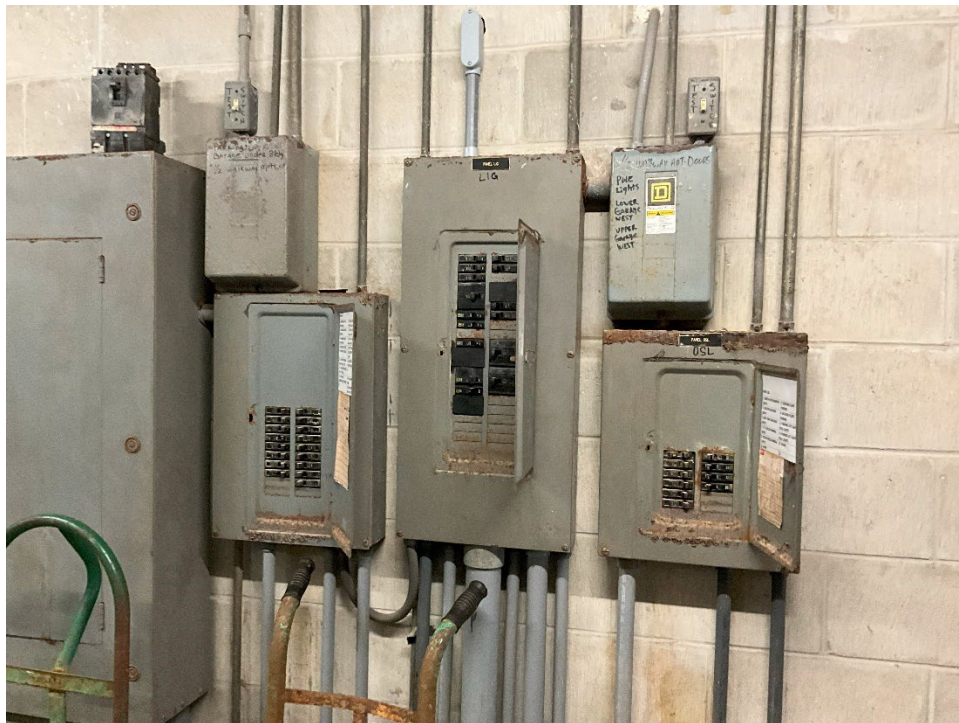
60. Typical example of the electrical equipment with corrosion.

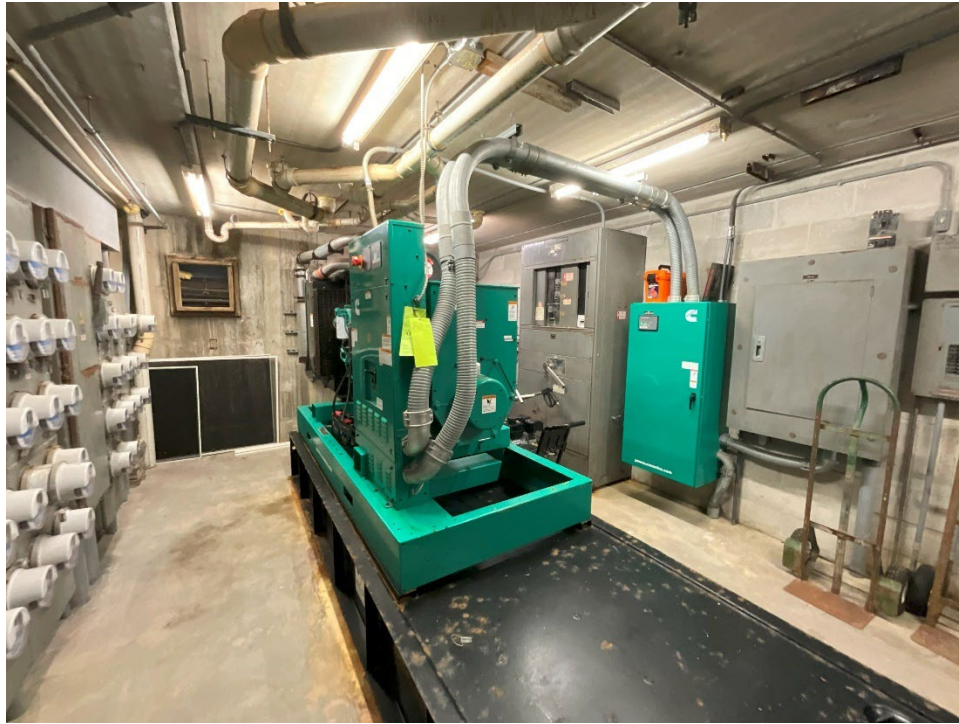
61. Typical example of the generator equipment.
