SOUTHPOINT CONDOMINIUM

LIMITED BUILDING CONDITION SURVEY REPORT

PROJECT NO. 19-1086

May 30, 2019
Project No: 19-1086

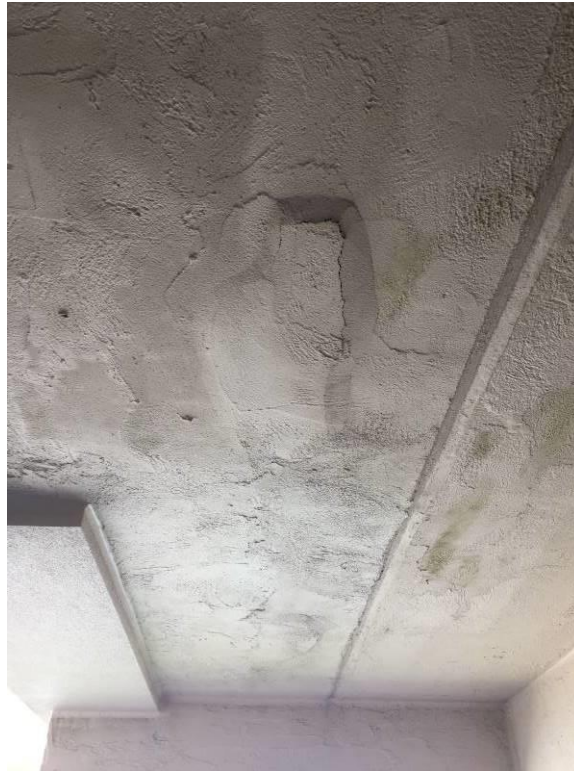
Concrete spalling on the walkways was more prevalent on the bottom side of the slabs. However, spalling on the top of the slabs was identified. The topside spalling may be limited to the topping that is cast over the precast panels used to provide positive drainage. Some of the topside spalling was located in the storage rooms adjacent to the elevators. The spalling adjacent to the stairwell or common doors may require the door be removed to make a proper repair.

Photograph #1 – Typical ceiling spall on walkways

Concrete and Stucco Repair: UEC recommends repairing all the concrete damage in accordance with the International Concrete Repair Institute Guidelines, ACI Building Code 562 and as specified by UEC. All concrete repairs should be inspected by an Engineer prior to casting back. The damaged areas will be excavated to sound concrete and uncorroded reinforcing steel. The excavations should be repaired with polymer modified repair mortars.

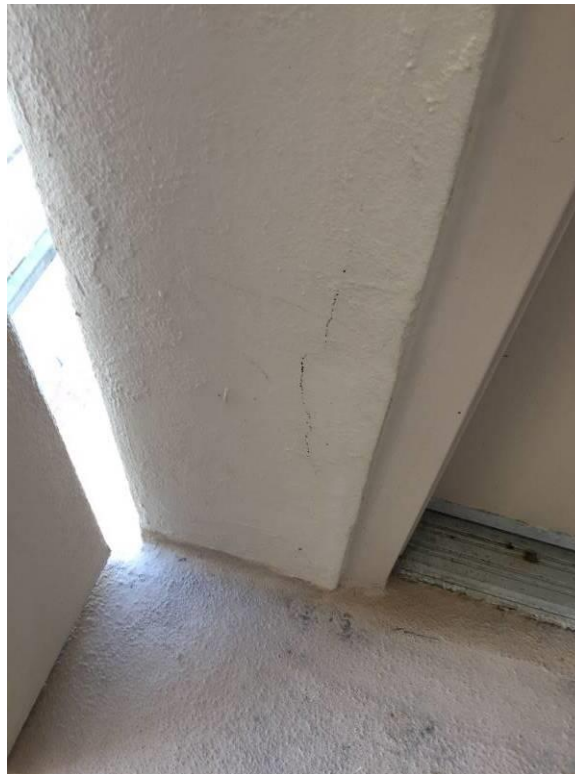
Stairwells: Structurally, the stairwells are in relatively good condition with minimal spalling. Spalling was identified on the exterior of the stairwell on the jambs of the stairwell doors. The South stairwell has a loose grab rail from the 1st floor down to the ground level close to the exit. The stairwell doors varied in condition; however, corrosion and rust bleed out was observed on some of the door frames.

Photograph #2 – Typical jamb spall on stairwell door

Any doors adjacent to concrete spalling must be removed to allow proper repair of the structure.

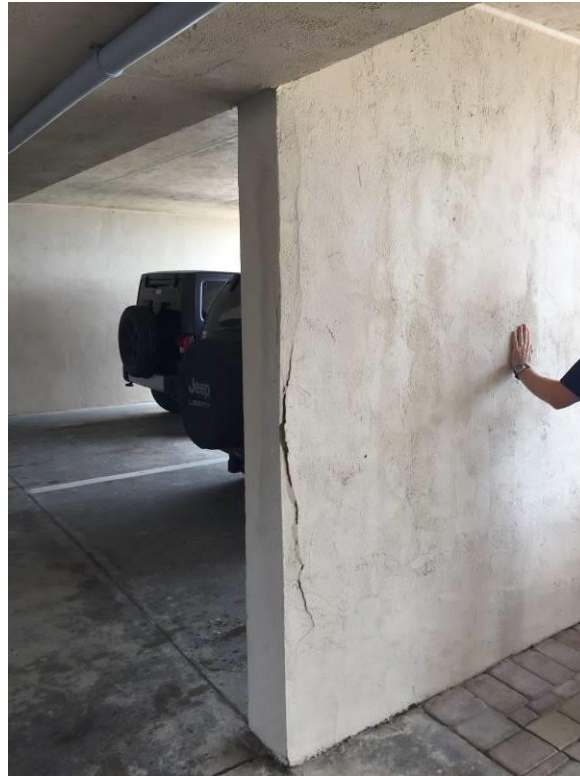
The ground floor parking area had many spalls located on the load bearing walls. Stucco disbondment was widespread on those walls as well.

Photograph #3 – Typical spall on load bearing wall in ground floor parking area

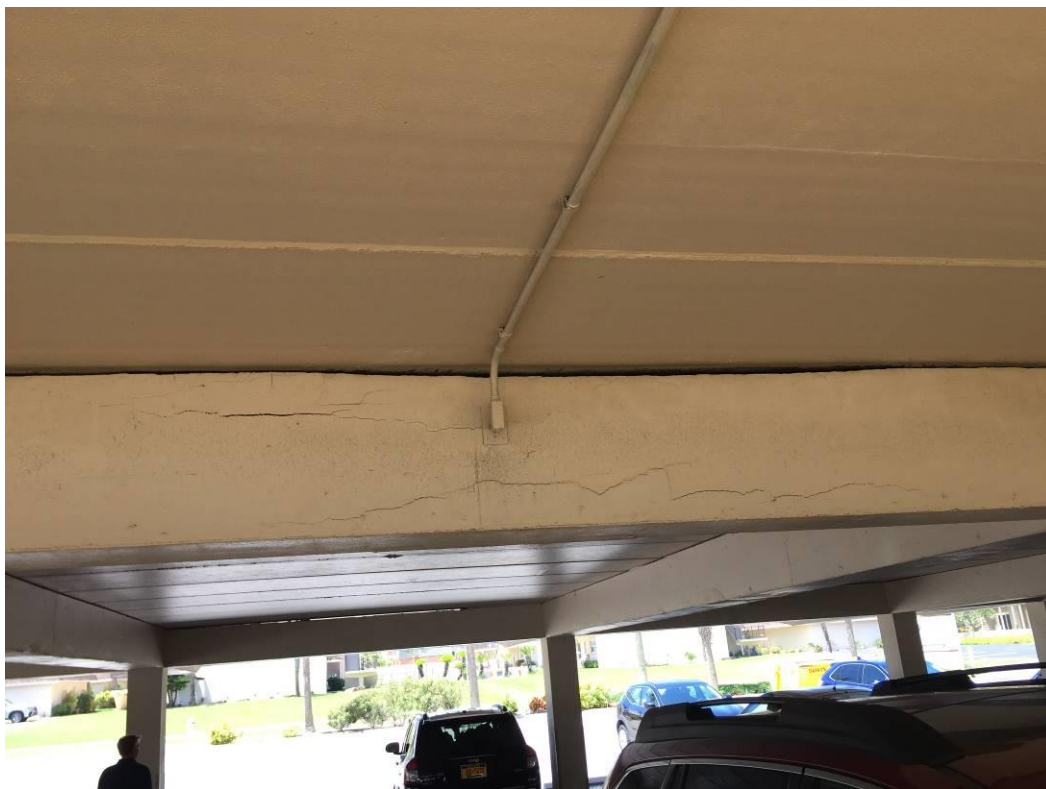
Parking Structure and Ground Floor Parking (Structural): The parking structure accounts for approximately half of the structural damage to the entire property. The main extent of damage on the parking structure is on the beams supporting the hollow core panels. The perimeter walls on the topside of the parking structure had many locations with smaller spalls and there was minimal damage on the columns and hollow core planks.

Photograph #4 – Typical spalling on beams supporting the parking structure

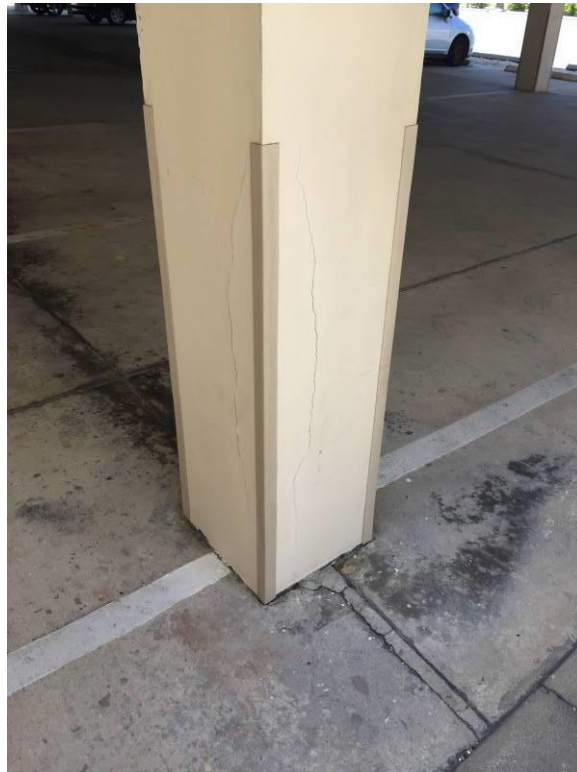
Photograph #5 – Typical column spalling on parking structure

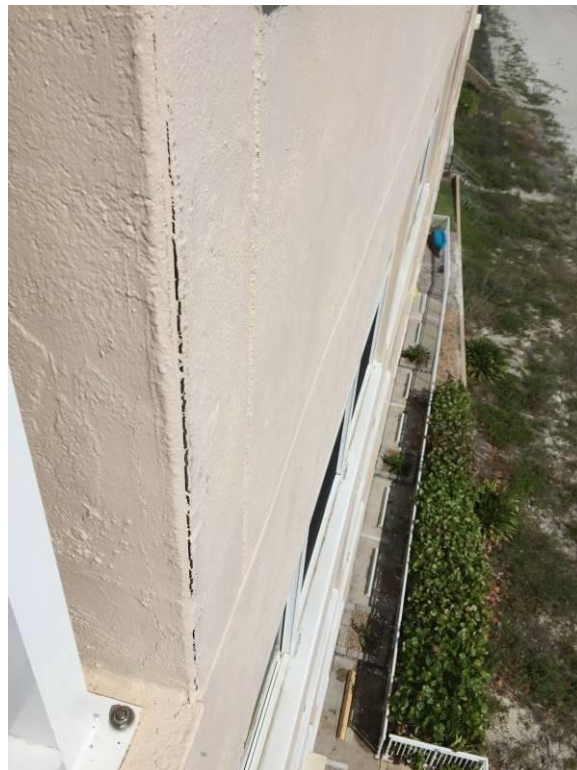
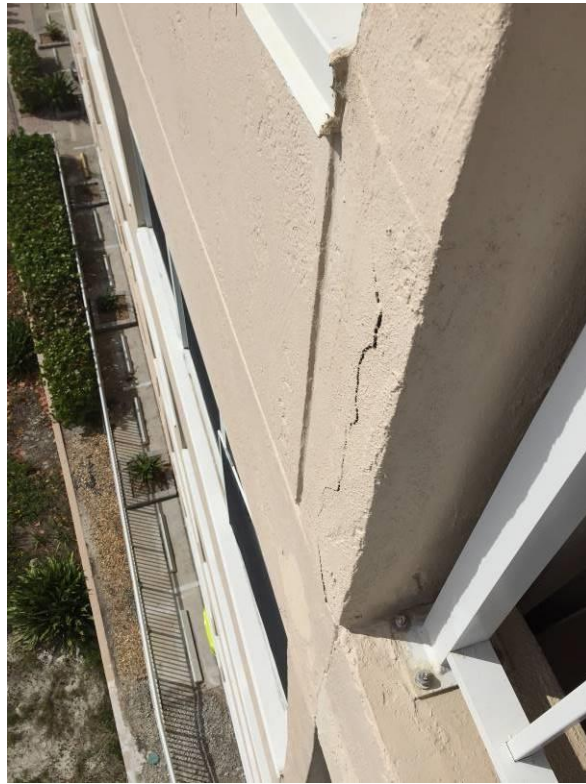
The cracked stucco on the framed walls between the balconies and the windows has the potential to allow water to ingress into the structural framing and unit interiors. This can have the potential to cause damage to the wall studs or the wall sheathing. Unfortunately, this will not be known until the stucco is removed and the extent of damage can be determined.

Photograph #6 – Typical cracking on framed wall section between balcony and window

Photograph #7 – Cracking in framed wall between the balcony and window

Where unsound stucco was cracked or appeared bulged, removal of the stucco is recommended to evaluate the cause of the disbondment and to properly adhere new stucco. A new latex modified stucco shall be specified as a replacement. Any damaged sheathing or framing should be replaced as needed when it is uncovered.

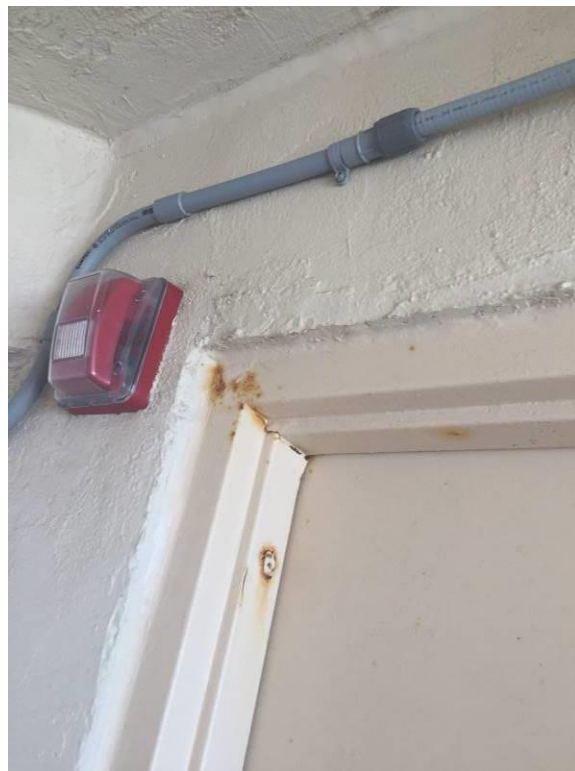
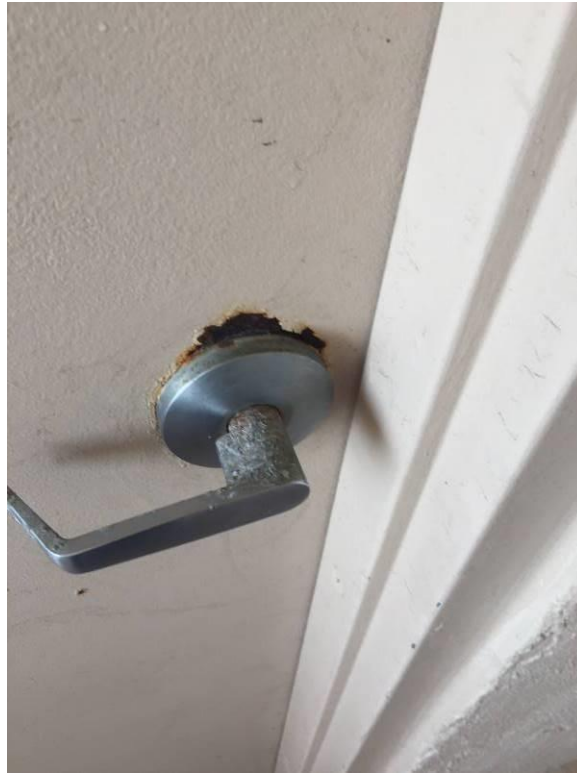
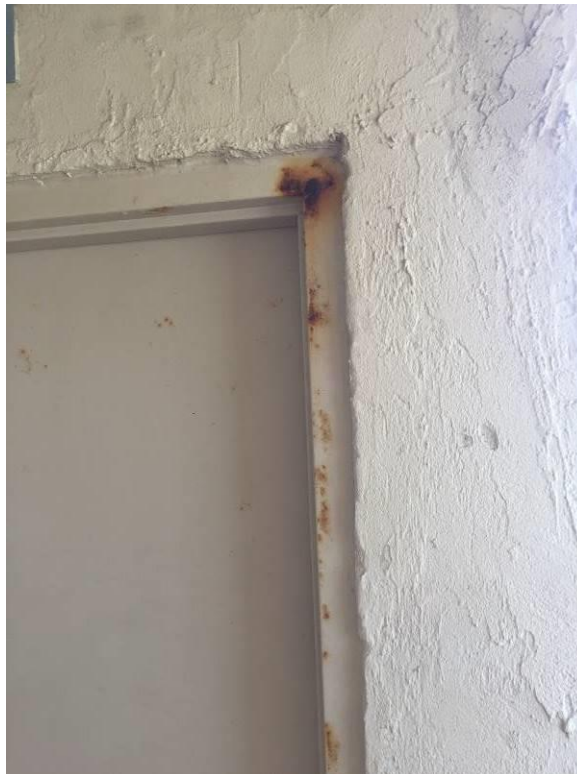
The steel stairwell door slabs and frames are corroding causing rust bleed staining. Trying to strip the paint, prepare the steel substrate and paint the doors and frames is not an economical long-term solution for the same reason as the aluminum guardrails. The corrosion is coming from inside the frames, so it will continue to occur and continually cause rust bleed out. Eventually, it can cause metal loss and holes in the frames or slabs. However, if the aesthetics is an issue, the doors can be prepared and have a field applied coating applied.

Photograph #8 – Typical corrosion of common walkway door frames

Photograph #9 – Typical corrosion on walkway common door slabs

Photograph #10 – Typical corrosion on walkway common doors

Walkway Common Doors: It should be budgeted to replace walkway common doors and frames with new fiberglass assemblies that meet the appropriate fire code. At this point in time, it is not cost effective to repair and paint the frames and doors from a longevity standpoint. Any doors that need to be removed to make proper concrete repairs may need to be replaced. The local municipality will need to provide direction if they will allow the door to be reinstalled.

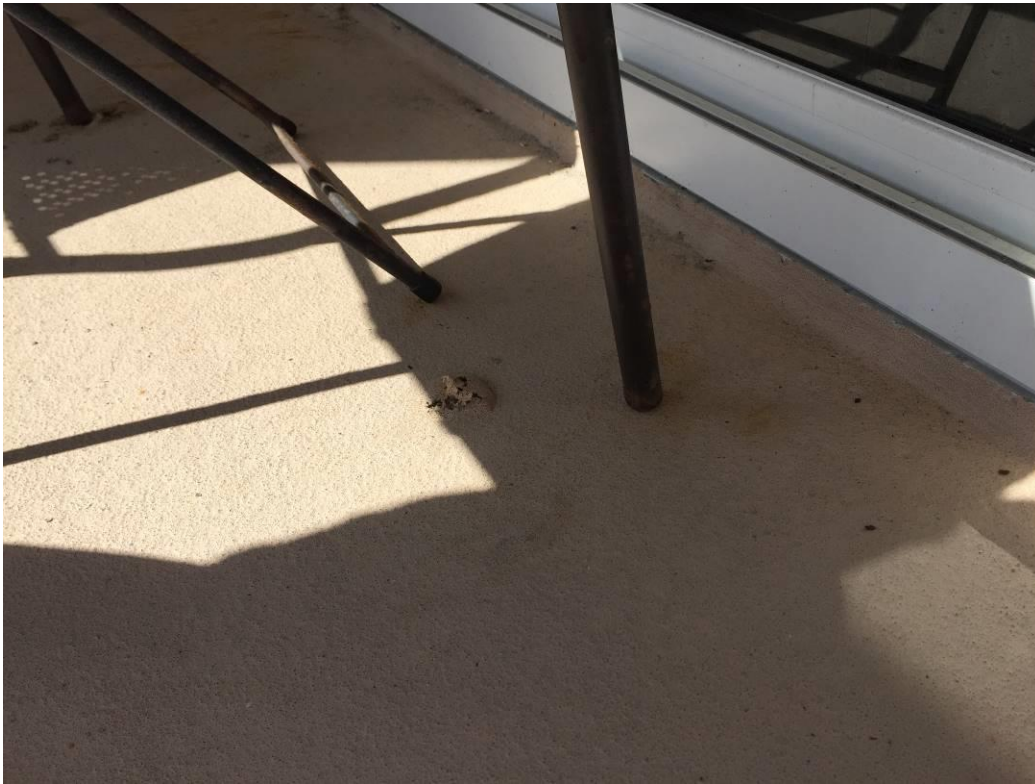
Waterproofing: The waterproof coatings on the balconies and walkways were generally in good condition with a few exceptions. These exceptions include blistering or torn coating potentially from furniture. It is our understanding there may be two deck coating systems applied. Carpet is installed on the walkways in front of the elevators. It was noted that some of the unit entry mats would hold water keeping the deck coating saturated. On the walkways by units 208 and 209, there were two areas of wrinkled and blistered deck coating.

It is our understanding that there are two full systems of urethane deck coating on the walkway and balcony slabs. Typically, the manufacturer does not recommend a third application of a coating system. Liquid applied coatings will tighten as they cure. This gives the potential to cause the older coating to lose adhesion to the substrate and result in blisters. That being said, the options are limited to removing all the coating to bare concrete and applying a new system, taking no action or applying a coating potentially without warranty. The other item to consider is if the coatings are not replaced, locations with concrete slab repair will need to have the deck coating patched which will have a repaired appearance. The ponding of water on the urethane coating systems either caused by the unit entry mats or low spots in the decks will cause the coating to degrade faster than normal wear and tear. The carpet on the walkways in front of the elevator can trap and hold moisture. Any spalling under the carpet can not be identified with the carpet in place.

Photograph #11 – Deck coating failure on balcony

The balcony and walkway deck coatings should be stripped to the concrete substrate and a new pedestrian grade urethane waterproofing system applied. There are different options for coating systems that can be discussed during the specification development phase. The parking structure deck coating should be removed to the concrete substrate and a new vehicular grade urethane deck coating system applied. A new floor to wall cant bead should be applied on the balconies, walkways and parking structure.

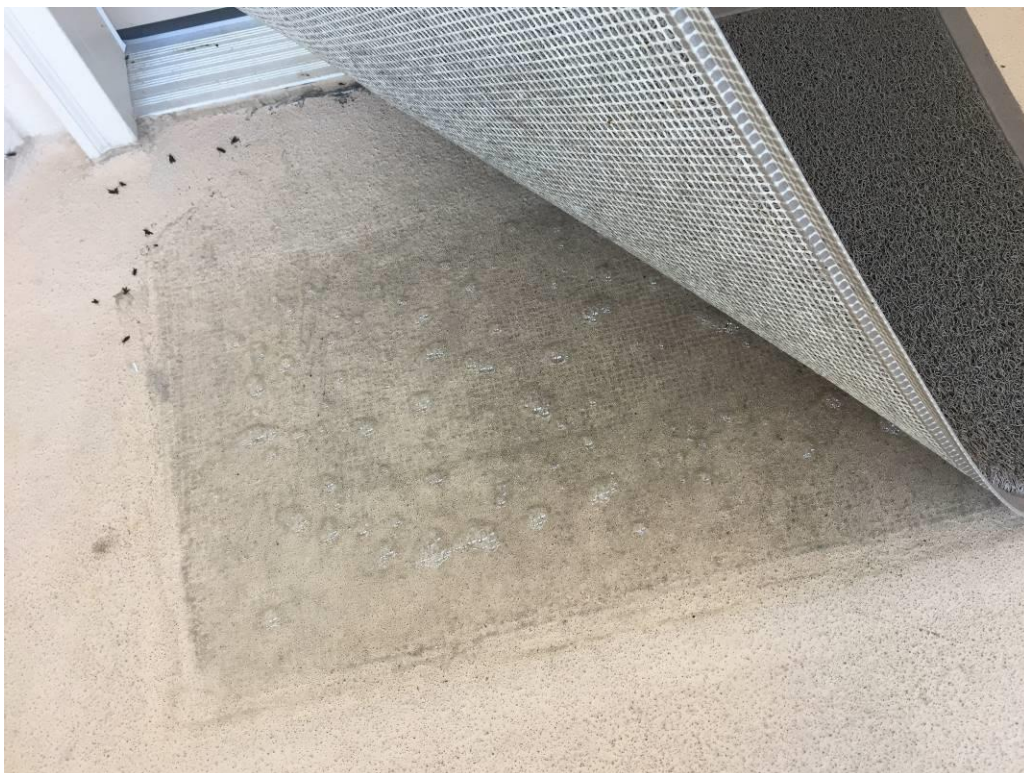
Photograph #12 – Water being held under unit entry door mat

The unit entry mats that hold water should be replaced with mats that do not trap moisture.

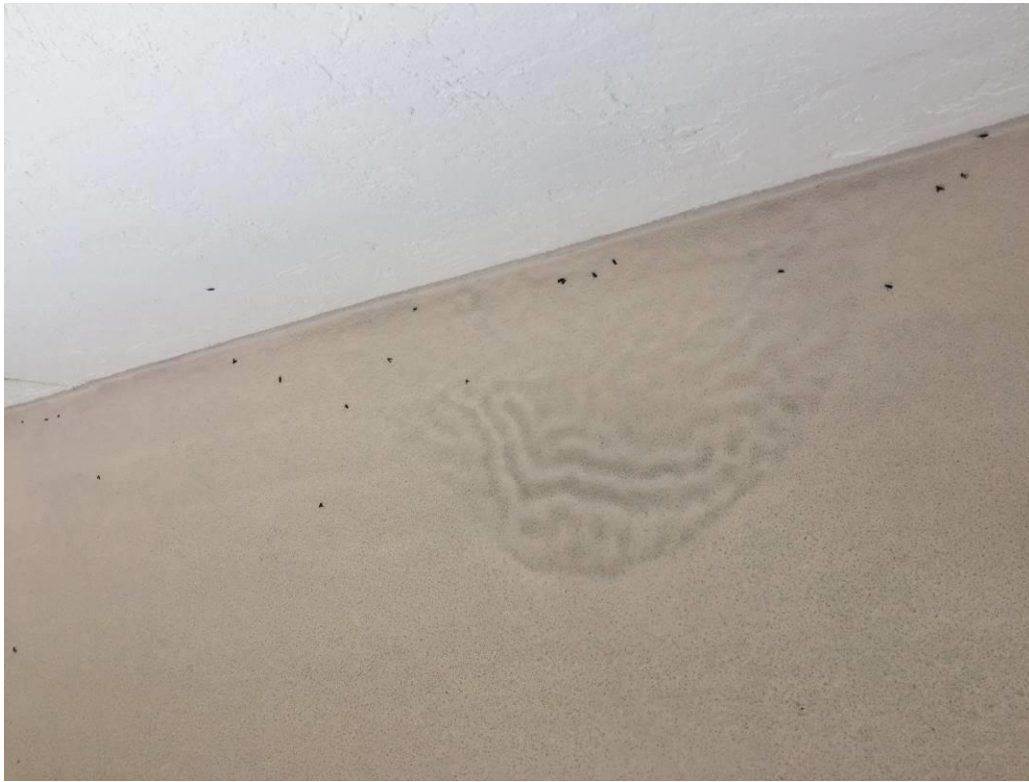
Photograph #13 – Wrinkles in walkway deck coating

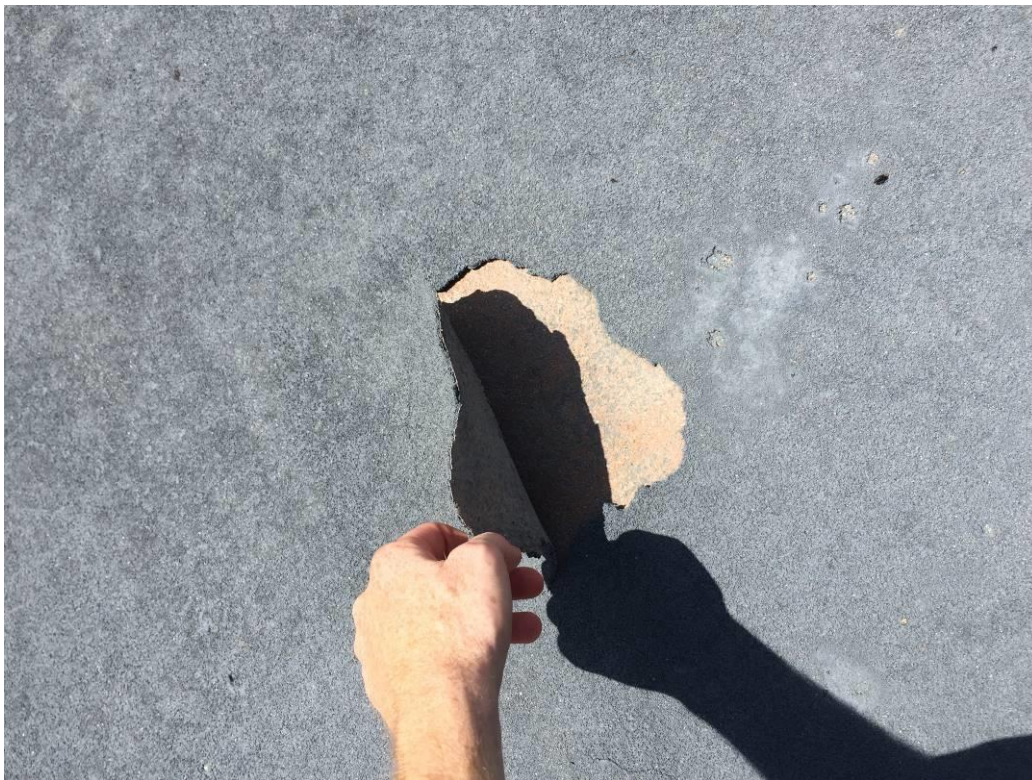
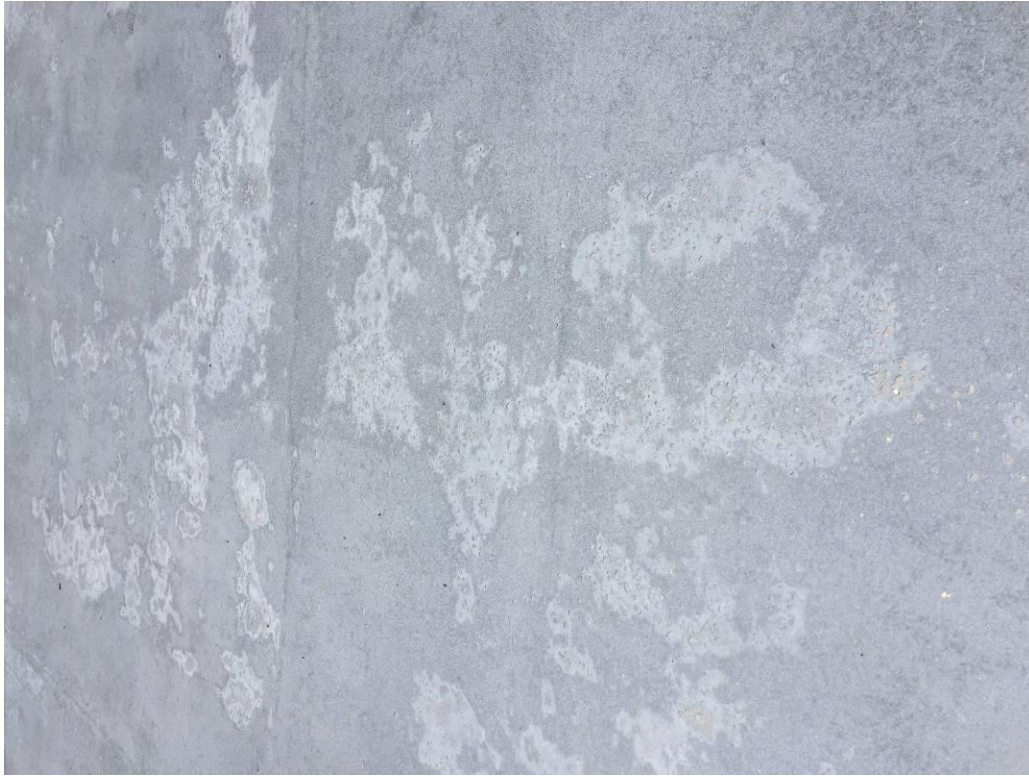
The parking structure deck coating is generally failing. There are many areas where the coating is no longer bonded to the concrete substrate. Aggregate loss is common. Blistered paint was common on the perimeter wall on the topside of the structure.

Photograph #14 – Failed deck coating on parking structure

Photograph #15 – Failed deck coating on parking structure

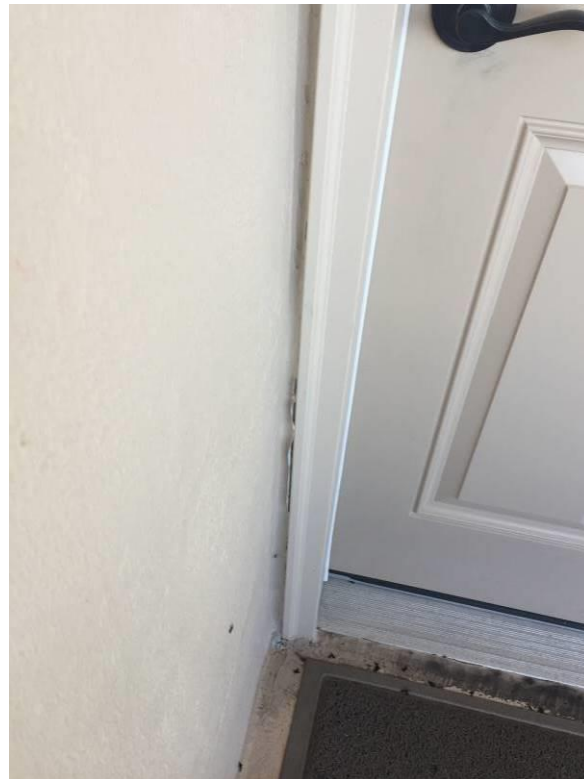
Joint sealants around windows and sliding glass doors varied in condition. However, many of the perimeter sealants had lost adhesion and had little residual elasticity. This includes the unit entry doors as well. Black Spotting and bulges were observed in the sealants around many door and windows.

Photograph #16 – Failed perimeter sealant at unit entry door

Waterproofing and Paint: Perimeter sealants around the sliding glass doors should be replaced with a new urethane sealant.

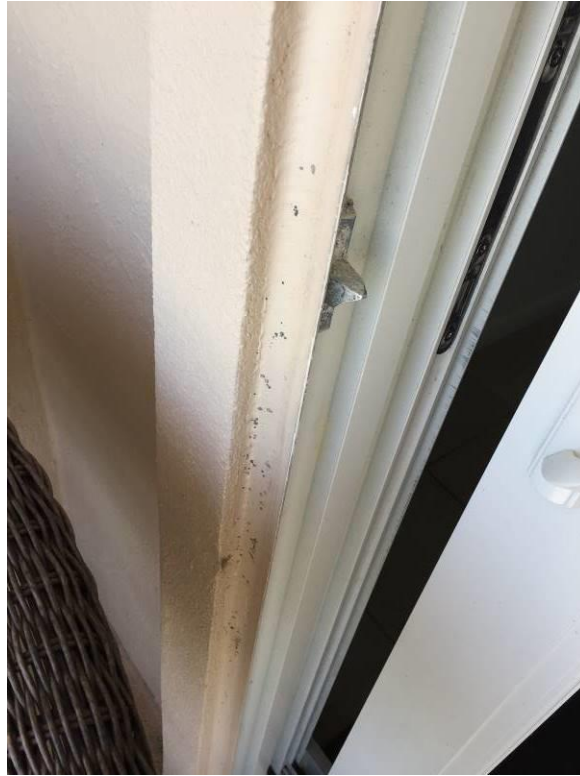
The sliding glass door thresholds and frames were oxidizing which manifests itself as pitting in the aluminum. A sealant will not properly bond to an oxidizing threshold or frame, making the joint susceptible to water penetration into the unit. The black spotting found on some of the perimeter sealants is indicative of painting the sealant prior to the sealant fully curing. In UEC's experience, subsequent paint coatings may not hide the spotting. The bulging behind the sealant appears to be caused by the oxidation of the aluminum. The oxidation creates a biproduct that can create these bulges.

Photograph #17 – Black spotting through sliding glass door perimeter sealant

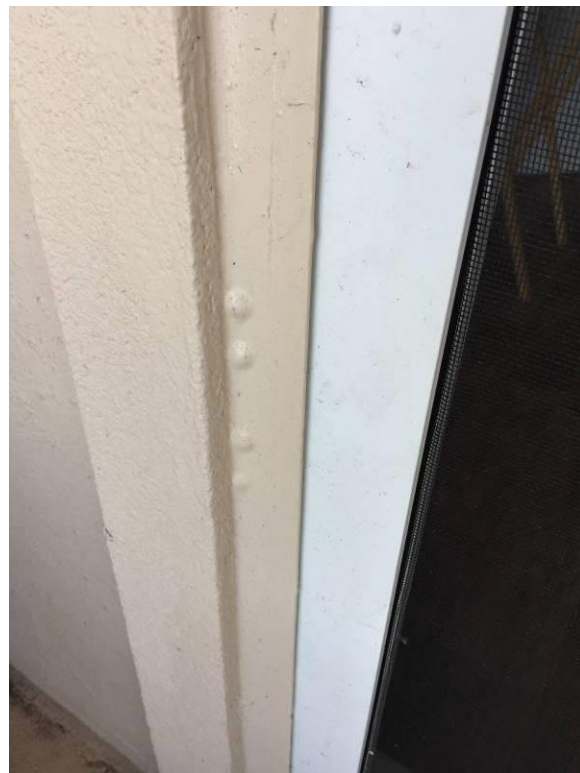
Photograph #18 – Blisters in perimeter sealant

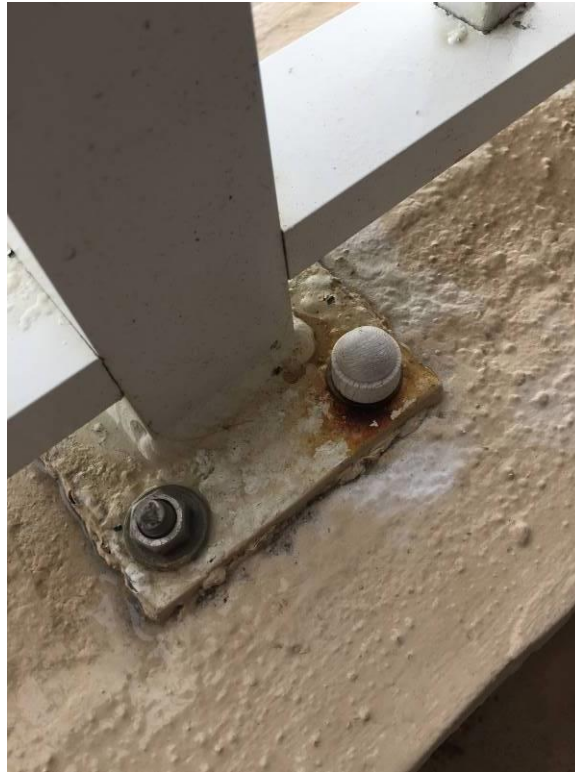
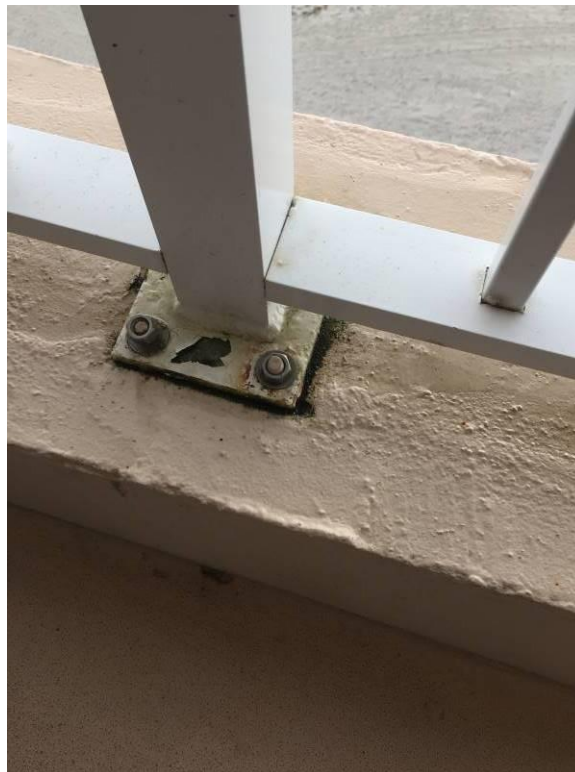
Guardrail System: It is our understanding that the balcony guardrails are around 10 years old and the walkway guardrails are approximately 5 years old. Oxidation is typical on the balcony base plates and was minimal on the framing members. The oxidation is less common on the walkway base plates and limited to the area directly around the fasteners. The coating on some of the base plates is flaking. The nuts and washers on the balcony base plates are corroding and causing rust staining on the plates. Outside of the base plates, the coating on the guardrail system appears to be in good shape. Cracking was typical on top of the walkway guard wall system, mainly at the location of the base plates.

The guardrails still provide fall protection for both the balconies and walkways. The oxidation produced on aluminum guardrails undermines the coating's adhesion and results in flaking and peeling coating. The oxidation cannot be stopped and therefore stripping and re-coating the rails generally is not an economical long-term solution. If aesthetics is an issue, the guardrails can be prepared and have a field applied coating applied. However, the oxidation will cause the new coating to fail in an unknown time frame. At some point in the future, the oxidation will begin to undermine the rails adequacy to perform structurally.

Photograph #19 – Typical balcony guardrail base plate with oxidation and rust bleed

Photograph #20 – Typical flaking paint on balcony guardrails

Guardrails: The rusting nuts and washers can be replaced on an as needed basis to prevent rust staining. The Association should begin budgeting for the replacement of the guardrails starting with the balcony rails. New fully welded surface mounted aluminum rails should be specified to be pretreated with a chromatic phosphate pretreatment before application of Kynar coatings.

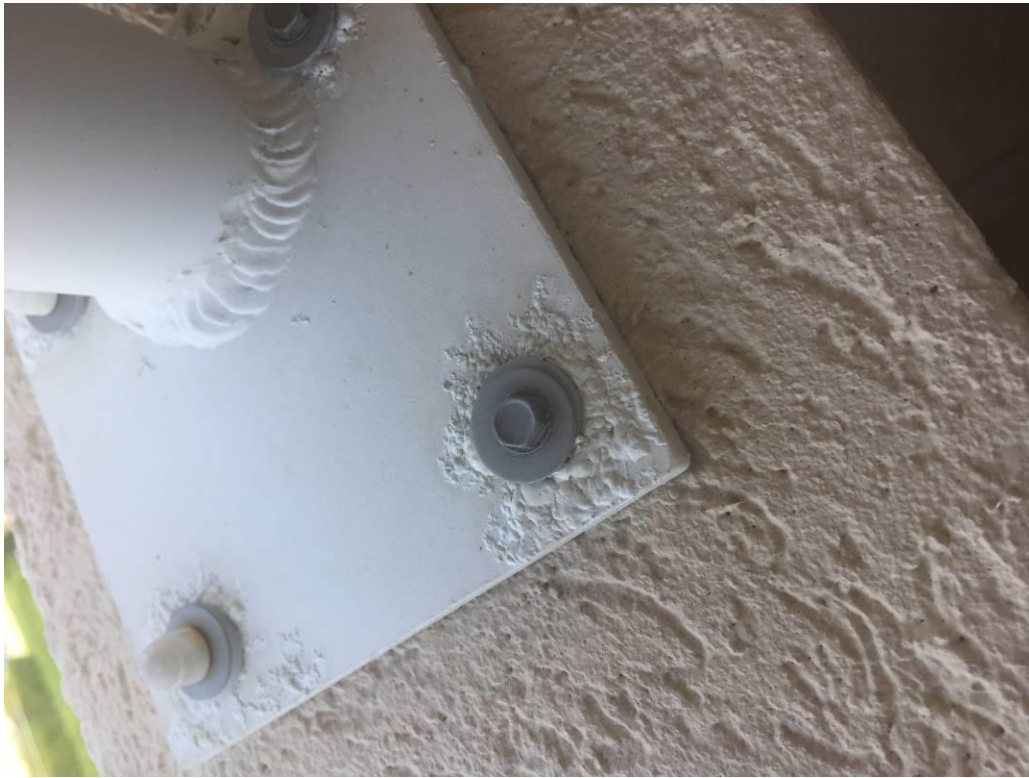
Photograph #21 – Typical oxidation on walkway guardrail base plates

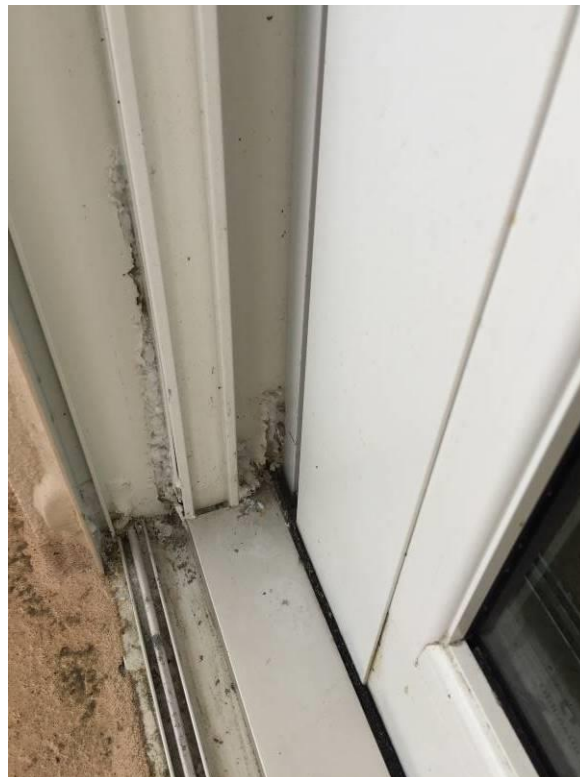
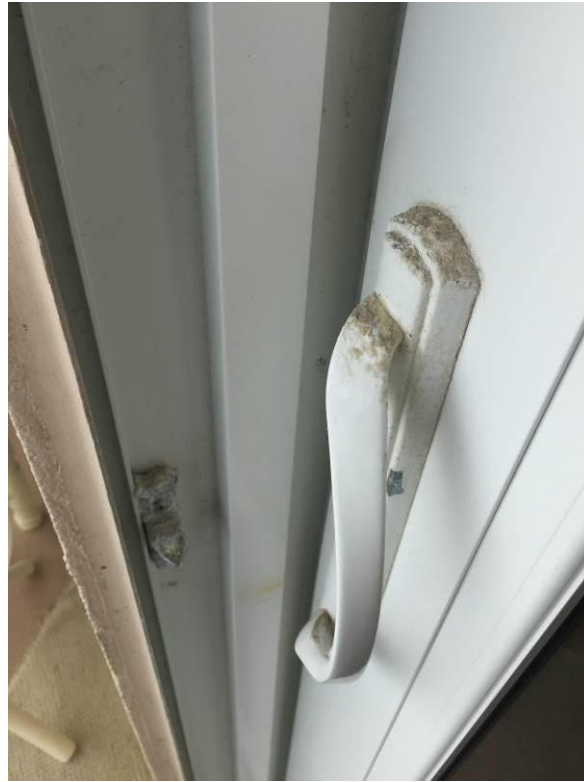
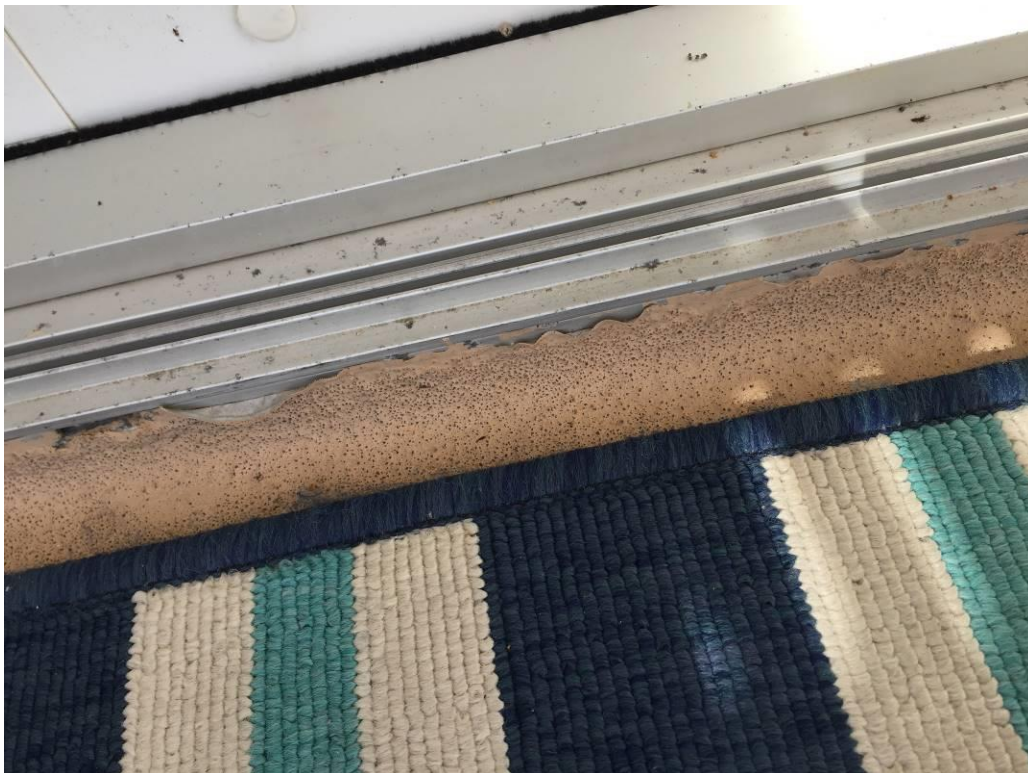
Windows and Sliding Glass Doors: The windows were generally in poor condition. Many of the frames have oxidized, leaving holes through the frames which in turn is causing coating failure. The sliding glass doors were in better shape than the windows. However, some of the sliding glass door thresholds were oxidizing as well as some door frames or trim pieces. Typically, door hardware was oxidizing or missing. Several doors were difficult to open.

Photograph #22 – Oxidizing sliding glass door framing

Photograph #23 – Typical oxidizing sliding glass door hardware

Photograph #24 – Typical oxidizing sliding glass door threshold with failed coating

The sliding glass doors should be serviced from a licensed sliding glass door installer familiar with the doors installed on the building. This can include replacement of oxidizing trim pieces and hardware if available. The threshold snap cover should be removed to inspect and repair any failed sealant over the fasteners.

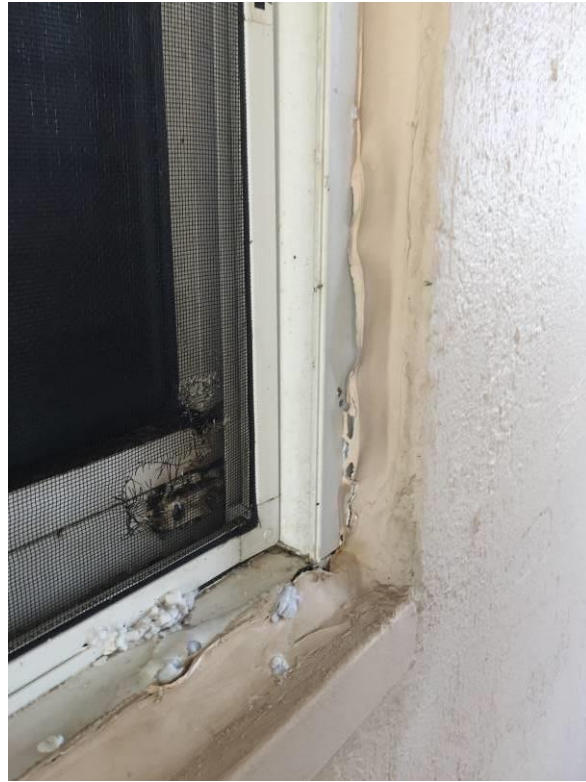
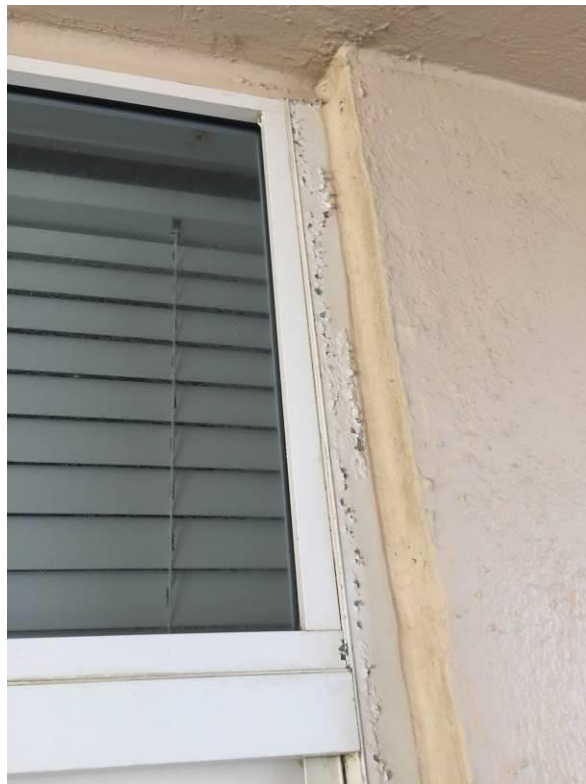
Photograph #25 – Typical oxidizing window

Photograph #26 – Typical oxidizing window

Sliding Glass Doors and Windows: The windows should be replaced with code compliant proper commercial or better grade fenestrations that meet higher performance standards for resisting water penetration, air infiltration and new energy standards.

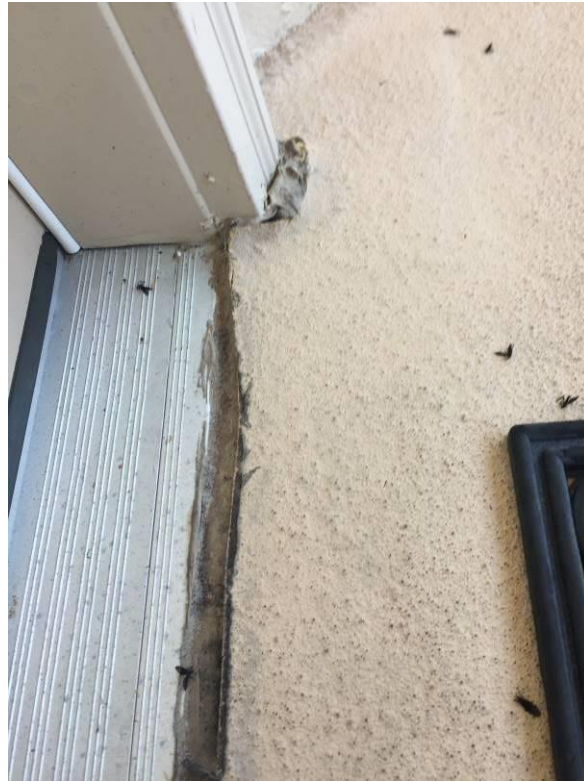
- a. Walkway Unit Doors: It appears a concrete topping was applied in front of the unit door for drainage. However, in some areas the topping is higher than the door threshold which will trap water against the door.
- b. Minimal blistered or peeling paint was observed on the building walls.
- c. Unit 502: Astro turf was installed over the urethane coating on the balcony. The condition of the coating or spalling could not be inspected.
- d. The drains on the parking structure are corroding.
- e. Rust spots were common on the bottom side of the drop-down soffit in the ground floor parking area.

Photograph #27 – Unit door with topping higher than threshold

Unit Doors: Options need to be explored for the proper remedy of the areas where the topping is higher than the door threshold.

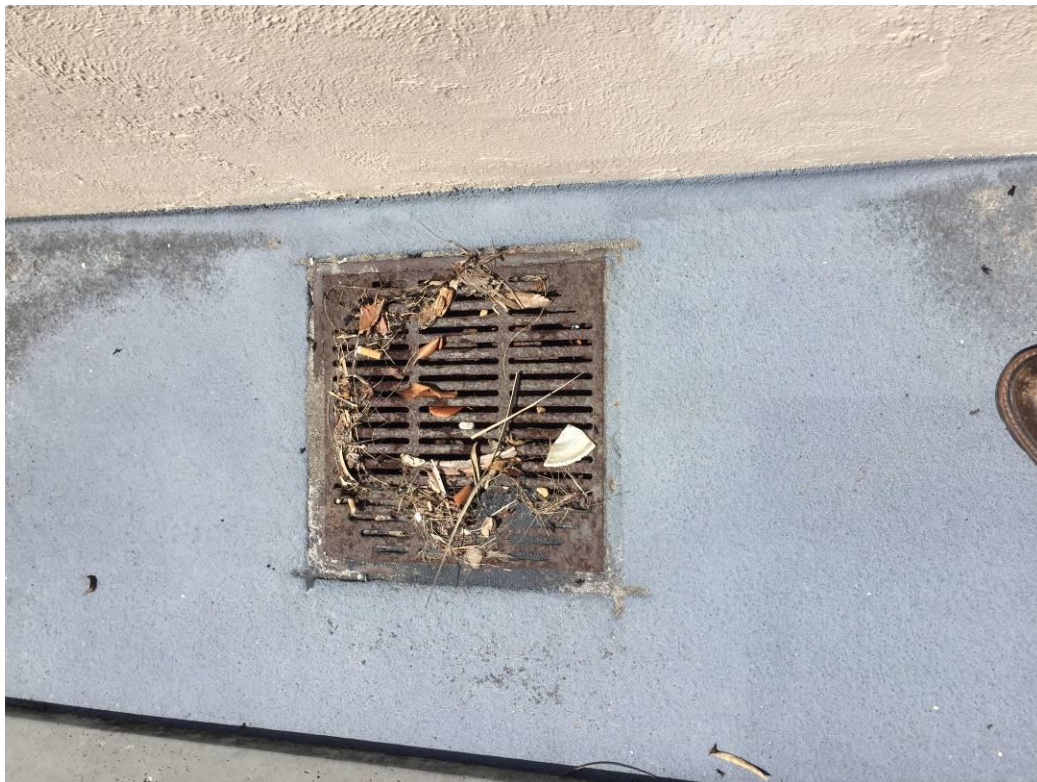
Photograph #28 – Typical corroding parking structure drain

Parking Structure Drains: The drains and drain covers should be replaced with new corrosion resistant drains and covers.

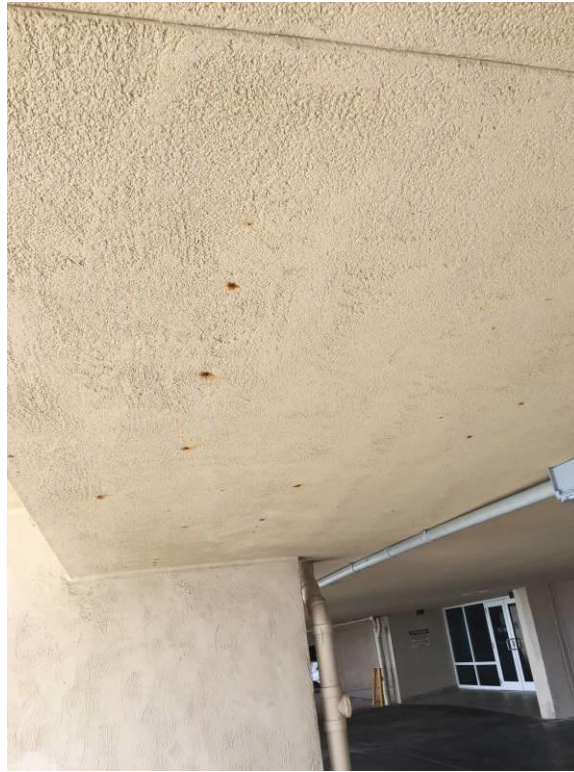
The rust spots on the bottom of the drop-down soffit in the ground floor parking area may be caused by the fasteners used to attach the sheathing to the framing. More exploratory work needs to be done to determine the cause of the rust spots. This will provide the information needed to direct a proper repair.

Photograph #29 – Typical rust spots on drop down soffit of ground floor parking area

Soffit Rust Spots in Ground Floor Parking Area: Exploratory work should be conducted to determine the cause of the rust spots to determine the proper repair.
