UNITED ENGINEERING CONSULTANTS, INC.

FIELD OBSERVATION REPORT PERMIT # BLDC-000287-2020

Report No. 75	Page 1 of 1
Project:	Southpoint Condominium	Inspection For:	Restoration Project
Day/Date:	Tuesday, January 19, 2021	Job No.	19-1086
Location:	4453 S. Atlantic Ave, Ponce Inlet	Engineer:	Timothy J. Snook, P.E.
Contractor:	ACE Enterprises, LLC	Project Foreman:	Wes Swaim
Subcontractor:	Gulfstream Glass (4)	Inspector:	Timothy J. Snook, P.E.
Weather:	64 Degrees @ 10:50 A.M.	Sunny	Light Breeze 0% Chance of Rain
Workforce Total:	14		
Activities:	Concrete repair, stucco application, painting, window installation, punch out

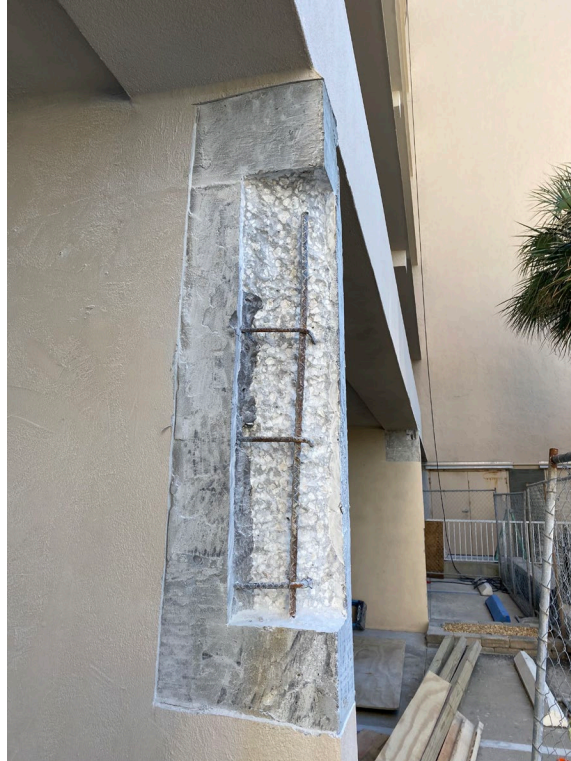
The Engineer was on-site to inspect completed concrete repairs on the divider walls in the garage and the header of Unit 505 window (See Photos 1-3). The excavations conformed to ICRI standards. The reinforcing steel was cleaned. The excavations were supplemented as directed. The excavations were approved to be cast. Forming and casting repairs is in-progress.

Picture 1: Completed excavation on the divider walls

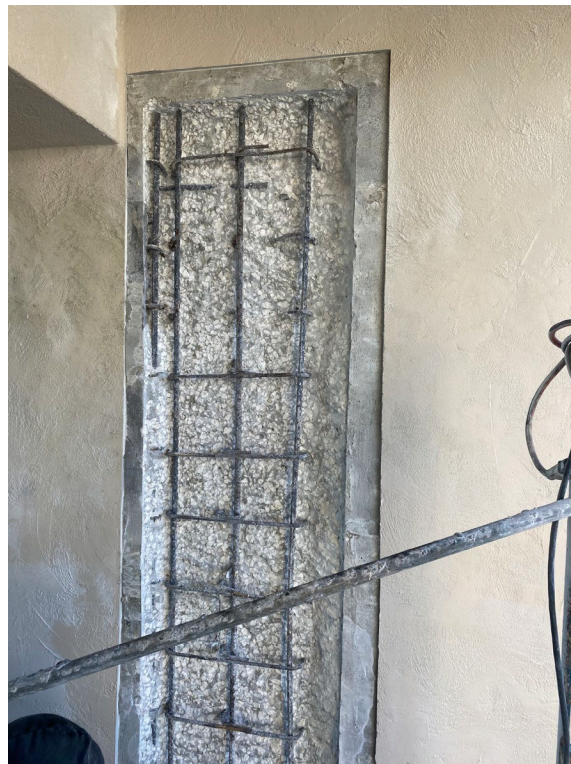
Picture 2: Completed excavation on the divider walls

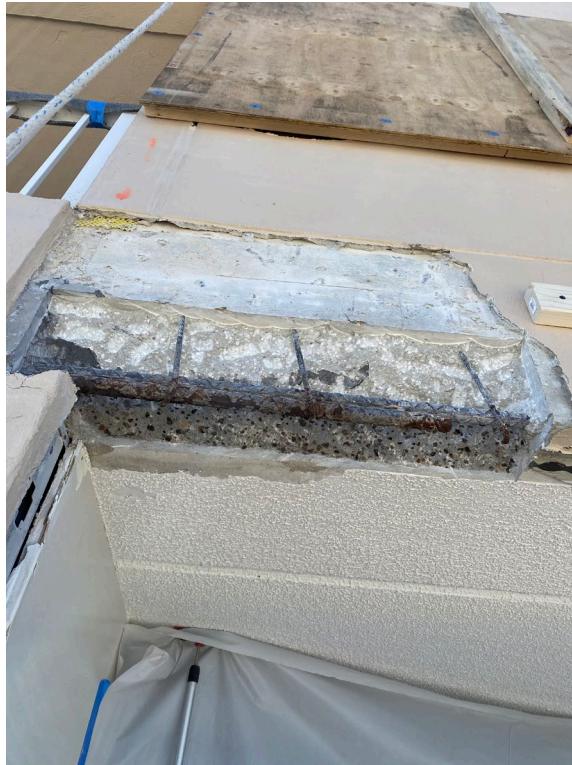
Picture 3: Header repair at Unit 505
