UNITED ENGINEERING CONSULTANTS, INC.

FIELD OBSERVATION REPORT PERMIT # BLDC-000287-2020

Report No. 77	Page 1 of 1
Project:	Southpoint Condominium	Inspection For:	Restoration Project
Day/Date:	Tuesday, January 26, 2021	Job No.	19-1086
Location:	4453 S. Atlantic Ave, Ponce Inlet	Engineer:	Timothy J. Snook, P.E.
Contractor:	ACE Enterprises, LLC	Project Foreman:	Wes Swaim
Subcontractor:	N/A	Inspector:	Timothy J. Snook, P.E.
Weather:	68 Degrees @ 10:20 A.M. Sunny	Light Breeze	0% Chance of Rain
Workforce Total:	14		
Activities:	Concrete repair, stucco application, floor grinding

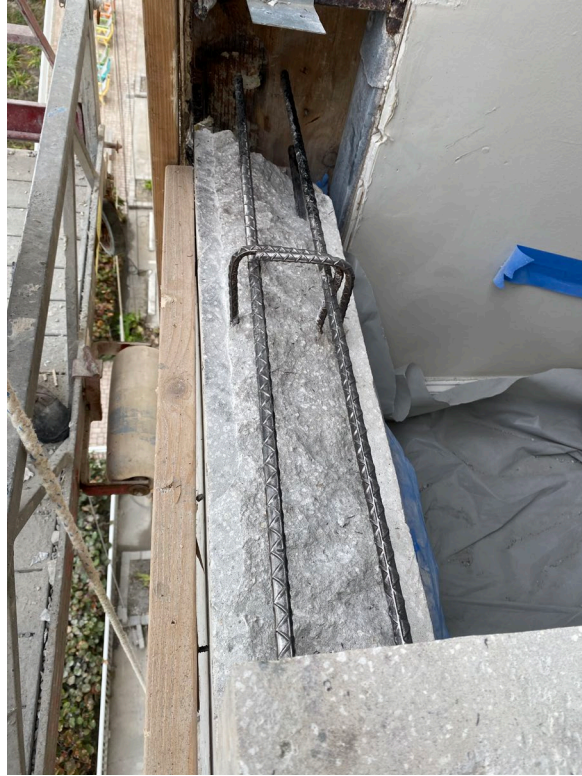
The Engineer was on-site to inspect completed concrete repairs on the header of Unit 505 and miscellaneous repairs on the 05/06 stacks (See Photo 1). The excavations conformed to ICRI standards. The reinforcing steel was cleaned. The excavations were supplemented as directed. The excavations were approved to be cast. Forming and casting repairs is in-progress.

Picture 1: Unit 505 window sill repair

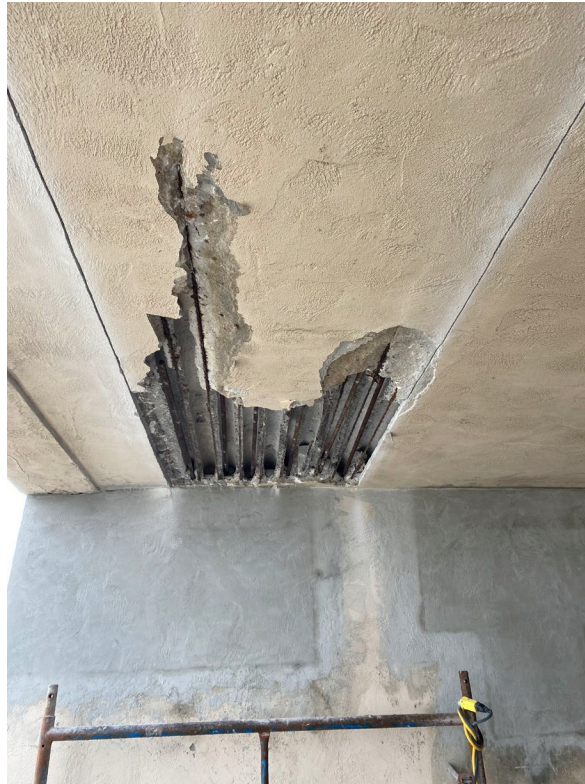
Concrete demolition continues on the 02 and 03 stack balconies as well as the ceiling of the parking garage. The Engineer inspected a concrete ceiling excavation under unit 103. The Owners Representative directed him to not go into the unit for the concrete repair. It will be made at another time in the future. This repair will be localized against the divider wall and under the balcony (See Photo 2).

Picture 2: Ceiling repair in garage below unit 103
