UNITED ENGINEERING CONSULTANTS, INC.

FIELD OBSERVATION REPORT PERMIT # BLDC-000287-2020

Report No. 78	Page 1 of 1
Project:	Southpoint Condominium	Inspection For:	Restoration Project
Day/Date:	Thursday, January 28, 2021	Job No.	19-1086
Location:	4453 S. Atlantic Ave, Ponce Inlet	Engineer:	Timothy J. Snook, P.E.
Contractor:	ACE Enterprises, LLC	Project Foreman:	Wes Swaim
Subcontractor:	N/A	Inspector:	Timothy J. Snook, P.E.
Weather:	56 Degrees @ 1:00 P.M. Sunny Windy 0% Chance of Rain		
Workforce Total:	11		
Activities:	Concrete repair, stucco application, floor grinding

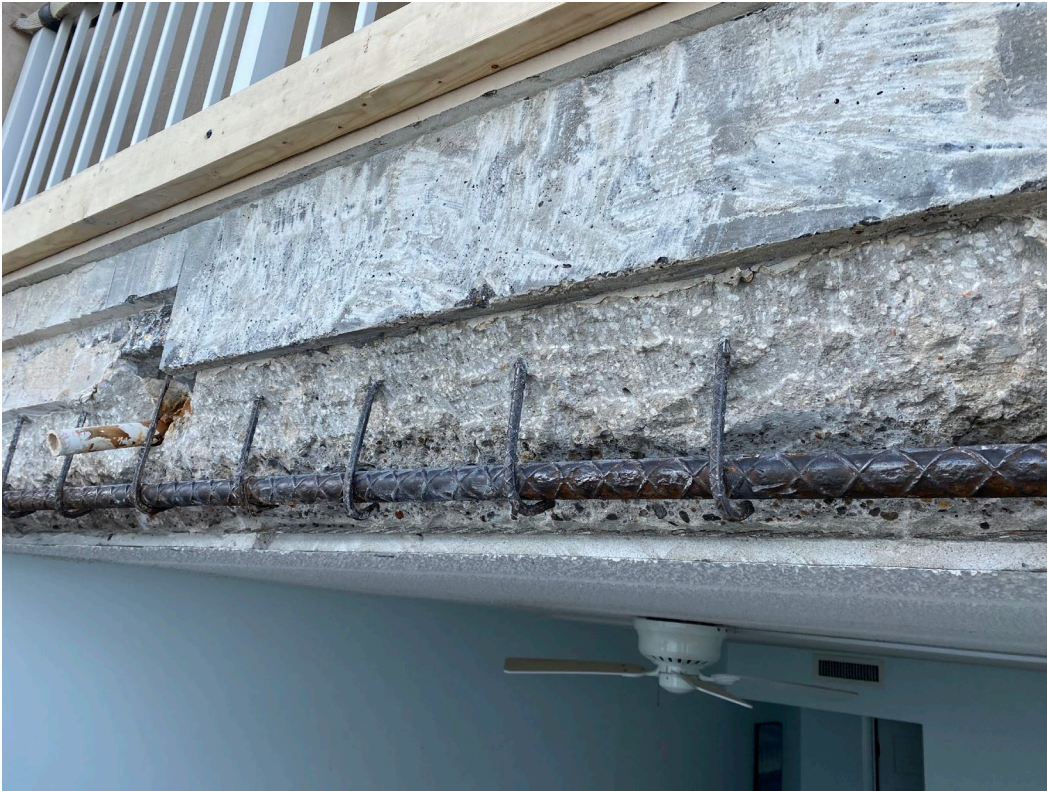
The Engineer was on-site to inspect the completed concrete repair on the header of Unit 602 (See Photo 1). The excavation conformed to ICRI standards. The reinforcing steel was cleaned. The excavation was approved to be cast. Forming repairs is in-progress. The Engineer provided direction for the supplementation of full depth repairs on the walkway and unit 103 balcony.

Picture 1: Unit 692 window header repair

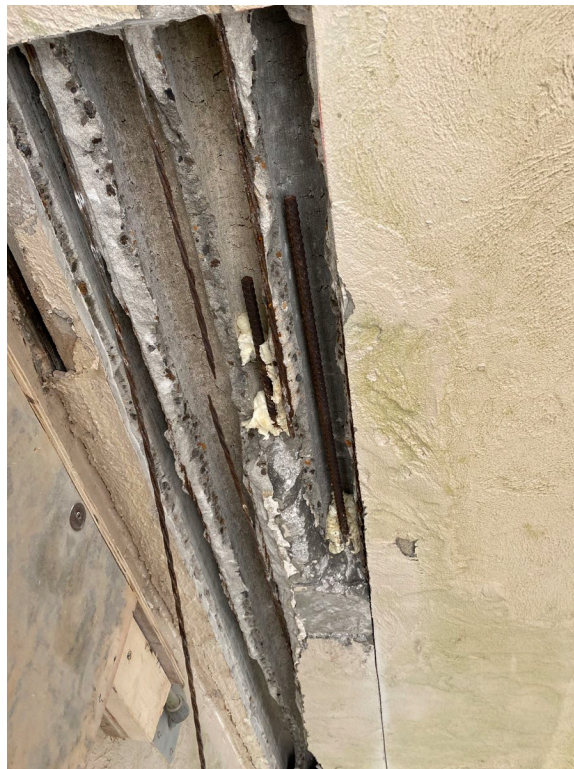
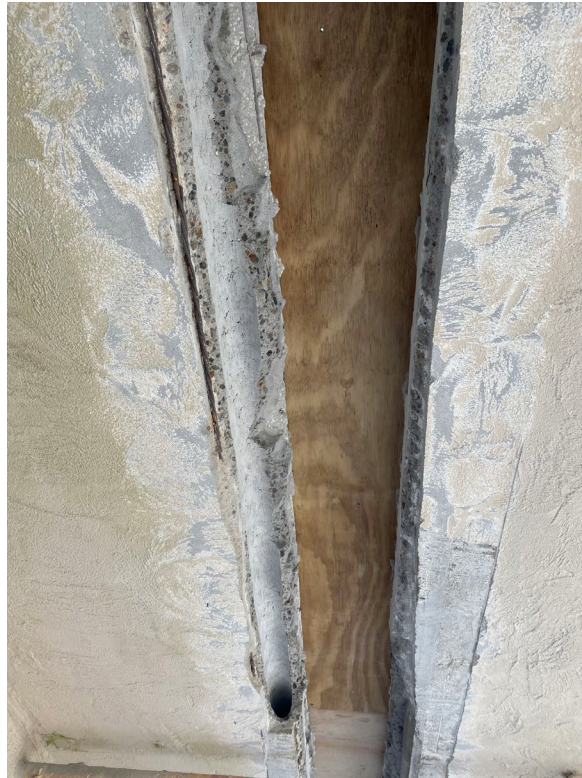
Concrete demolition continues on the walkways as well as the ceiling of the parking garage (See Photos 2-3).

Picture 2: In-progress walkway repair

Picture 3: In-progress walkway repair

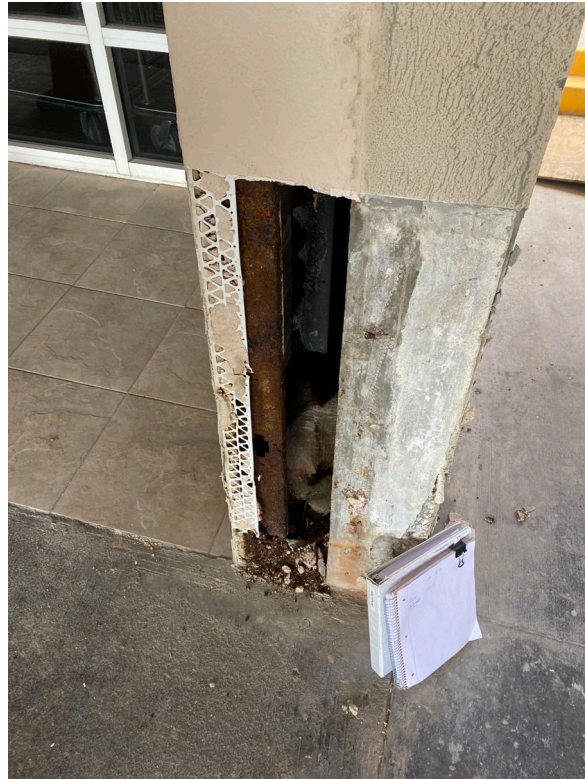
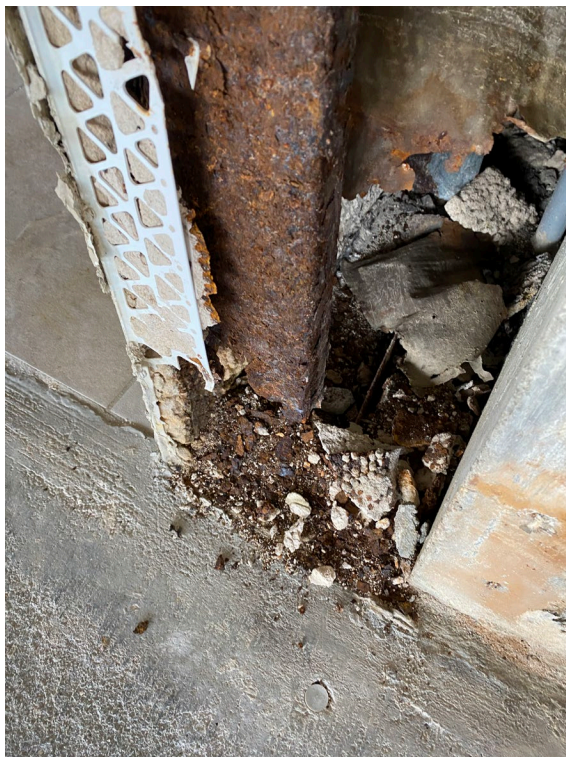
The Engineer inspected a stucco repair area on the Northeast side of the elevator lobby entrance that exposed a corroded light gage metal stud (See Photos 4-5). The Engineer directed the Contractor chase the stud to find non-corroded steel. A new section of stud will be spliced to the existing stud.

Picture 4: Corroded wall stud, East side of elevator lobby

Picture 5: Corroded wall stud, East side of elevator lobby
