# UNITED ENGINEERING CONSULTANTS, INC.

## FIELD OBSERVATION REPORT PERMIT # BLDC-000287-2020

Report No. 47	Page 1 of 1
Project:	Southpoint Condominium	Inspection For:	Restoration Project
Day/Date:	Monday, October 12, 2020	Job No.	19-1086
Location:	4453 S. Atlantic Ave, Ponce Inlet	Engineer:	Timothy J. Snook, P.E.
Contractor:	ACE Enterprises, LLC	Project Foreman:	Wes Swaim
Subcontractor:	Gulfstream Glass (3)	Inspector:	Timothy J. Snook, P.E.
Weather:	88 Degrees @ 1:15 P.M.	Sunny	Light Breeze 10% Chance of Rain
Workforce Total:	12		
Activities:	Concrete repair, Window trim installation, stucco, pressure washing

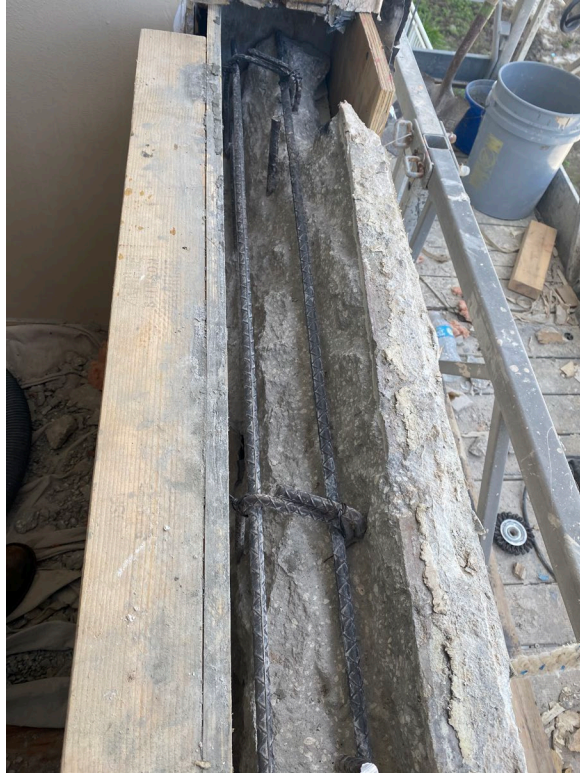
The Engineer was on-site to inspect the completed repair at Unit 208 window sill (See Photo 1). The excavation conformed to ICRI standards. The reinforcing steel was cleaned and no supplemental steel was needed. The excavation was approved to be cast.

Picture 1: Unit 208 window sill repair

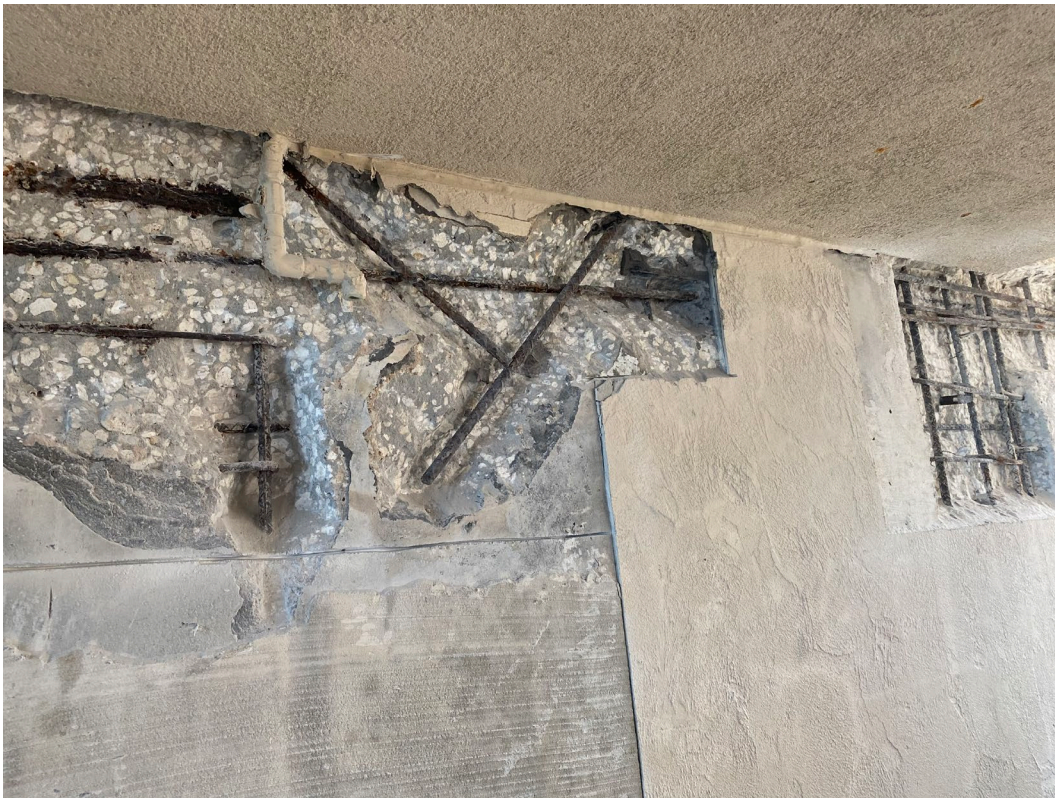
Picture 2: In-progress concrete repairs

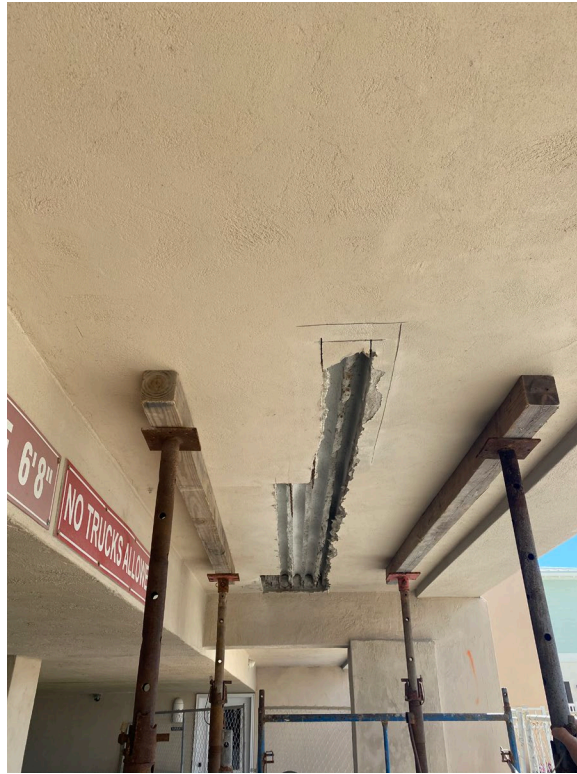
Picture 3: In-progress slab repair below 1<sup>st</sup> floor walkway

Concrete demolition continues in the garage under the building (See Photo 2). The Engineer provided direction for a full depth walkway slab repair (See Photos 3-4).

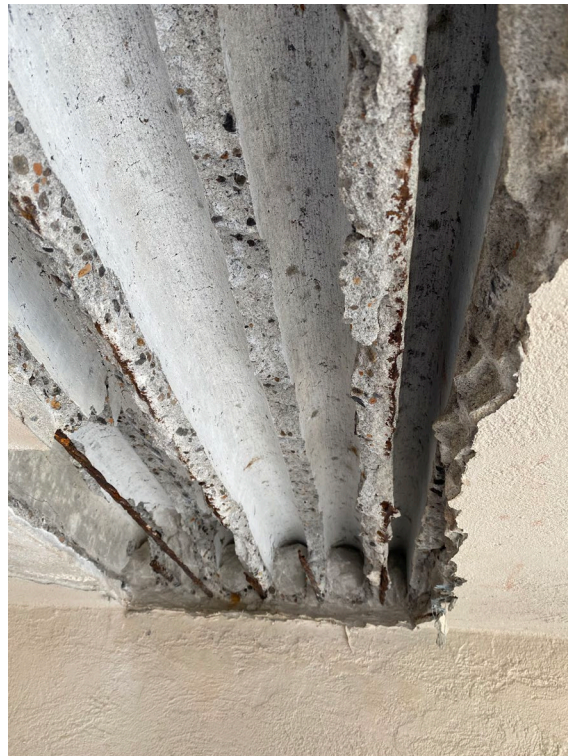
Picture 4: Close up of broken steel cables in walkway repair
