# UNITED ENGINEERING CONSULTANTS, INC.

## FIELD OBSERVATION REPORT PERMIT # BLDC-000287-2020

Report No. 48	Page 1 of 1
Project:	Southpoint Condominium	Inspection For:	Restoration Project
Day/Date:	Wednesday, October 14, 2020	Job No.	19-1086
Location:	4453 S. Atlantic Ave, Ponce Inlet	Engineer:	Timothy J. Snook, P.E.
Contractor:	ACE Enterprises, LLC	Project Foreman:	Wes Swaim
Subcontractor:	Gulfstream Glass (2)	Inspector:	Timothy J. Snook, P.E.
Weather:	74 Degrees @ 7:50 A.M. Sunny	Light Breeze	10% Chance of Rain
Workforce Total:	15		
Activities:	Concrete repair, stairwell door installation, painting, pressure washing

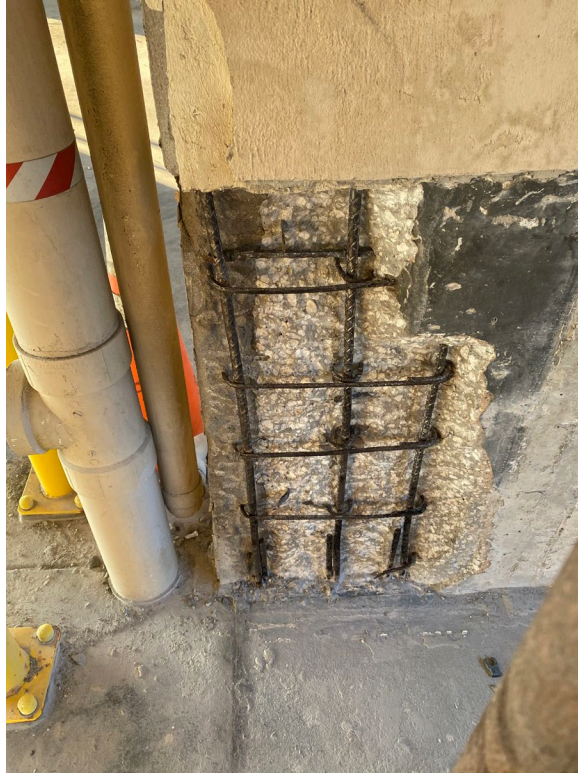
The Engineer was on-site to inspect the completed repairs in the garage under the building (See Photos 1-2). The excavations conformed to ICRI standards. The reinforcing steel was cleaned and supplemental steel was installed as directed. The excavations were approved to be cast.

Picture 1: Completed excavation

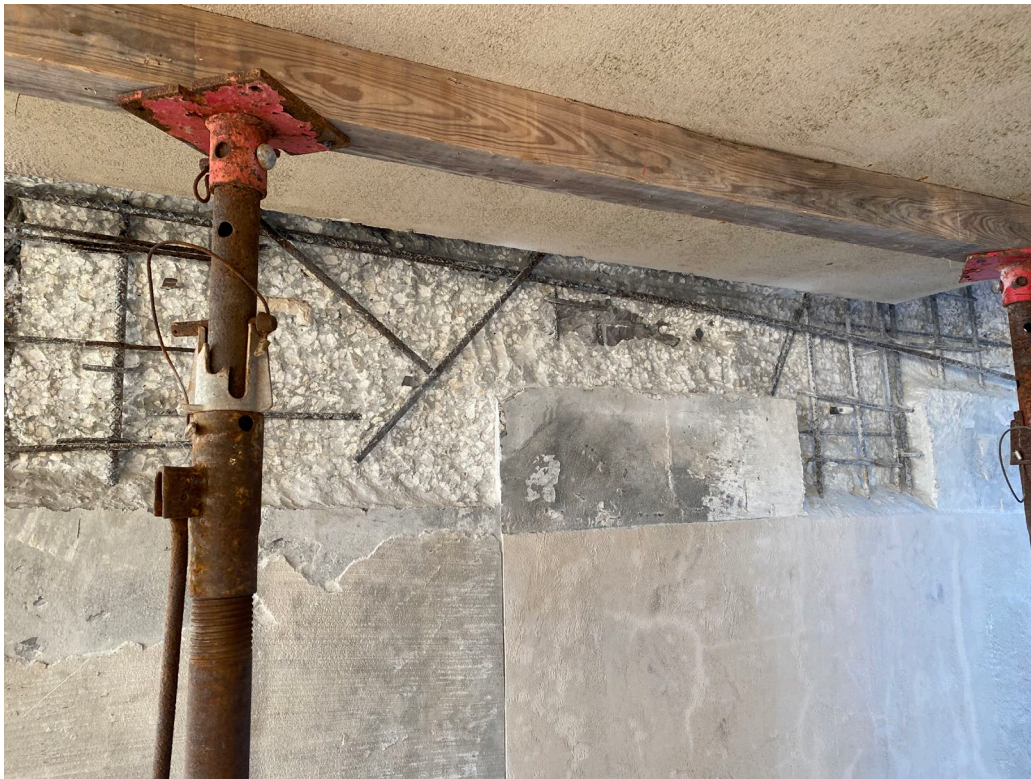
Picture 2: Completed excavation prior to steel cleaning

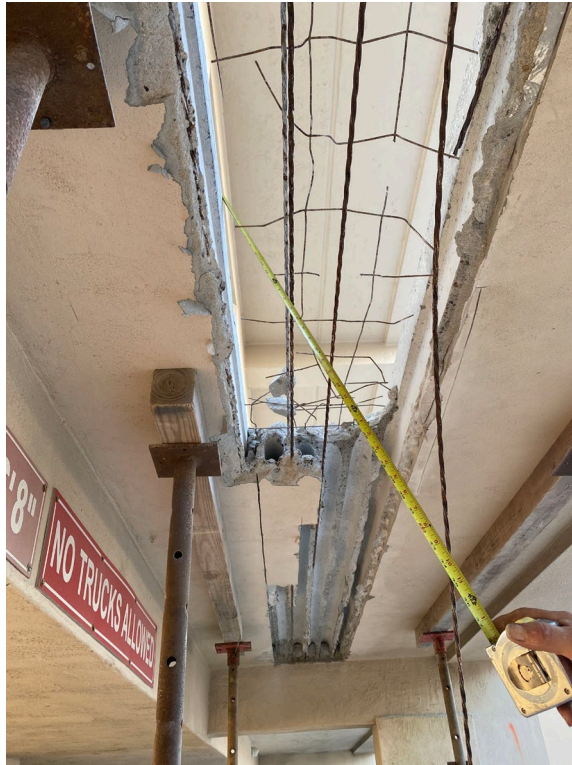
Concrete demolition continues in the garage under the building and on the 1<sup>st</sup> floor walkway (See Photo 3).

Picture 3: In-progress walkway repair
