FIELD OBSERVATION REPORT PERMIT # BLDC-000287-2020

Report No. 44	Page 1 of 1
Project:	Southpoint Condominium	Inspection For:	Restoration Project
Day/Date:	Friday, October 2, 2020	Job No.	19-1086
Location:	4453 S. Atlantic Ave, Ponce Inlet	Engineer:	Timothy J. Snook, P.E.
Contractor:	ACE Enterprises, LLC	Project Foreman:	Wes Swaim
Subcontractor:	Gulfstream Glass (4)	Inspector:	Timothy J. Snook, P.E.
Weather:	71 Degrees @ 9:20 A.M. Sunny Light Breeze 0% Chance of Rain		
Workforce Total:	13		
Activities:	Concrete repair, window installation, stucco repair, pressure washing, grinding

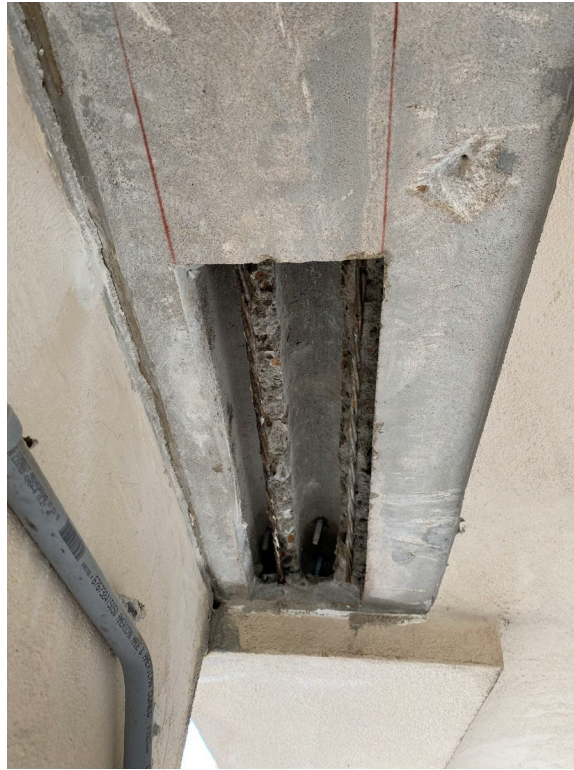
The Engineer was on-site to inspect an in-progress concrete repair in the slab in front of the 1st floor South stairwell (See Photo 1). One of the reinforcing strands is broken and requires supplementation. The Engineer provided the direction for steel supplementation.

Picture 1: In-progress ceiling repair

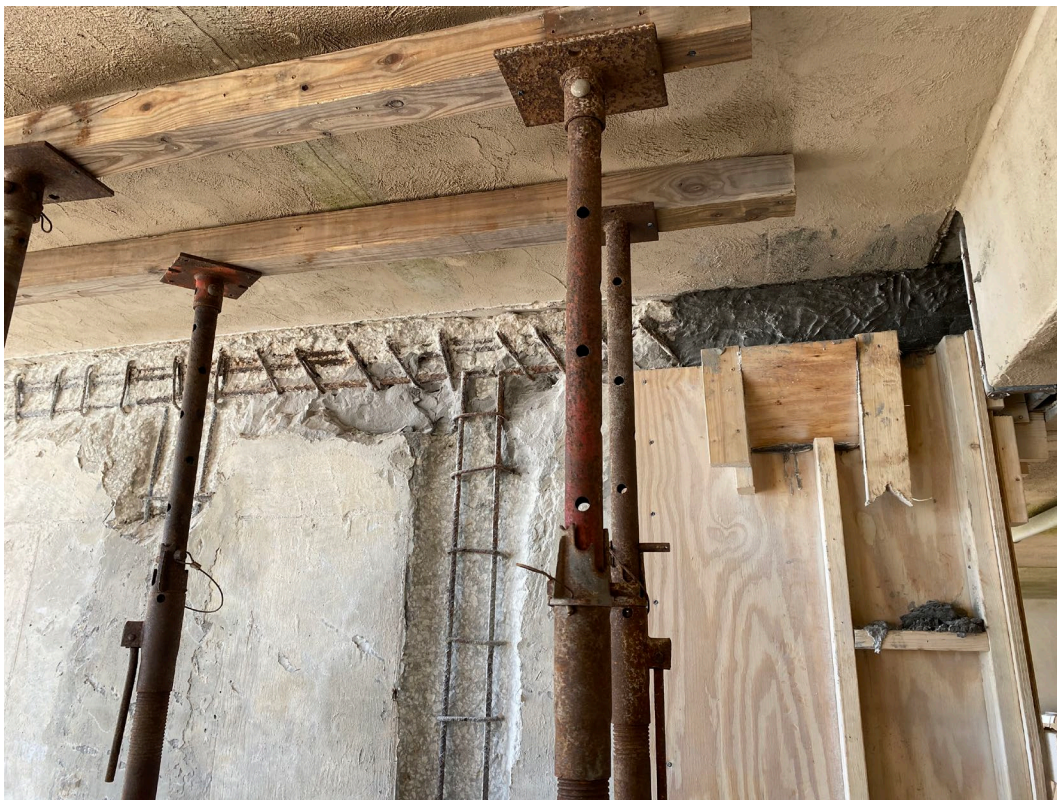
Concrete demolition continues in the parking area below the building (See Photo 2).

Picture 2: In-progress demon walls in parking area below the building

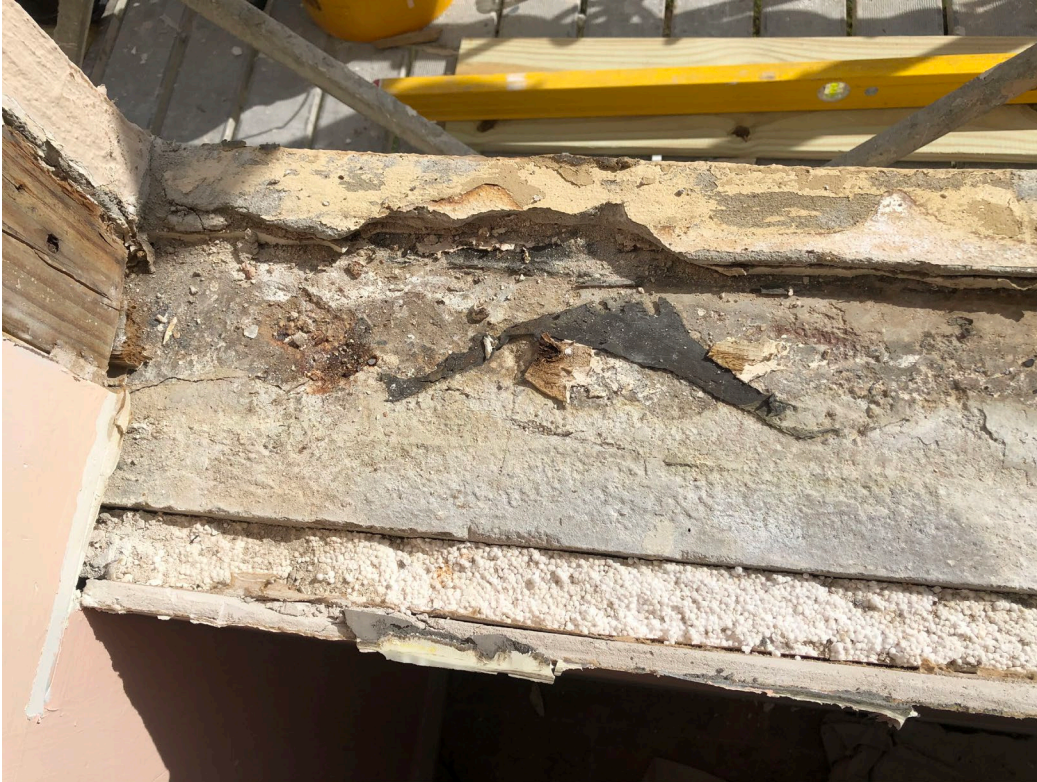
Gulfstream removed the window of Units 309 and 308 today. There was concrete damage on the window sill of both units that will require a hardwall barrier be installed prior to demolition (See Photos 3-4).

Picture 3: Cracked window sill of Unit 309

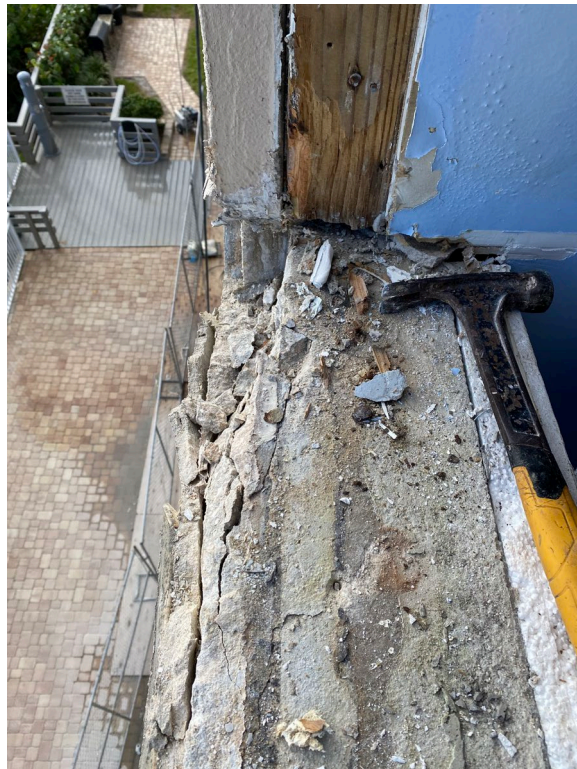
Picture 4: Cracked window sill of Unit 308
