UNITED ENGINEERING CONSULTANTS, INC.

FIELD OBSERVATION REPORT PERMIT # BLDC-000287-2020

| Project: | Southpoint Condominium | Inspection For: | Restoration Project |
| Day/Date: | Tuesday, October 20, 2020 | Job No. | 19-1086 |

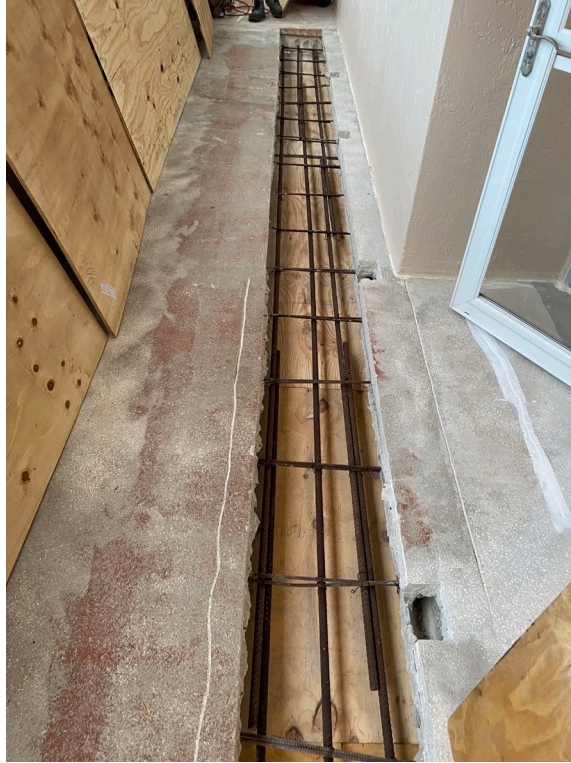
The Engineer was on-site to inspect the completed repairs in the garage under the building and the first floor walkway full depth repair (See Photos 1-4). The excavations conformed to ICRI standards. Supplemental steel installation was in-progress on the full depth. The bottom steel was installed and approved. Top steel installation was in-progress. The reinforcing steel was cleaned. The excavations were approved to be cast.

Picture 1: 1st floor walkway repair prior to top steel installation

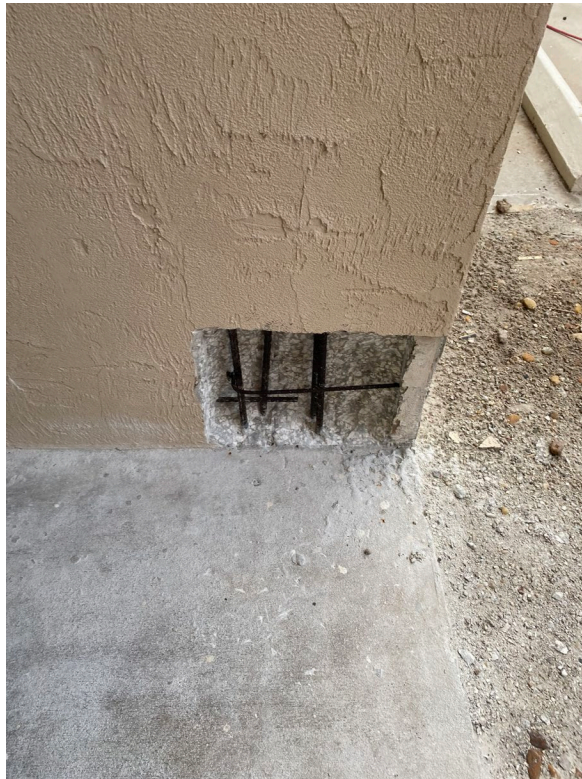
Picture 2: Typical wall repair

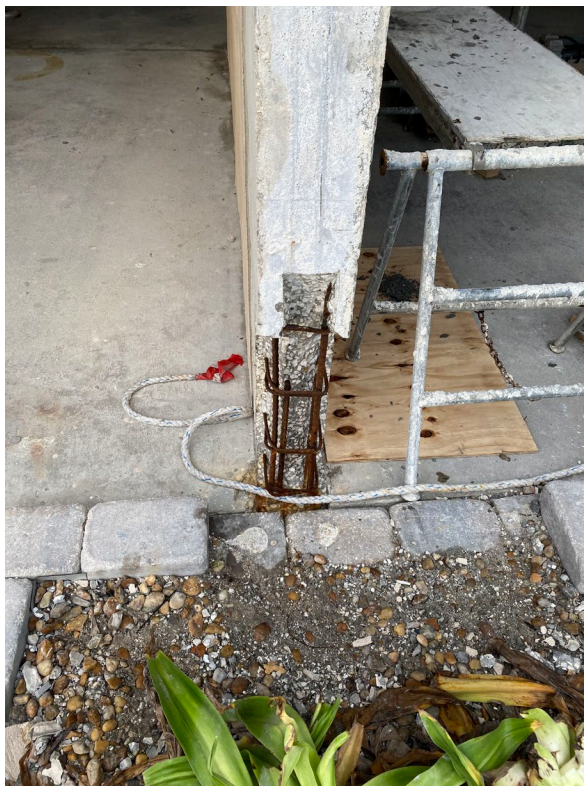
Picture 3: Typical wall repair

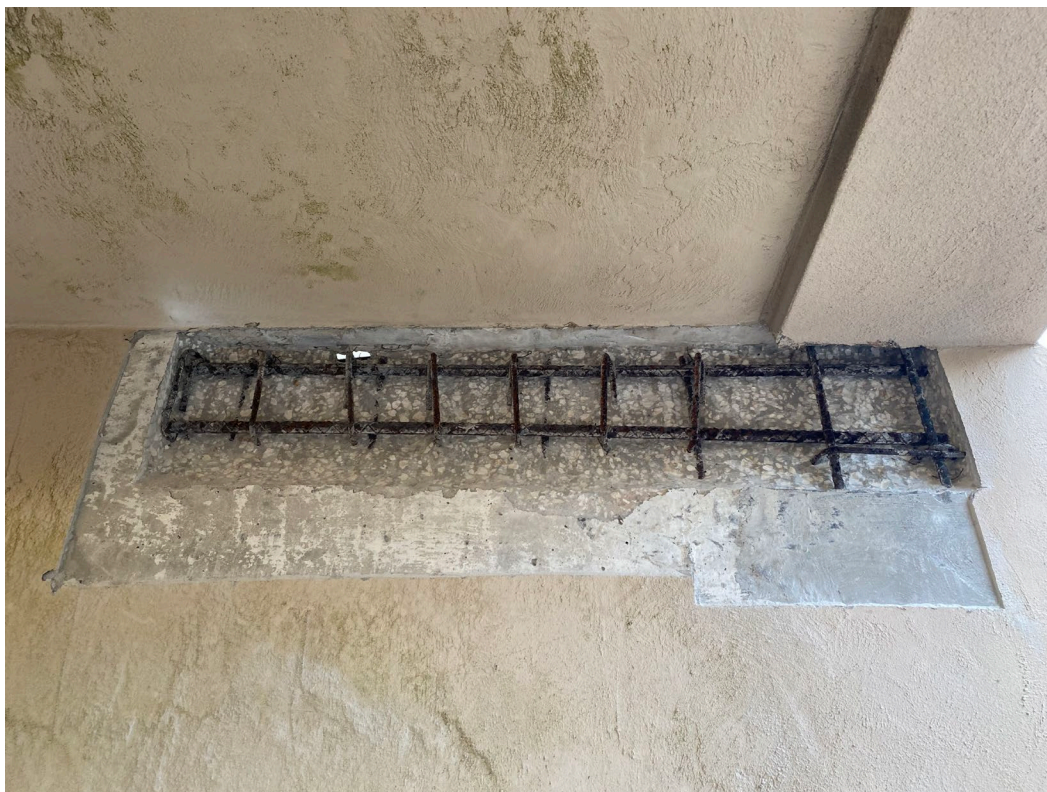
Picture 4: Typical wall repair

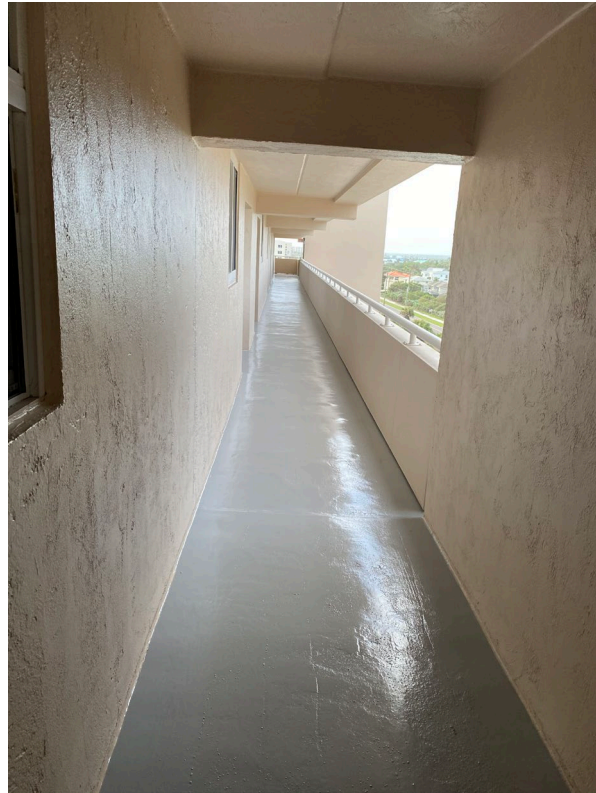
Deck coating began yesterday on the walkways floors 7 and 6 (See Photo 5). The rain stopped the contractor from progressing further. Today, base coat application continues starting on the 5th floor.

Picture 5: Base coat application on the 6th floor walkway
