UNITED ENGINEERING CONSULTANTS, INC.

FIELD OBSERVATION REPORT PERMIT # BLDC-000287-2020

| Project: | Southpoint Condominium | Inspection For: | Restoration Project |
| Day/Date: | Thursday, October 22, 2020 | Job No. | 19-1086 |

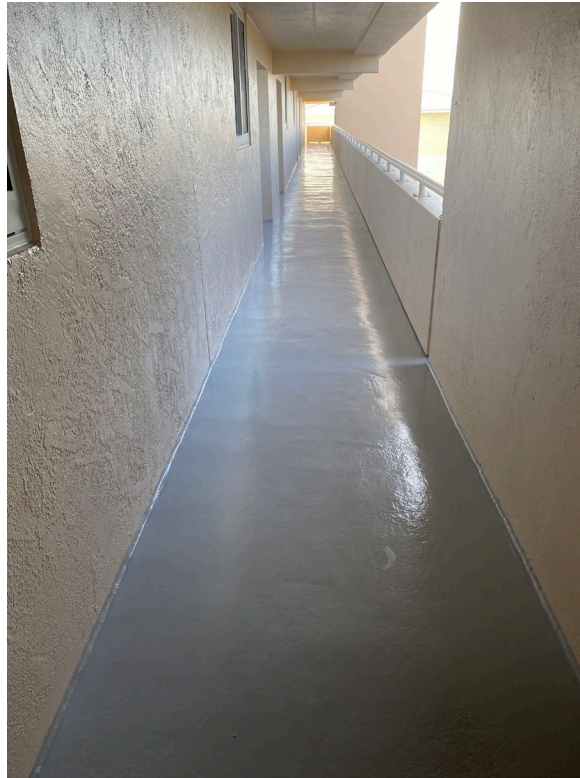
The base coat has been applied to the walkways of the 2nd floor through the 7th floor (See Photos 1-2). Any blisters are being flat caulked as recommended by the Manufacturer. Application of the intermediate coat sanded to the point of rejection will begin on the 2nd floor progressing upwards.

Picture 1: Typical base coat application

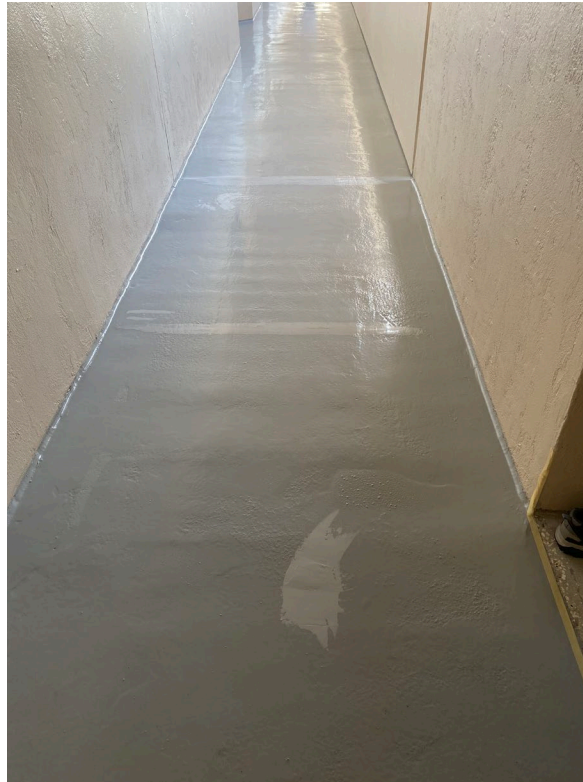
Picture 2: Typical flat caulking of blisters

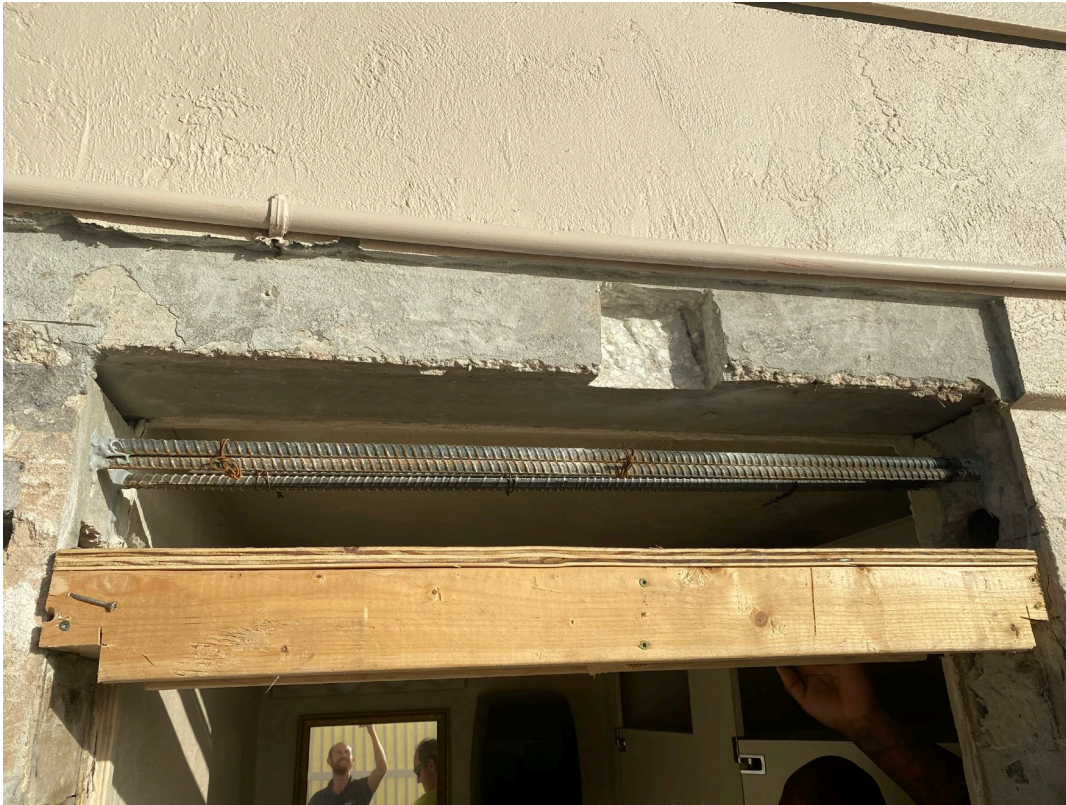
The Engineer was on-site to inspect the completed repairs header repairs and the window sill of Units 108 and 109 (See Photos 3-4). The excavations conformed to ICRI standards. Supplemental steel was installed as directed. The reinforcing steel was cleaned. The excavations were approved to be cast.

Picture 3: Header repair at Women's bathroom

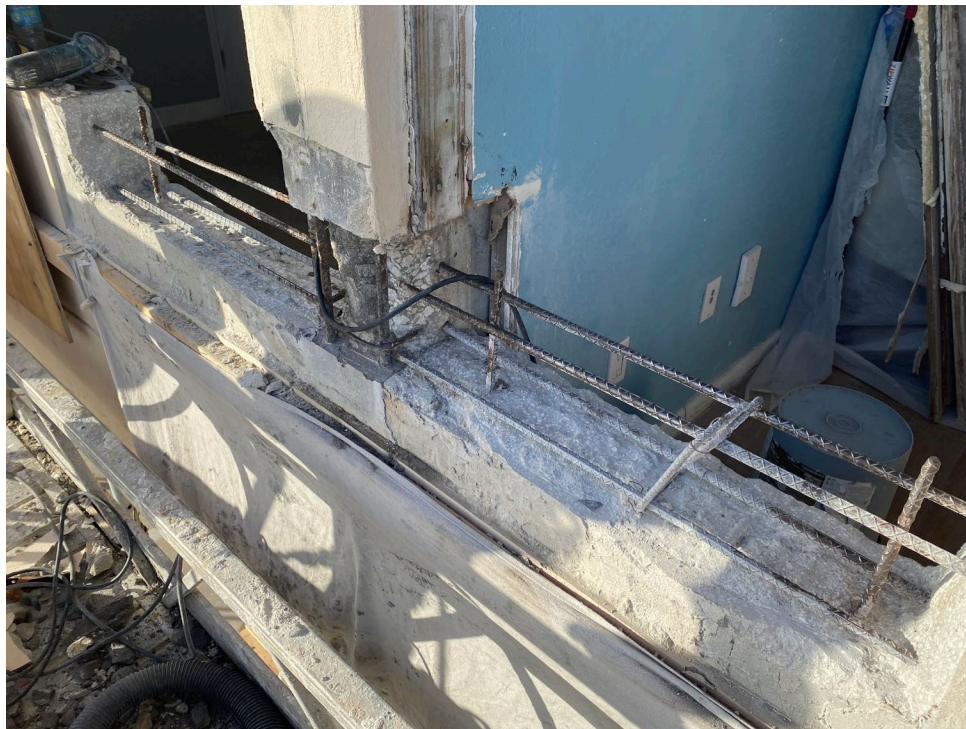
Picture 4: Unit 108 and 109 window sill repairs

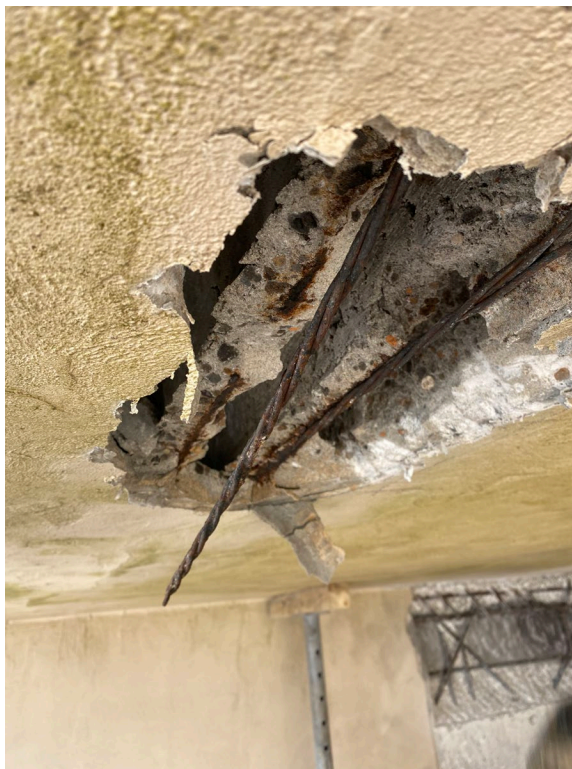
The Contractor excavated a small area of a bulging crack on the bottom side of Unit 108. The crack runs North to South under the balcony and bedroom. The exploratory work found two corroded tendons in the hollow core slab (See Photo 5). One tendon was fully broken and the other had broken strands. The Engineer notified the Manager and recommended the repair be made full depth since the crack transfers through the top of the panel. Cracks can be seen in the tile in the bedroom.

Picture 5: Broken tendons in ceiling of slab below Unit 108
