## FIELD OBSERVATION REPORT PERMIT # BLDC-000287-2020

Report No. 45	Page 1 of 1
Project:	Southpoint Condominium	Inspection For:	Restoration Project
Day/Date:	Tuesday, October 6, 2020	Job No.	19-1086
Location:	4453 S. Atlantic Ave, Ponce Inlet	Engineer:	Timothy J. Snook, P.E.
Contractor:	ACE Enterprises, LLC	Project Foreman:	Wes Swaim
Subcontractor:	Gulfstream Glass (6)	Inspector:	Timothy J. Snook, P.E.
Weather:	76 Degrees @ 10:00 A.M.	Sunny	Light Breeze 0% Chance of Rain
Workforce Total:	15		
Activities:	Concrete repair, window installation, pressure washing, stairwell door installation

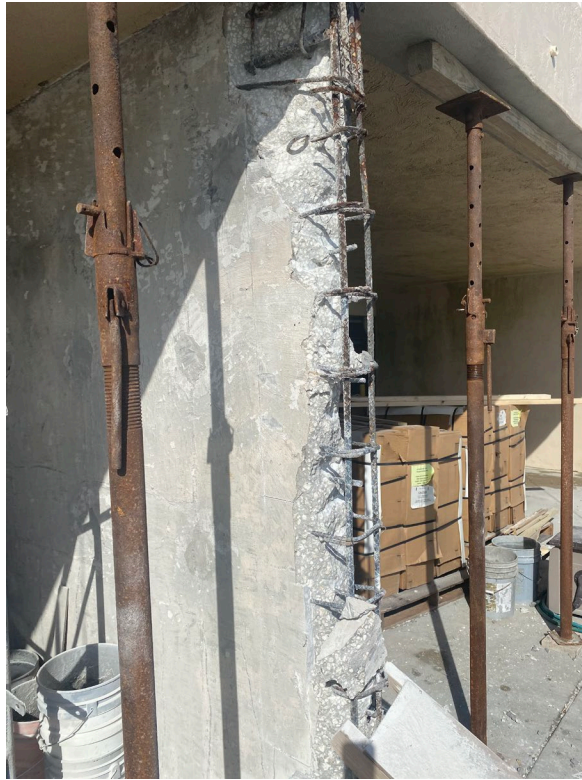
The Engineer was on-site to inspect in-progress concrete repairs (See Photo 1). The Engineer provided direction for chasing steel and steel supplementation. Concrete demolition continues in the parking area below the building and at units 308 and 309.

Picture 1: In-progress concrete repair

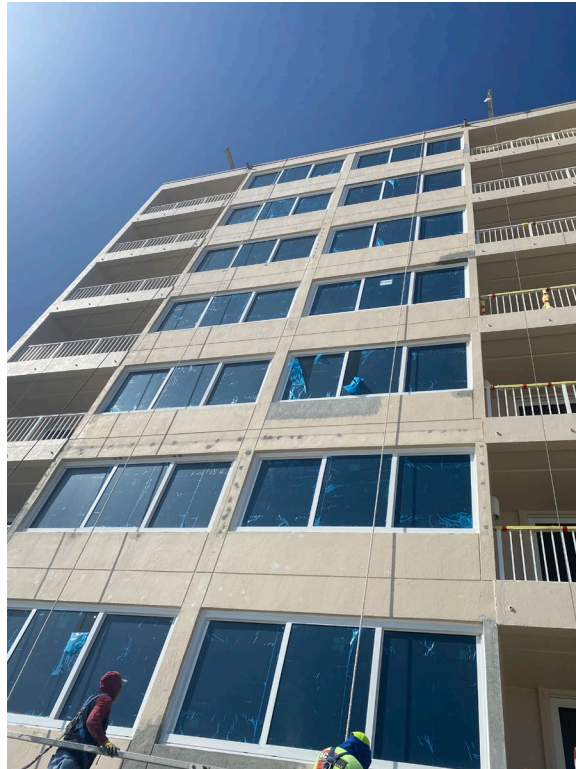
The 10/11 stack window drop is being prepped for paint application (See Photo 2).

Picture 2: 10/11 window stack

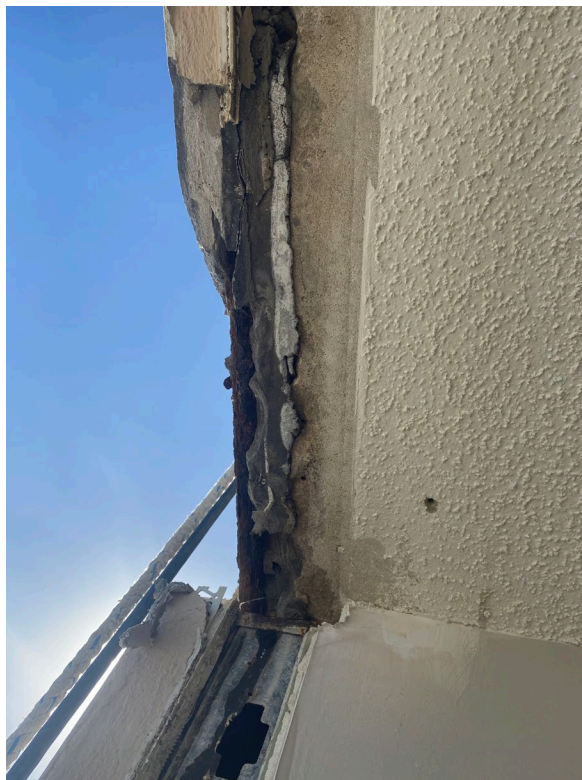
Gulfstream removed the window of Units 507 and 407 today. There is concrete damage in the header of Unit 507 and the South jamb stud needs supplemented by a new metal angle at the base (See Photos 3-4). The substrate in the opening for Unit 407 was approved for the installation of the window.

Picture 3: Unit 507 header spall

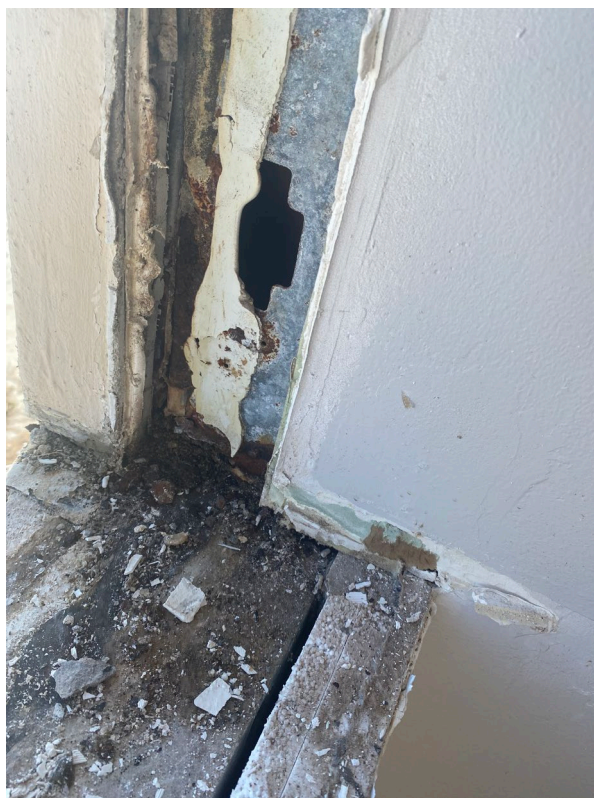
Picture 4: Unit 507 South jamb corrosion

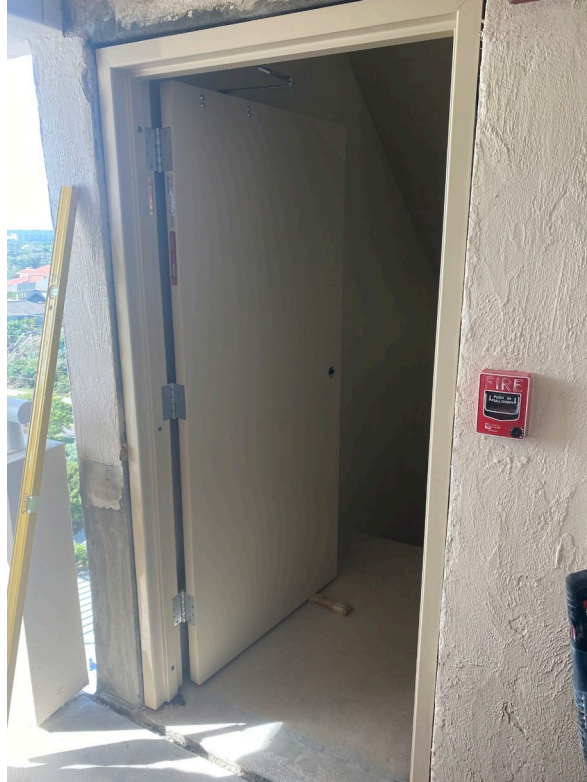
Installation of the stairwell doors began today in the South stairwell (See Photos 5-6). Engineer observed proper use of shims.

Picture 5: 7<sup>th</sup> floor stairwell door in-progress installation

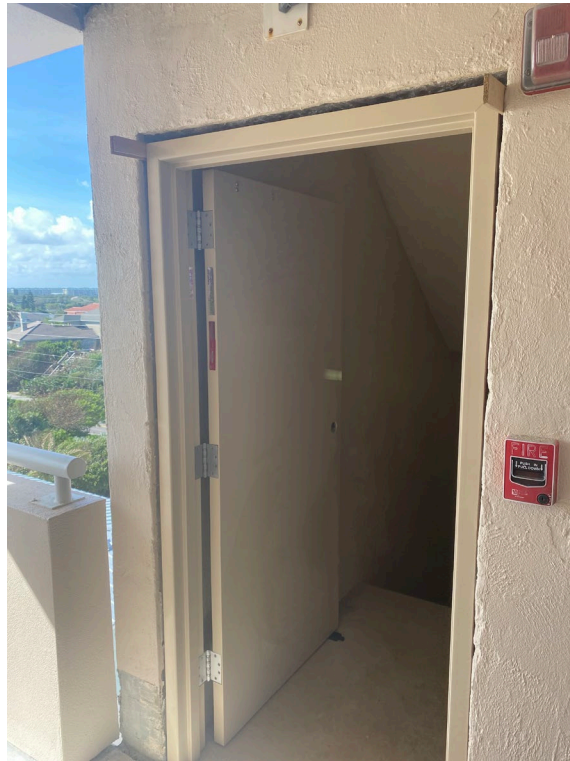
Picture 6: 6<sup>th</sup> floor stairwell door in-progress installation
