UNITED ENGINEERING CONSULTANTS, INC.

FIELD OBSERVATION REPORT PERMIT # BLDC-000287-2020

Report No. 46	Page 1 of 1
Project:	Southpoint Condominium	Inspection For:	Restoration Project
Day/Date:	Thursday, October 8, 2020	Job No.	19-1086
Location:	4453 S. Atlantic Ave, Ponce Inlet	Engineer:	Timothy J. Snook, P.E.
Contractor:	ACE Enterprises, LLC	Project Foreman:	Wes Swaim
Subcontractor:	Gulfstream Glass (6)	Inspector:	Timothy J. Snook, P.E.
Weather:	91 Degrees @ 1:25 P.M. Sunny Light Breeze 20% Chance of Rain		
Workforce Total:	15		
Activities:	Concrete repair, window installation, stairwell door installation, stucco

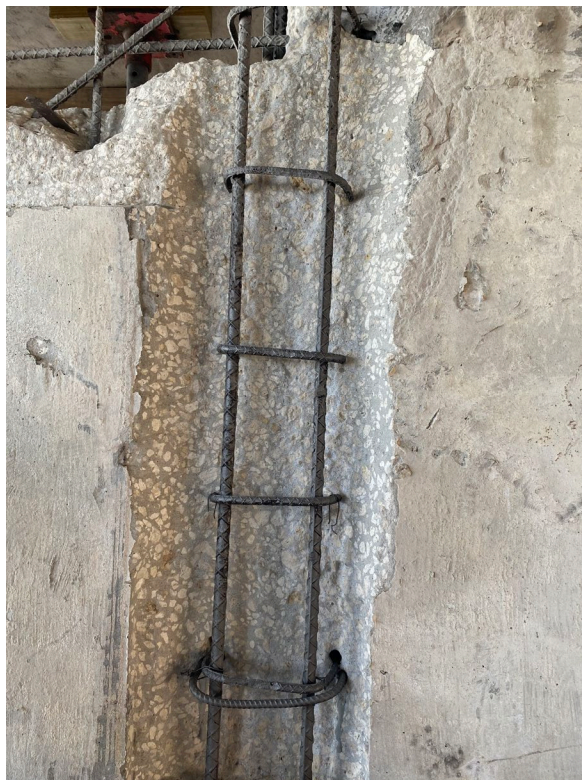
The Engineer was on-site to inspect completed concrete repairs (See Photos 1-3). The excavations conformed to ICRI standards. The reinforcing steel was cleaned. Supplemental steel was installed as directed. The excavations were approved to be cast. Concrete demolition continues.

Picture 1: Approved excavation

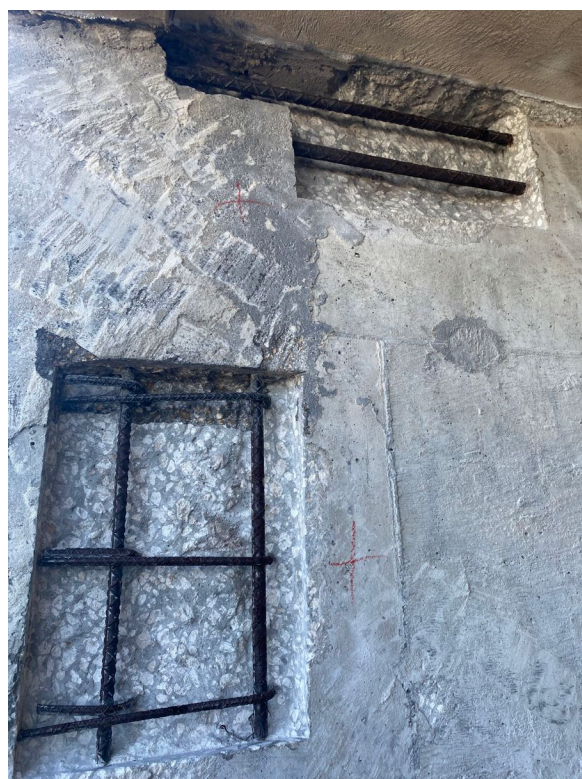
Picture 2: Approved excavation

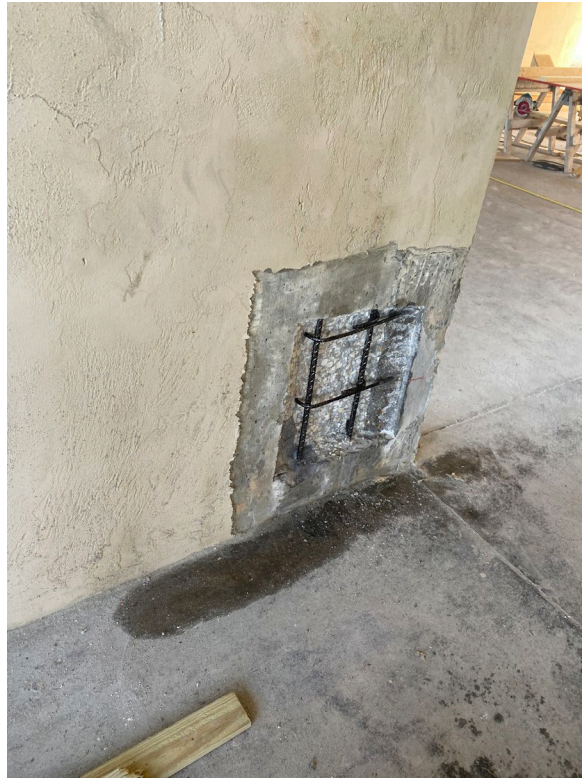
Picture 3: Approved excavation

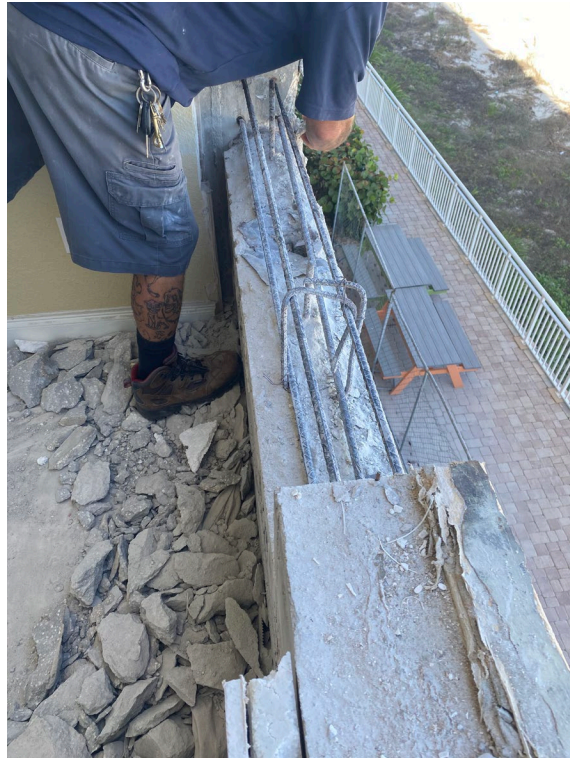
Gulfstream removed the window of Units 208 and 209 today. Both window sill had concrete spalling (See Photos 4-5). The Engineer inspected and approved the excavations to be cast.

Picture 4: Unit 209 window sill repair

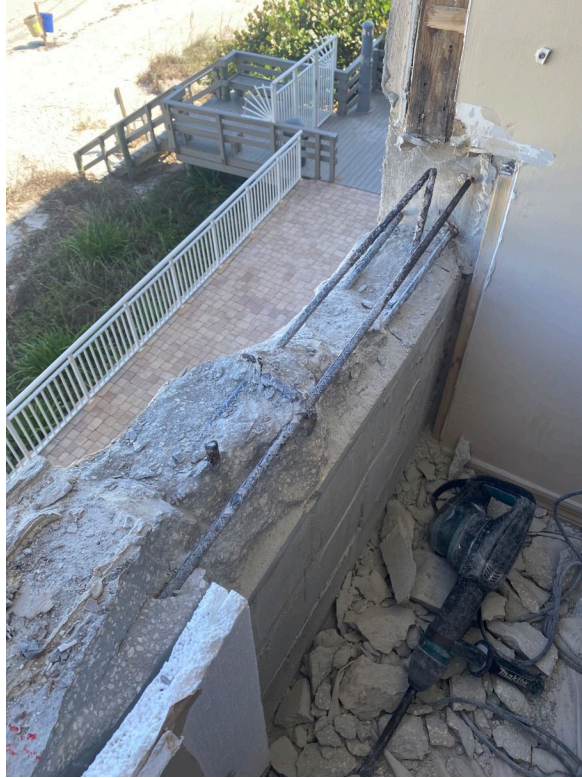
Picture 5: Unit 208 in-progress window sill repair

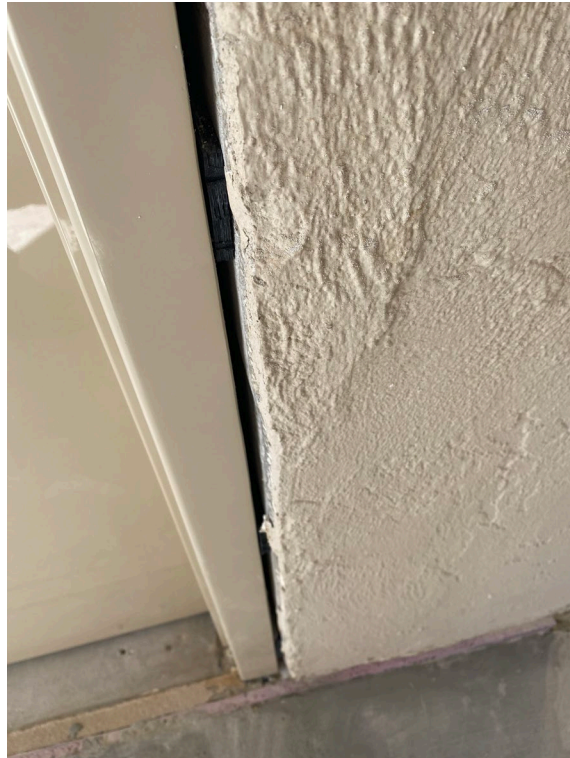
Installation of the stairwell doors continues today in the South stairwell (See Photos 6-7). Engineer observed proper use of shims and attachments. Stucco application around the door frames is in-progress.

Picture 6: Typical use of shims

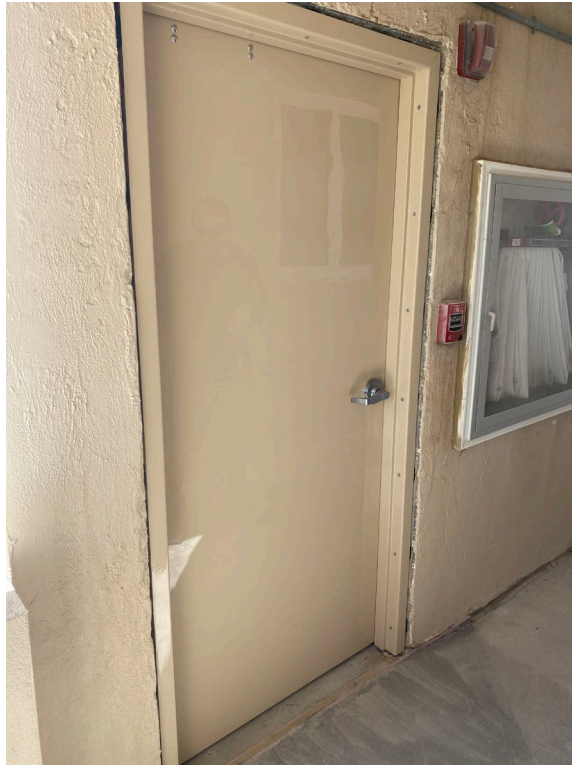
Picture 7: Typical fastening of stairwell doors
