UNITED ENGINEERING CONSULTANTS, INC.

FIELD OBSERVATION REPORT PERMIT # BLDC-000287-2020

Report No. 58	Page 1 of 1
Project:	Southpoint Condominium	Inspection For:	Restoration Project
Day/Date:	Friday, November 20, 2020	Job No.	19-1086
Location:	4453 S. Atlantic Ave, Ponce Inlet	Engineer:	Timothy J. Snook, P.E.
Contractor:	ACE Enterprises, LLC	Project Foreman:	Wes Swaim
Subcontractor:	N/A	Inspector:	Timothy J. Snook, P.E.
Weather:	76 Degrees @ 10:30 A.M. Overcast	Windy	20% Chance of Rain
Workforce Total:	7		
Activities:	Concrete demo, Hardwall installation, prep for painting

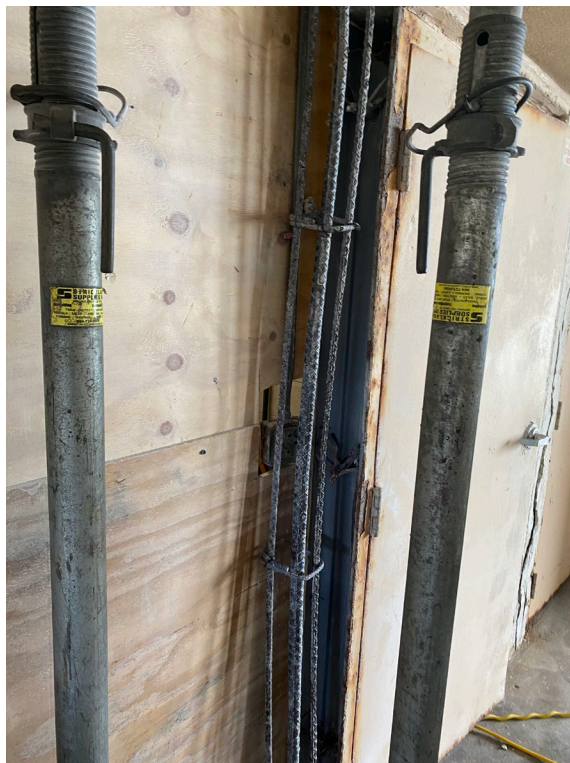
Concrete demolition continues on the North half of the garage. The Engineer was on-site to inspect completed repairs (See Photos 1-2). The inspected excavations conformed to ICRI standards. No supplemental steel was required. The existing steel still needs to be cleaned. Once the steel is cleaned, the excavations can be cast.

Picture 1: Completed excavation

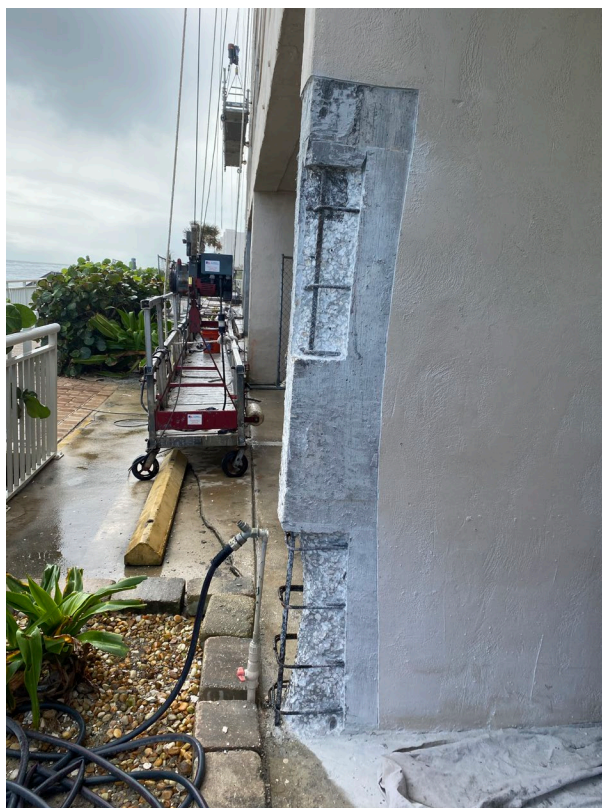
Picture 2: Completed excavations

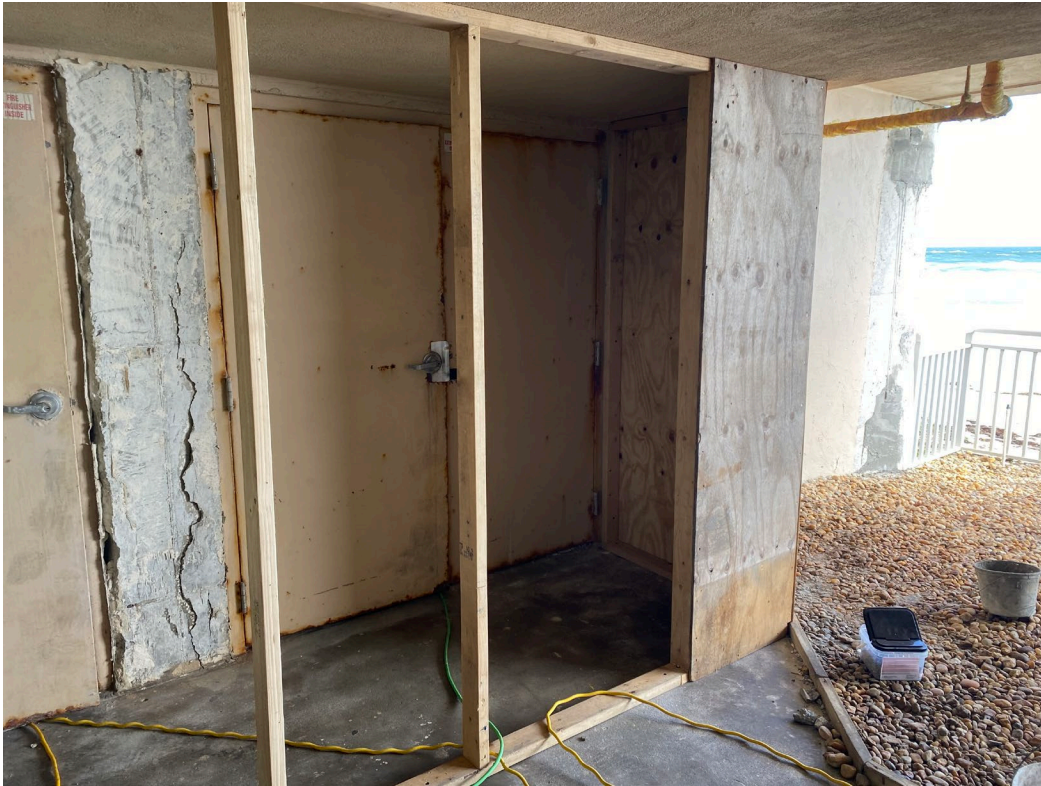
A hardwall barrier is being installed in front of the maintenance room (See Photo 3). The doors need to be removed to make repairs to the concrete jambs.

Picture 3: In-progress hardwall installation

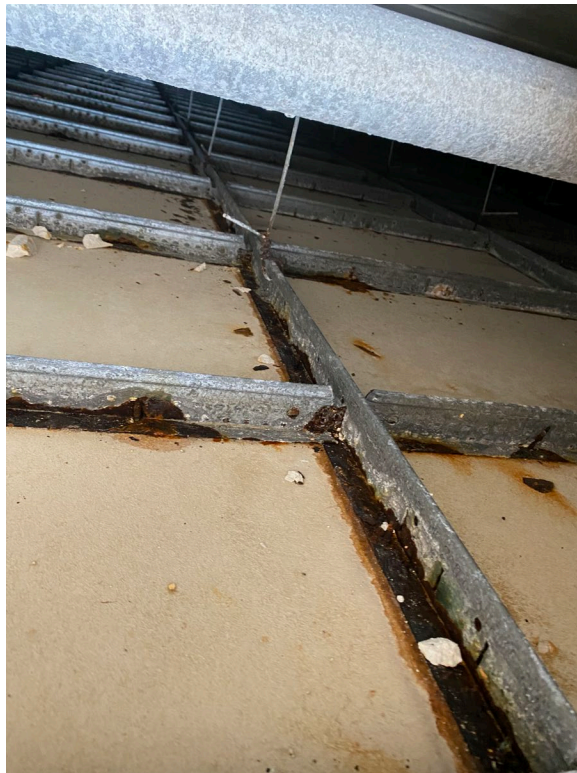
The Contractor opened a section of soffit, so the framing members could be inspected (See Photo 4). The framing members typically exhibited corrosion on the flanges. This is where the soffit sheathing attaches to. Supplementing the framing will be discussed with the Contractor.

Picture 4: Typical corroded flanges of garage soffit attachment
