UNITED ENGINEERING CONSULTANTS, INC.

FIELD OBSERVATION REPORT PERMIT # BLDC-000287-2020

Report No. 70	Page 1 of 1
Project:	Southpoint Condominium	Inspection For:	Restoration Project
Day/Date:	Wednesday, December 30, 2020	Job No.	19-1086
Location:	4453 S. Atlantic Ave, Ponce Inlet	Engineer:	Timothy J. Snook, P.E.
Contractor:	ACE Enterprises, LLC	Project Foreman:	Wes Swaim
Subcontractor:	N/A	Inspector:	Timothy J. Snook, P.E.
Weather:	66 Degrees @ 8:30 A.M. Sunny	Light Breeze	15% Chance of Rain
Workforce Total:	16		
Activities:	Concrete repair, painting, stucco application, pressure washing

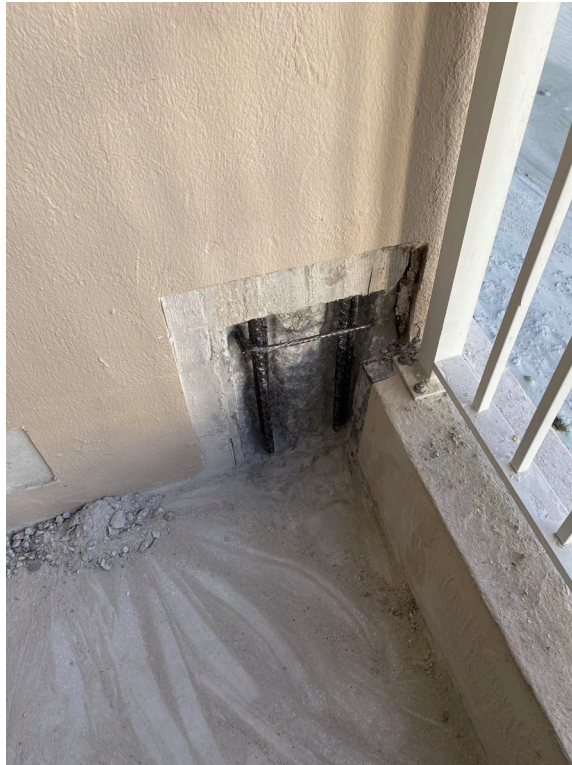
Picture 1: Typical wall repair

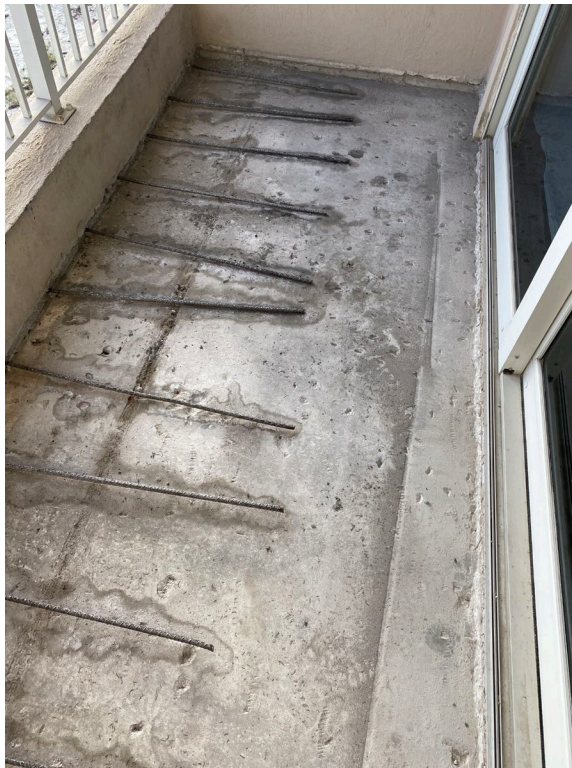
Picture 2: Typical topping replacement

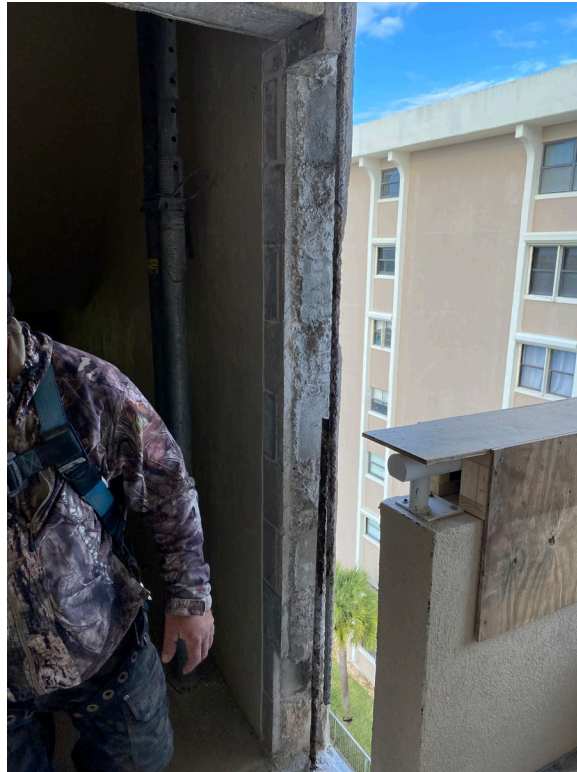
Picture 3: Typical wall repair on walkways

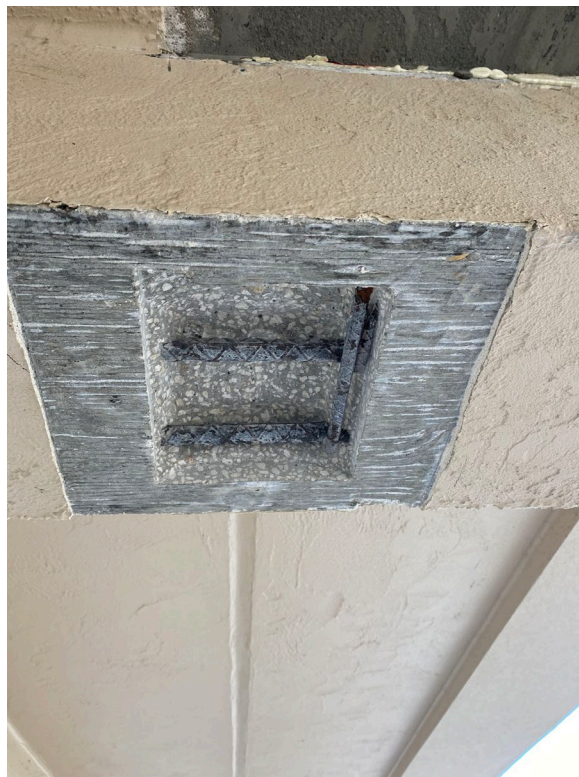
Picture 4: Beam excavation on the walkways

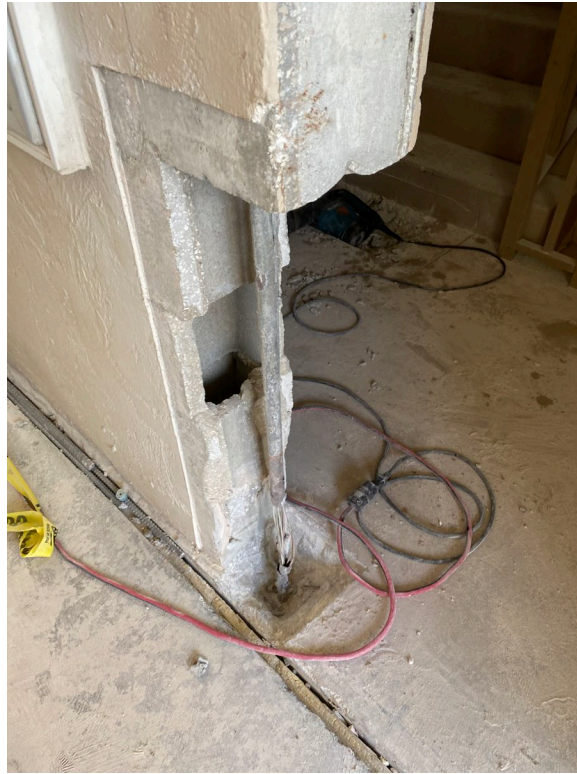
The South jamb on the 7th floor North stairwell opening had severely corroded conduits. A licensed electrician will be called to repair the conduits.

Picture 5: Corroded electrical conduits found in stairwell door jamb on the 7th floor

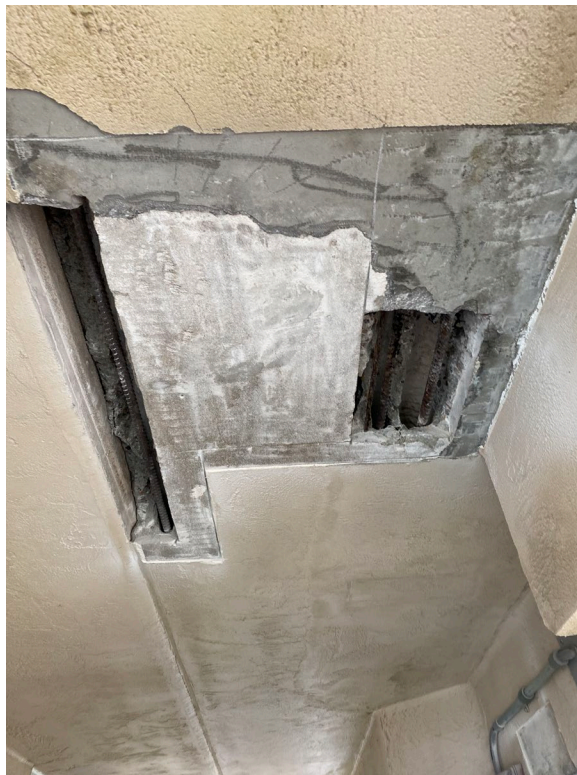
Picture 6: Typical ceiling excavations on the walkways
