FIELD OBSERVATION REPORT PERMIT # BLDC-000287-2020

Report No. 83	Page 1 of 1
Project:	Southpoint Condominium	Inspection For:	Restoration Project
Day/Date:	Tuesday, February 16, 2021	Job No.	19-1086
Location:	4453 S. Atlantic Ave, Ponce Inlet	Engineer:	Timothy J. Snook, P.E.
Contractor:	ACE Enterprises, LLC	Project Foreman:	Wes Swaim
Subcontractor:	Gulfstream (4)	Inspector:	Timothy J. Snook, P.E.
Weather:	64 Degrees @ 7:50 A.M. Sunny Light Breeze 10% Chance of Rain		
Workforce Total:	15		
Activities:	Concrete repair, stucco application, window installation, paint application

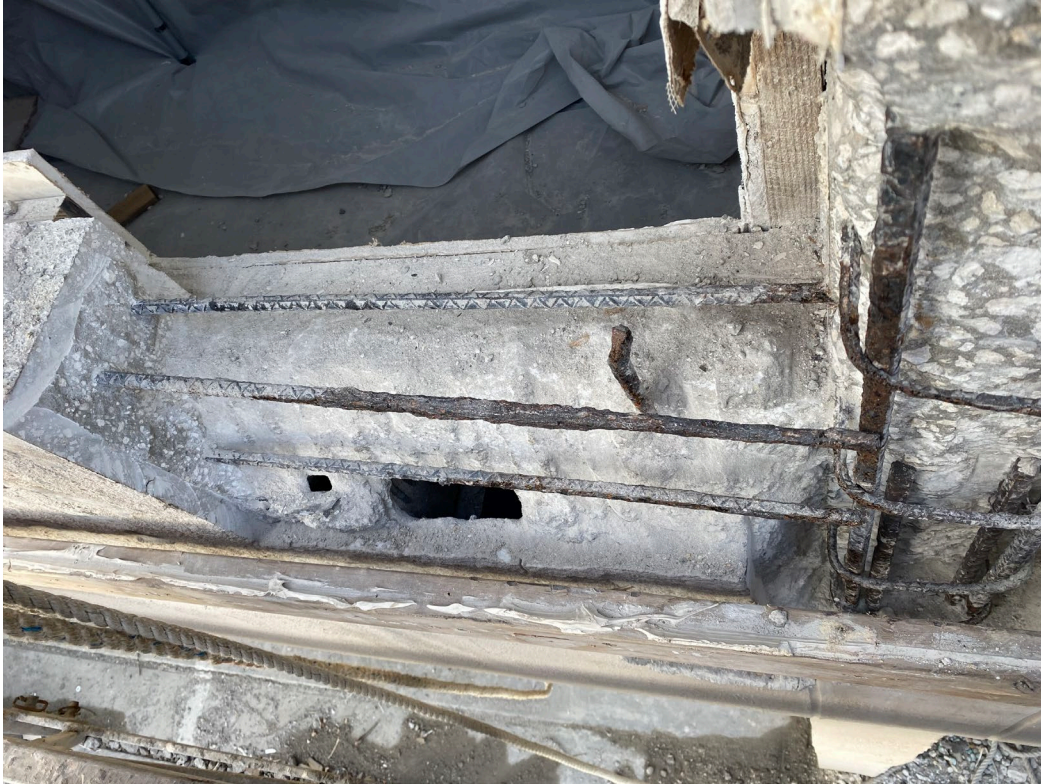
The Engineer was on-site to inspect the window sill repair on Unit 103 and wall repair on the North stairwell (See Photo 1). The excavations conformed to ICRI standards. The existing reinforcing steel needs to be cleaned. The excavations were approved to be cast. Forming excavations is in-progress. The window has been removed from Unit 102 and the entire sill is cracked and will need to be repaired (See Photo 2)

Picture 1: Unit 103 window sill repair

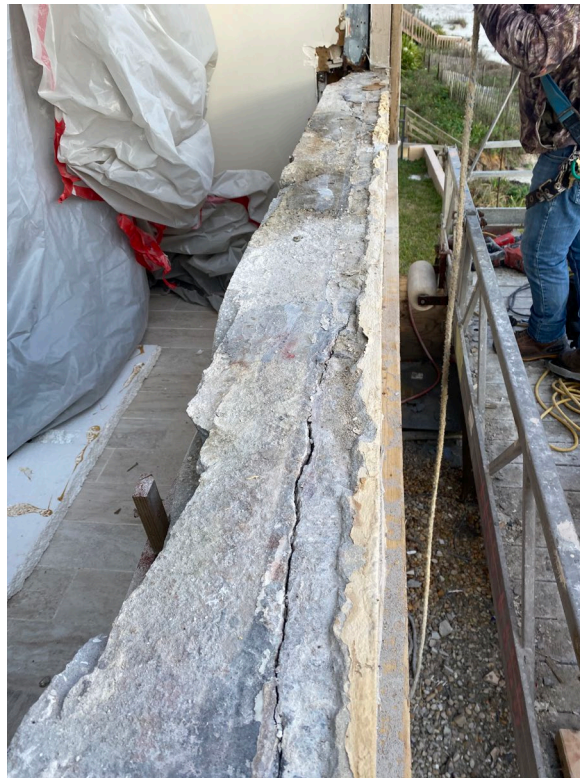
Picture 2: Cracked window sill of Unit 102
