# UNITED ENGINEERING CONSULTANTS, INC.

## FIELD OBSERVATION REPORT PERMIT # BLDC-000287-2020

Report No. 84	Page 1 of 1
Project:	Southpoint Condominium	Inspection For:	Restoration Project
Day/Date:	Friday, February 19, 2021	Job No.	19-1086
Location:	4453 S. Atlantic Ave, Ponce Inlet	Engineer:	Timothy J. Snook, P.E.
Contractor:	ACE Enterprises, LLC	Project Foreman:	Wes Swaim
Subcontractor:	N/A	Inspector:	Timothy J. Snook, P.E.
Weather:	71 Degrees @ 7:50 A.M. Sunny Light Breeze 90% Chance of Rain		
Workforce Total:	11		
Activities:	Concrete repair, stucco application, paint application, deck coating, grinding decks

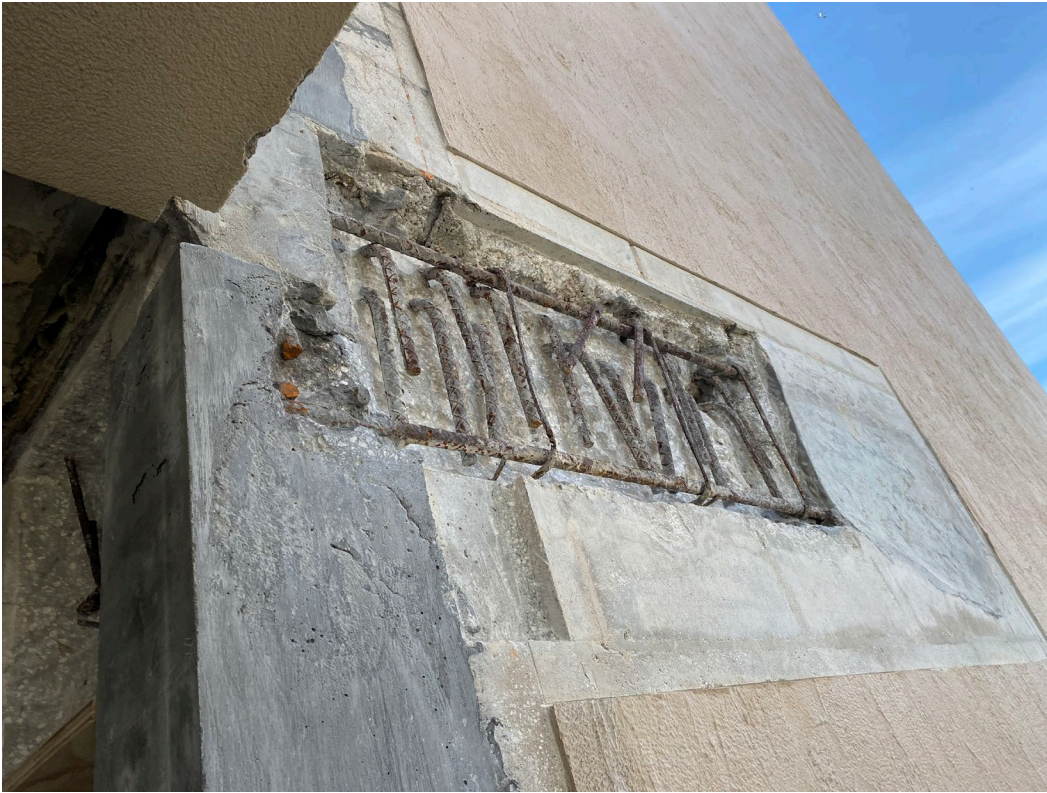
The Engineer was on-site to inspect the miscellaneous concrete repairs on the walkways and repairs around the window openings on Units 203, 204 and 105 (See Photos 1-7). The excavations conformed to ICRI standards. The existing reinforcing steel needs to be cleaned. The excavations were approved to be cast. Sandblasting and forming excavations is in-progress.

Picture 1: Wall repair on North stairwell

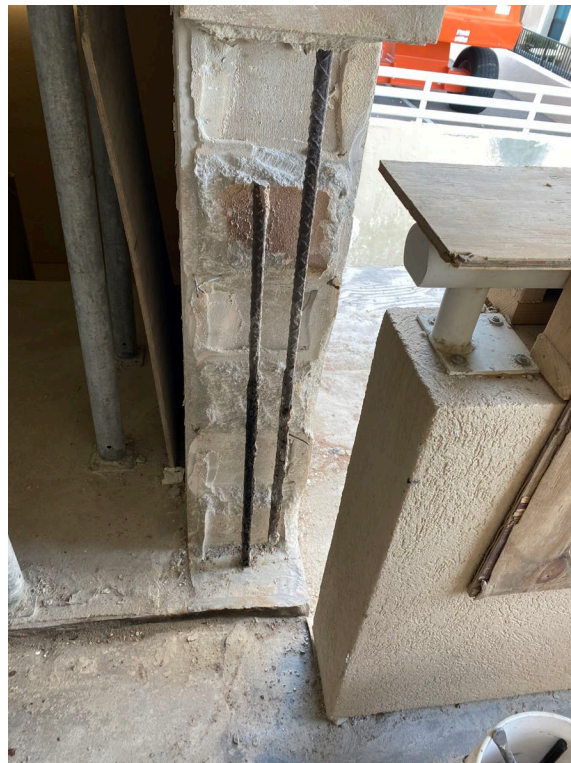
Picture 2: Typical jamb repair on North stairwell

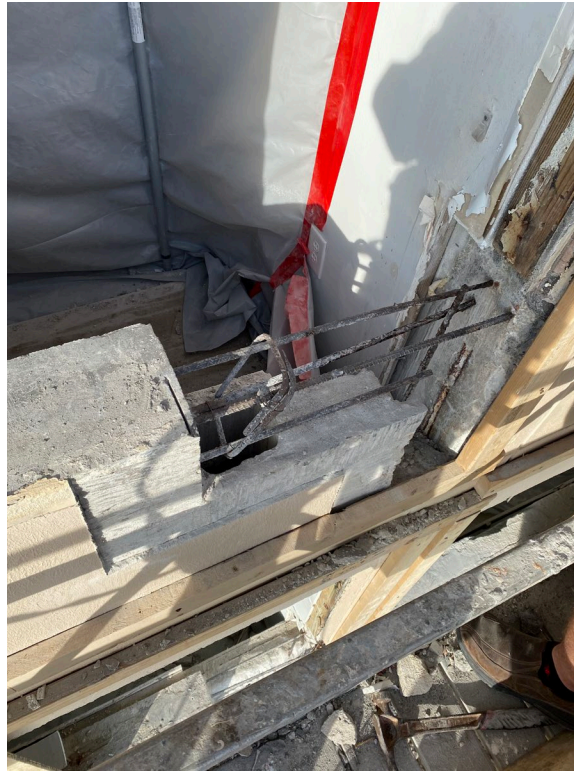
Picture 3: Unit 203 window sill repair

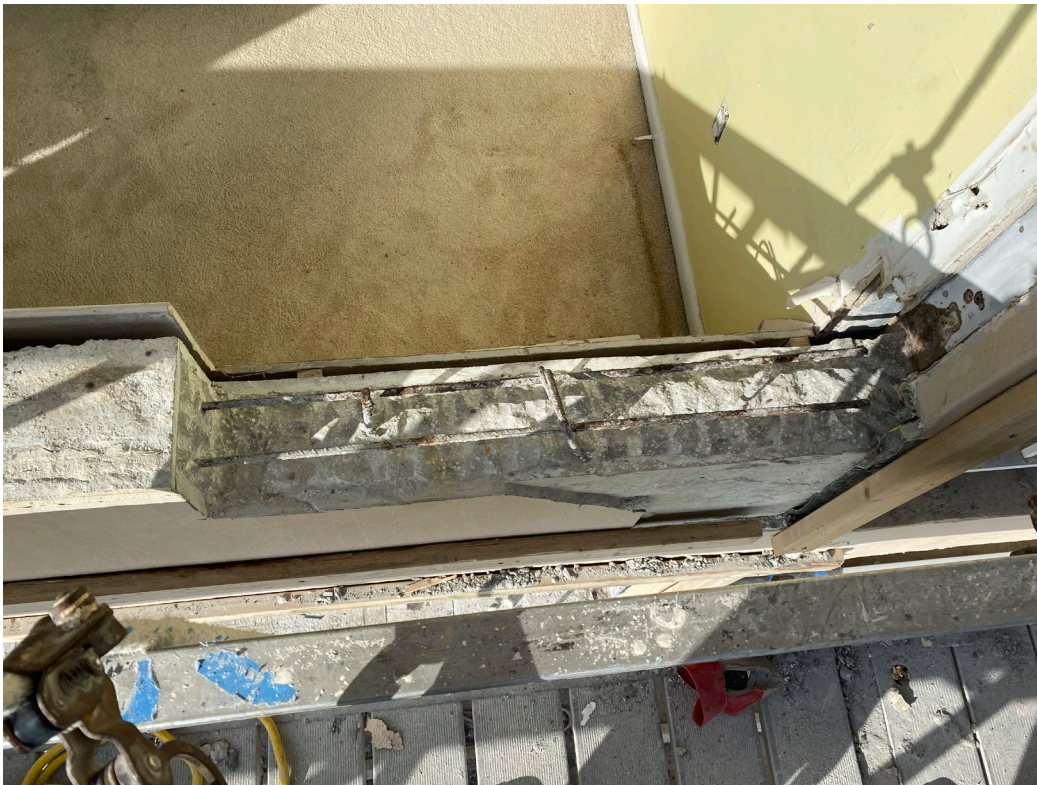
Picture 4: Unit 204 window sill repair

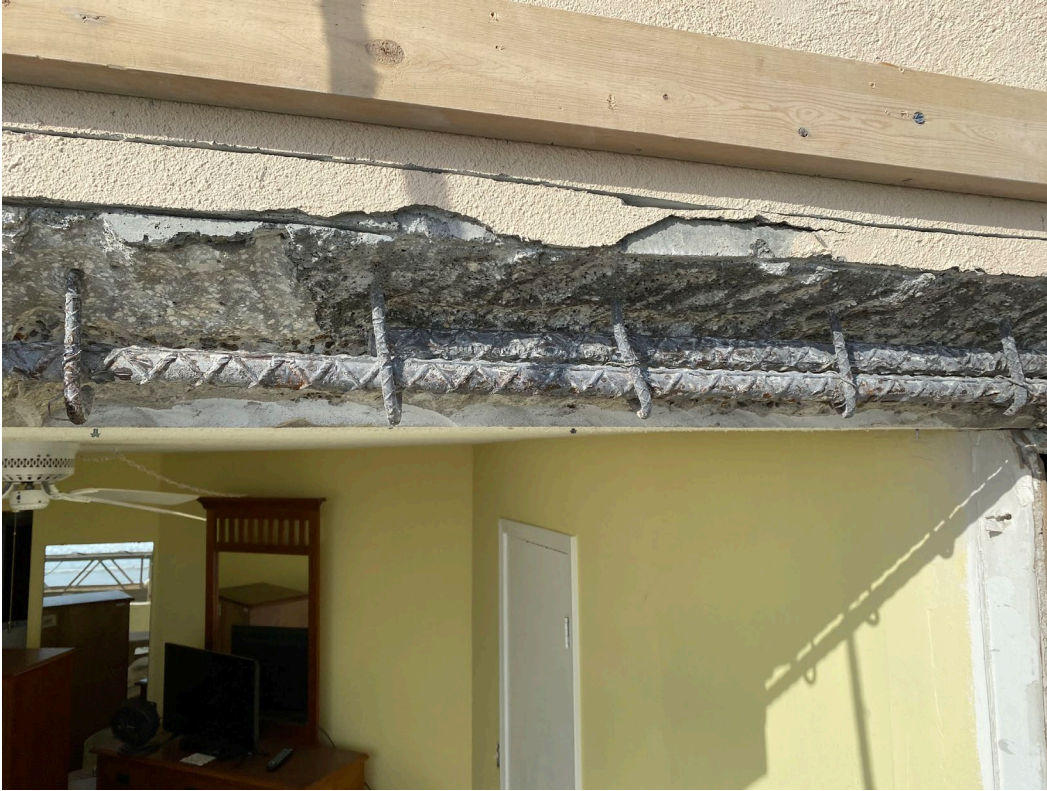
Picture 5: Unit 204 header repair

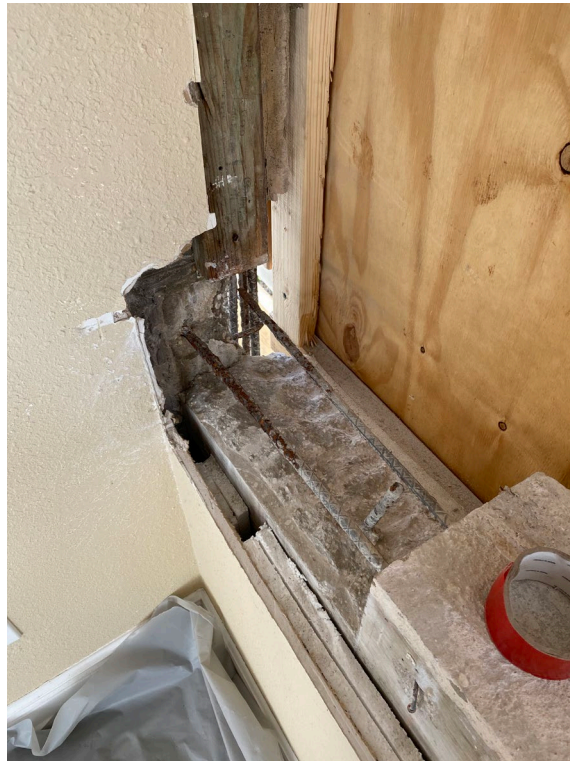
Picture 6: Unit 105 window sill repair

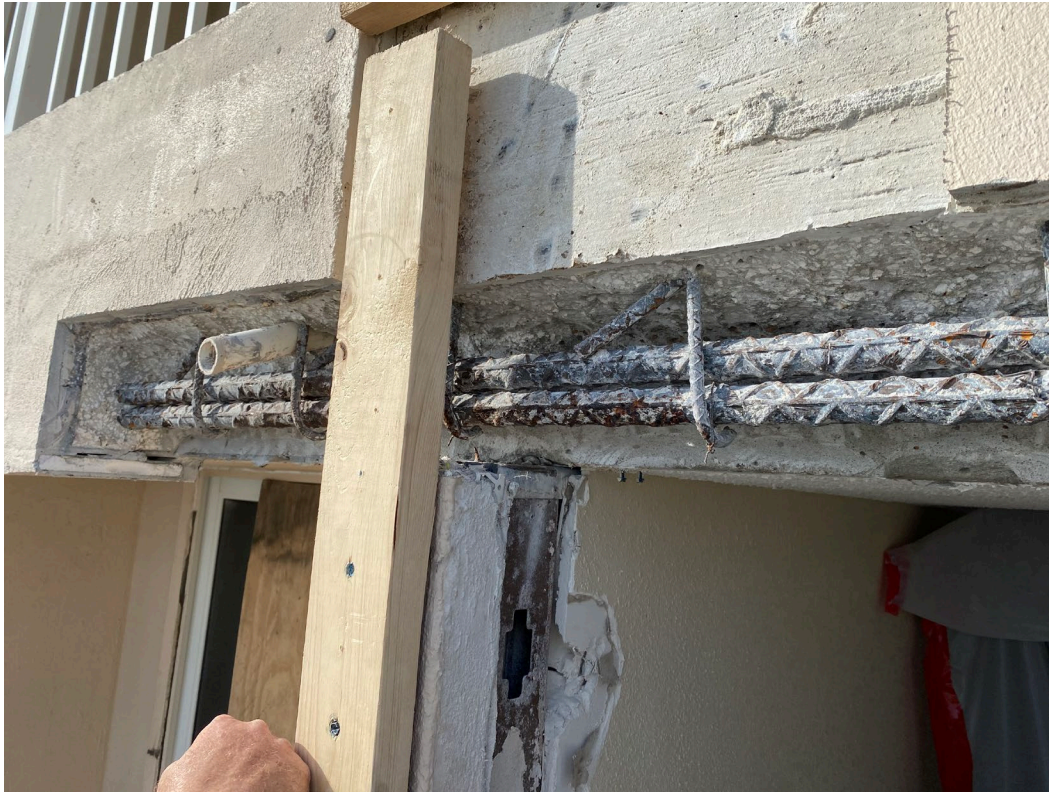
Picture 7: Unit 105 header repair
