FIELD OBSERVATION REPORT PERMIT # BLDC-000287-2020

Report No. 91	Page 1 of 1
Project:	Southpoint Condominium	Inspection For:	Restoration Project
Day/Date:	Friday, March 12, 2021	Job No.	19-1086
Location:	4453 S. Atlantic Ave, Ponce Inlet	Engineer:	Timothy J. Snook, P.E.
Contractor:	ACE Enterprises, LLC	Project Foreman:	Wes Swaim
Subcontractor:	Gulfstream Glass (4)	Inspector:	Timothy J. Snook, P.E.
Weather:	66 Degrees @ 8:00 A.M. Sunny Windy 0% Chance of Rain		
Workforce Total:	13		
Activities:	Concrete repair, pressure washing, window installation

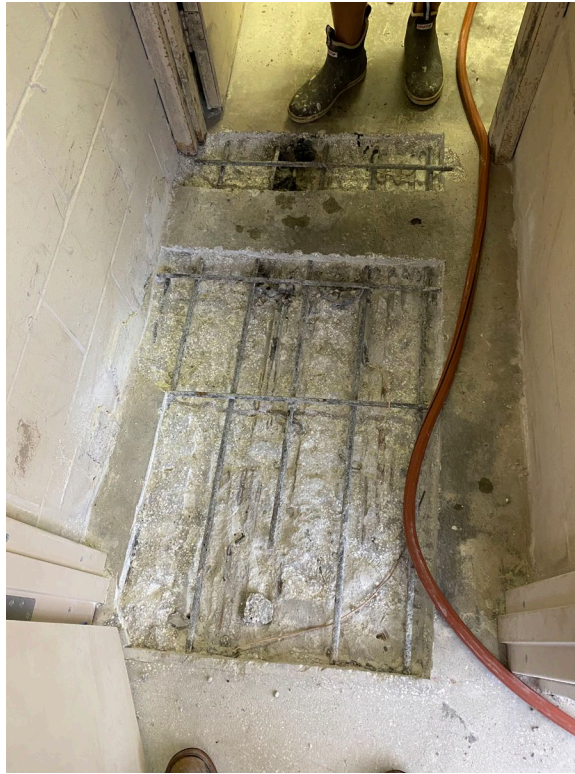
Concrete repairs continue on the walkways. Forms are being installed on the 1st floor ceiling repair at the North stairwell. Excavations at the 5th floor trash room and 2nd floor North stairwell landing were inspected (See Photo 1). Both excavations conformed to ICRI standards and were approved to be cast. Casting of approved repairs is in-progress.

Picture 1: 5th floor trash room repair
