UNITED ENGINEERING CONSULTANTS, INC.

FIELD OBSERVATION REPORT PERMIT # BLDC-000287-2020

Report No. 92	Page 1 of 1
Project:	Southpoint Condominium	Inspection For:	Restoration Project
Day/Date:	Tuesday, March 16, 2021	Job No.	19-1086
Location:	4453 S. Atlantic Ave, Ponce Inlet	Engineer:	Timothy J. Snook, P.E.
Contractor:	ACE Enterprises, LLC	Project Foreman:	Wes Swaim
Subcontractor:	Gulfstream Glass (4)	Inspector:	Timothy J. Snook, P.E.
Weather:	71 Degrees @ 9:20 A.M. Sunny Light Breeze 0% Chance of Rain		
Workforce Total:	15		
Activities:	Concrete repair, painting, stucco application, window installation

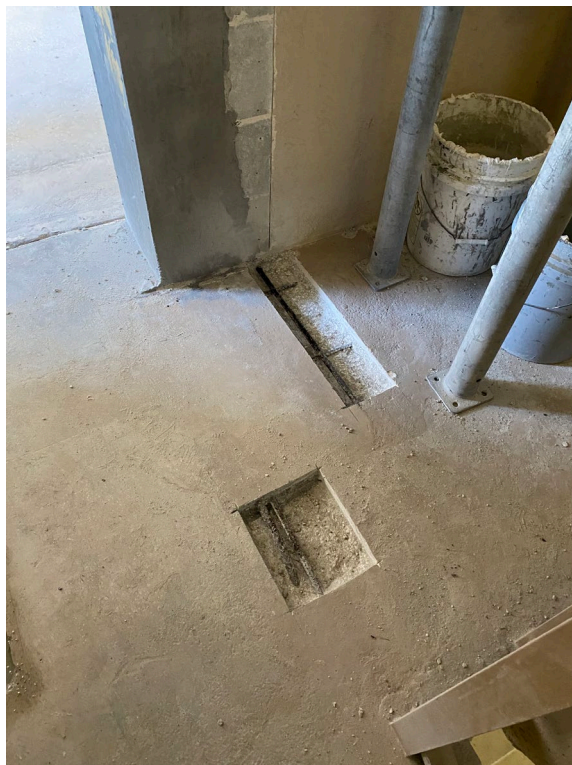
Concrete repair continue on the walkways. The 1st floor ceiling repair at the North stairwell is being cast. Excavations at the 3rd and 1st floor trash rooms and 2nd floor North stairwell landing were inspected (See Photos 1-2). All excavations conformed to ICRI standards and were approved to be cast. Casting of approved repairs is in-progress.

Picture 1: North stairwell repairs

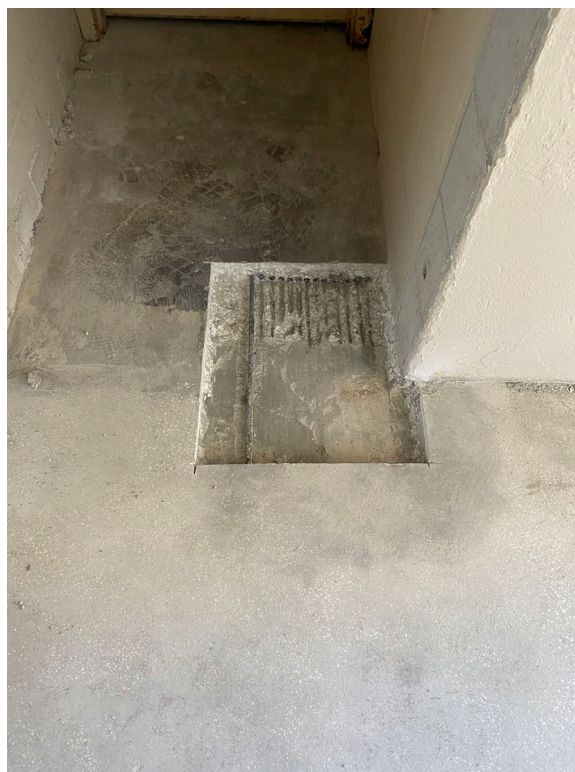
Picture 2: 3rd floor trash room repair

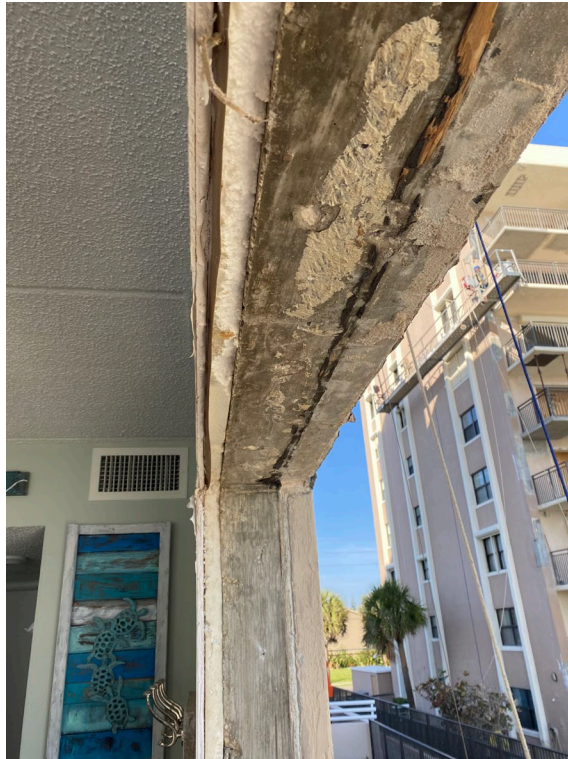
Installation of the North window in Unit 101 is in-progress. The Engineer inspected the substrate and it is in good condition (See Photo 3).

Picture 3: Substrate of Unit 101 North window
