UNITED ENGINEERING CONSULTANTS, INC.

FIELD OBSERVATION REPORT PERMIT # BLDC-000287-2020

Report No. 89	Page 1 of 1
Project:	Southpoint Condominium	Inspection For:	Restoration Project
Day/Date:	Friday, March 5, 2021	Job No.	19-1086
Location:	4453 S. Atlantic Ave, Ponce Inlet	Engineer:	Timothy J. Snook, P.E.
Contractor:	ACE Enterprises, LLC	Project Foreman:	Wes Swaim
Subcontractor:	Gulfstream Glass (4)	Inspector:	Timothy J. Snook, P.E.
Weather:	56 Degrees @ 8:00 A.M. Sunny Light Breeze 0% Chance of Rain		
Workforce Total:	16		
Activities:	Concrete repair, painting, caulking, stucco application, window installation

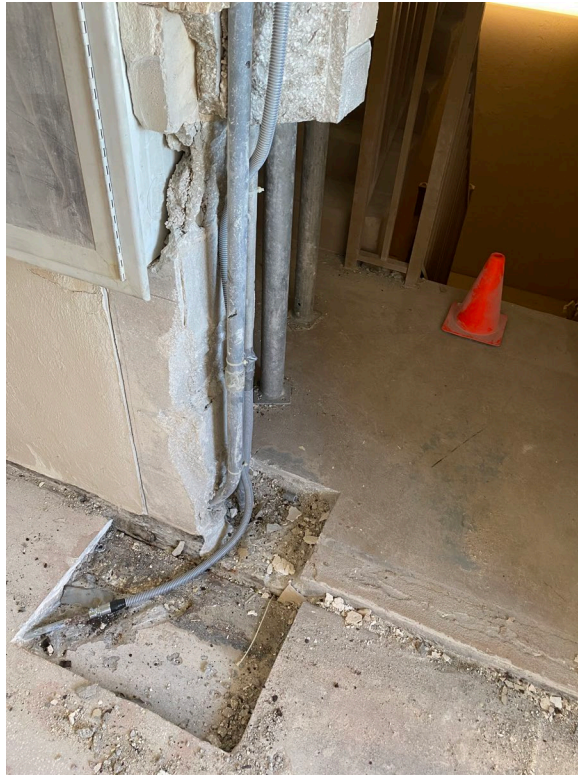
The Engineer was on-site to inspect concrete repairs on the 1st floor walkway (See Photos 1-2). The excavations inspected conformed to ICRI standards. The reinforcing steel was cleaned and the excavations were approved to be cast. Forming is in-progress of the 1st floor stairwell header. Remove formboards from previously cast patches is in-progress on the walkways.

Picture 1: 1st floor jamb repair

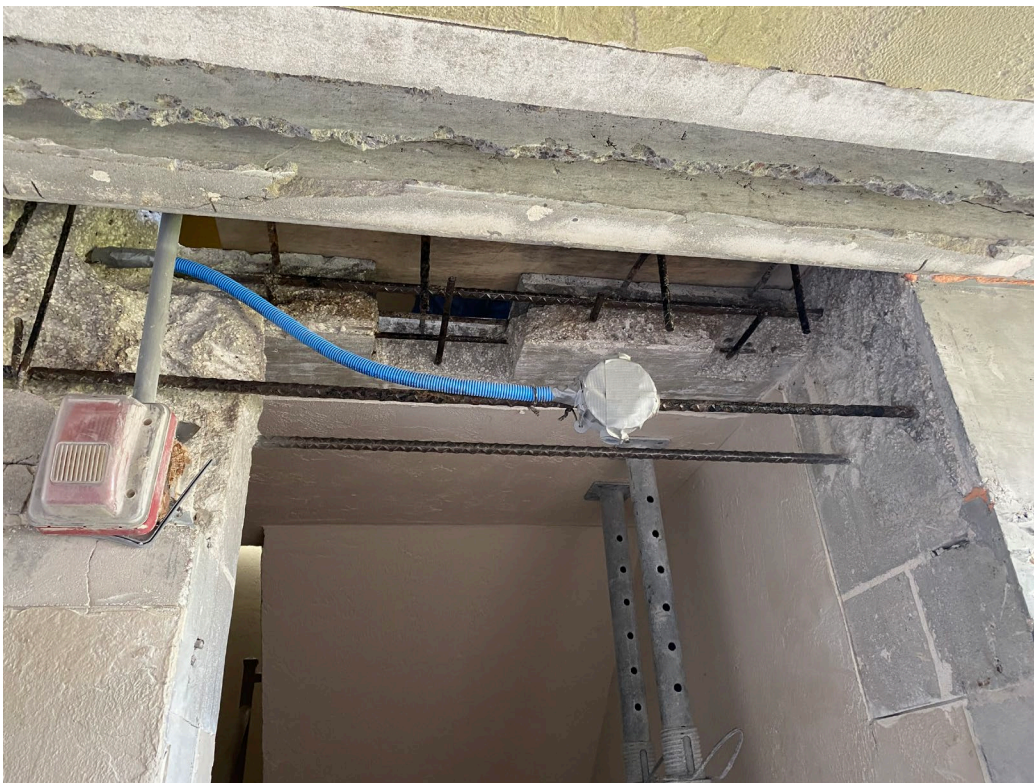
Picture 2: 1st floor stairwell header repair
