UNITED ENGINEERING CONSULTANTS, INC.

FIELD OVSERVATION REPORT PERMIT # BLDC-000287-2020

Report No. 3	Page 1 of 1
Project:	Southpoint Condominium	Inspection For:	Restoration Project
Day/Date:	Tuesday, May 12, 2020	Job No.	19-1086
Location:	4453 S. Atlantic Ave, Ponce Inlet	Engineer:	Timothy J. Snook, P.E.
Contractor:	ACE Enterprises, LLC	Project Foreman:	Wes Swaim
Subcontractor:	GAR Waterblasting (4)	Inspector:	Timothy J. Snook, P.E.
Weather:	74 Degrees @ 8:55 A.M. Sunny	Light Breeze	0% Chance of Rain
Workforce Total:	10		
Activities:	Grind coatings, concrete demo

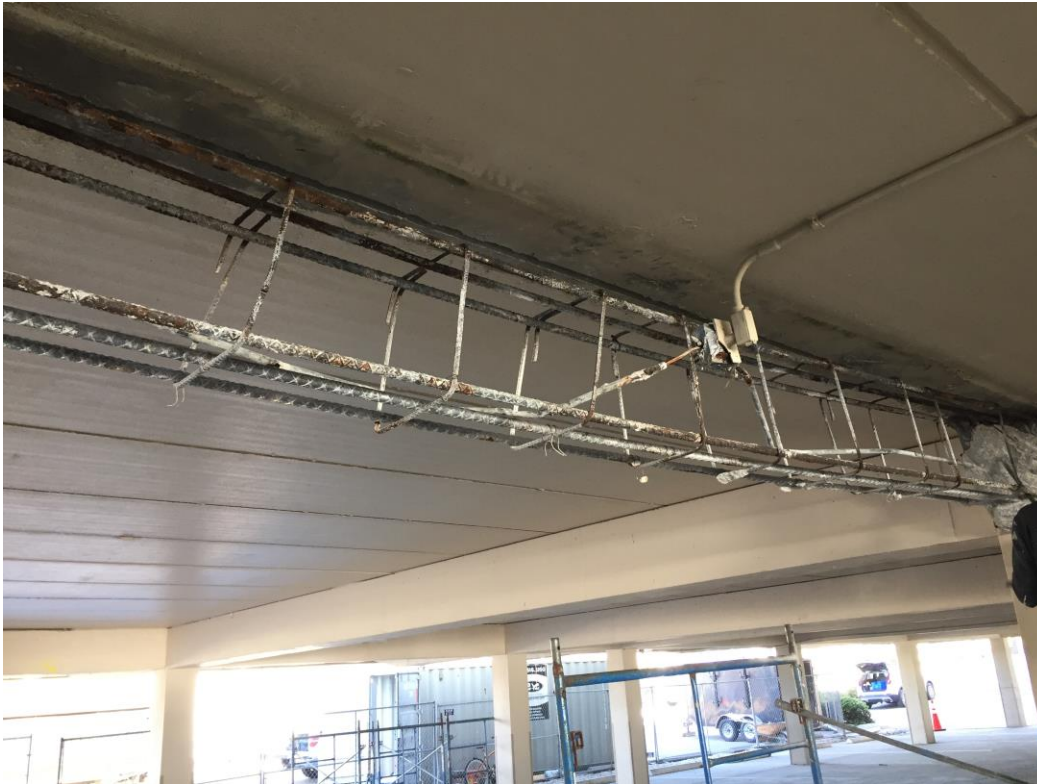
Concrete demolition is in-progress on the bottom side of the parking deck (See Photos 1-3). The Engineer was on-site to provide direction for supplementation of the beams running in the North/South direction. The #7 bars will need to have a minimum lap of 41.5". The stirrups will be replaced with new stirrups where section-loss is exhibited. Epoxy doweling the bars where required was discussed at the columns.

Picture 1: In-progress demolition of beam running in the North/South direction

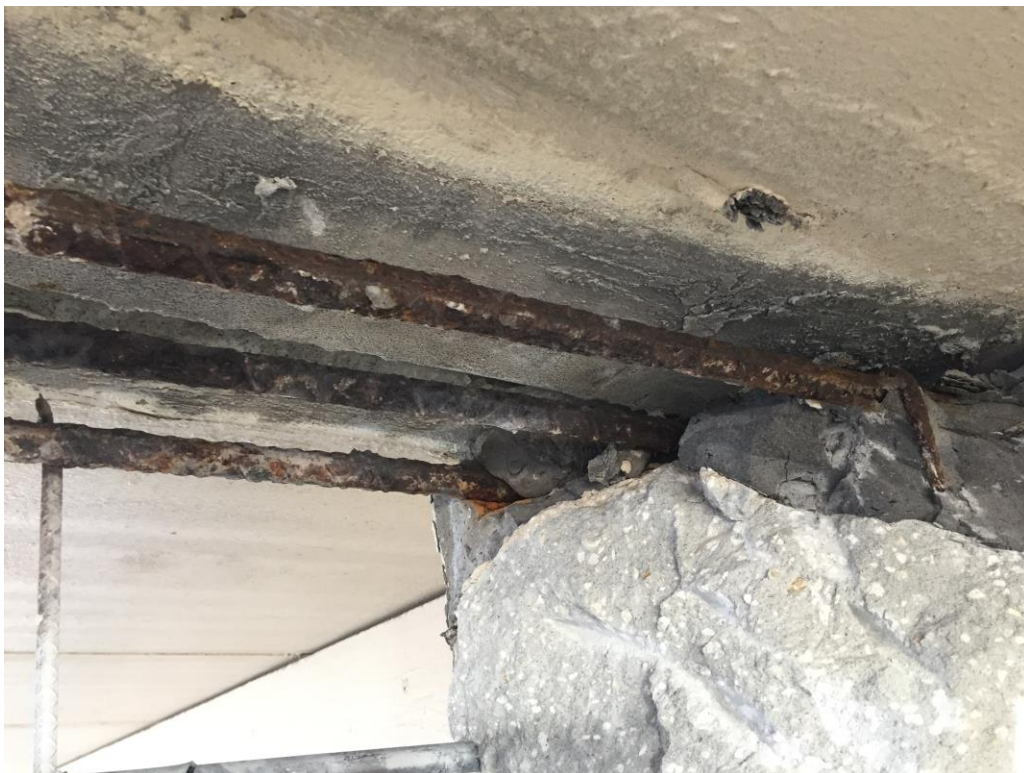
Picture 2: In-progress demolition of beam running in the North/South direction

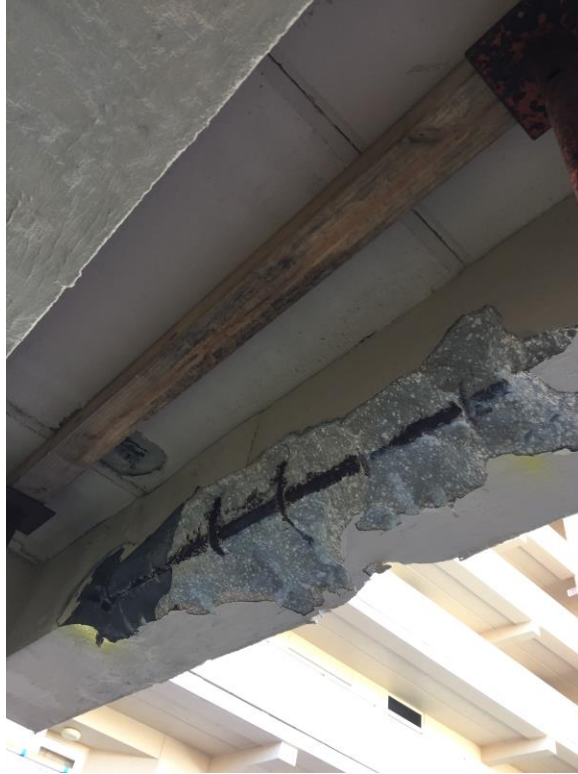
Picture 3: In-progress demolition of beam running in the East/West direction

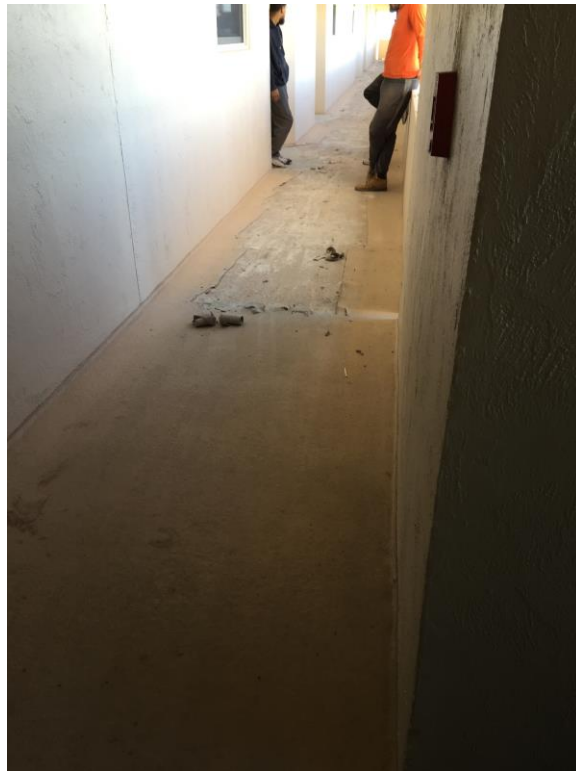
Removal of the walkway deck coatings is in-progress (See Photos 4-5). The subcontractor is stripping the center portion of the decks where the machine will reach. The remainder of the coating will need to be removed by grinders. The 2nd floor has been completed and stripping is in-progress on the 7th floor.

Picture 4: In-progress stripping of walkway coatings

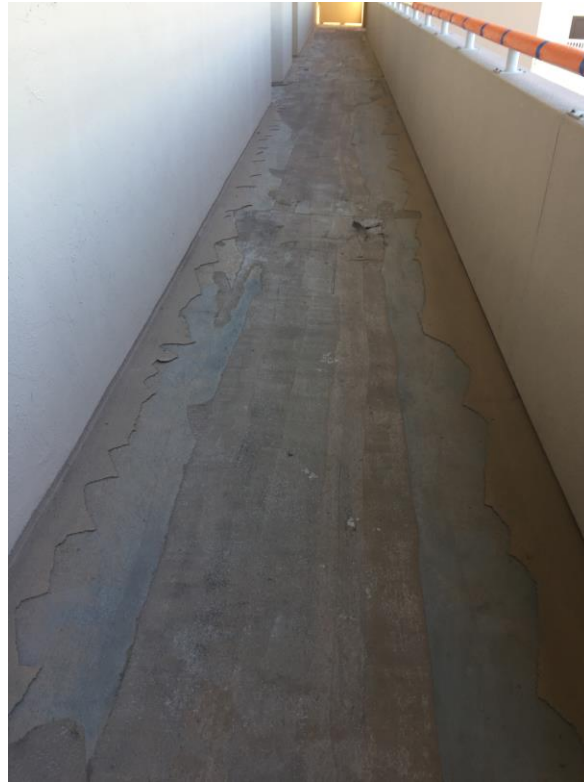
Picture 5: In-progress walkway stripping
