UNITED ENGINEERING CONSULTANTS, INC.

FIELD OVSERVATION REPORT PERMIT # BLDC-000287-2020

| Project: | Southpoint Condominium | Inspection For: | Restoration Project |
| Day/Date: | Wednesday, June 24, 2020 | Job No. | 19-1086 |

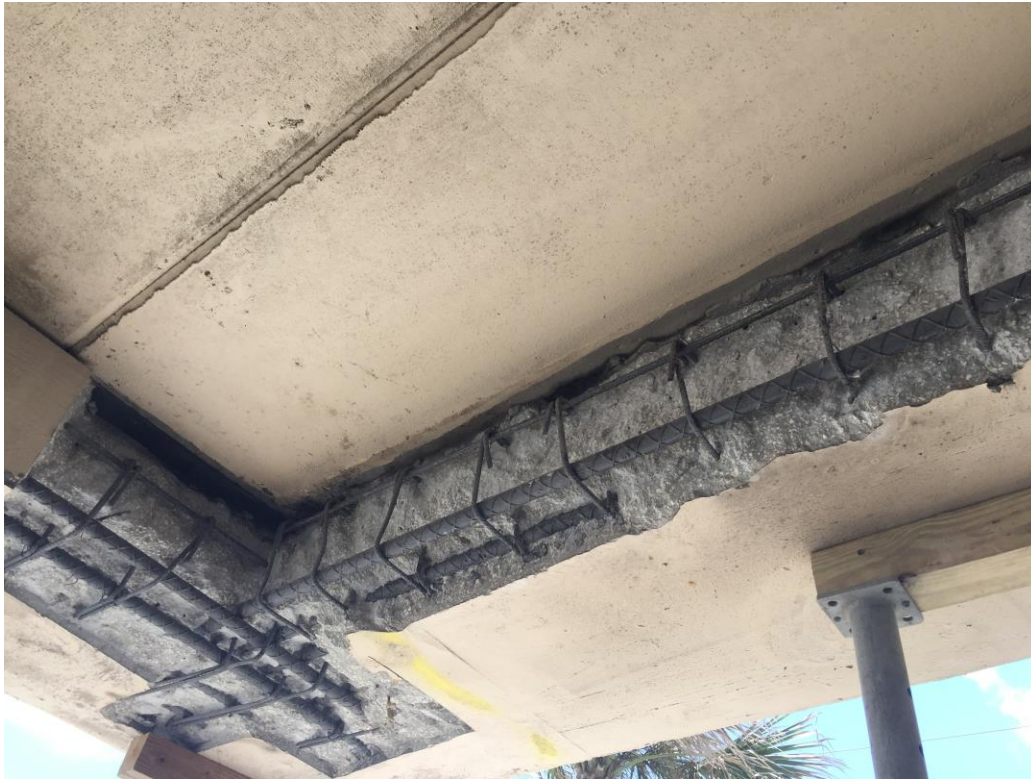
The Engineer was on-site to inspect completed excavations (See Photos 1-2). The excavations inspected conformed to ICRI standards. The steel was sandblasted. Any supplemental steel was installed as directed. The excavations were approved to be cast.

Picture 1: Typical beam excavation

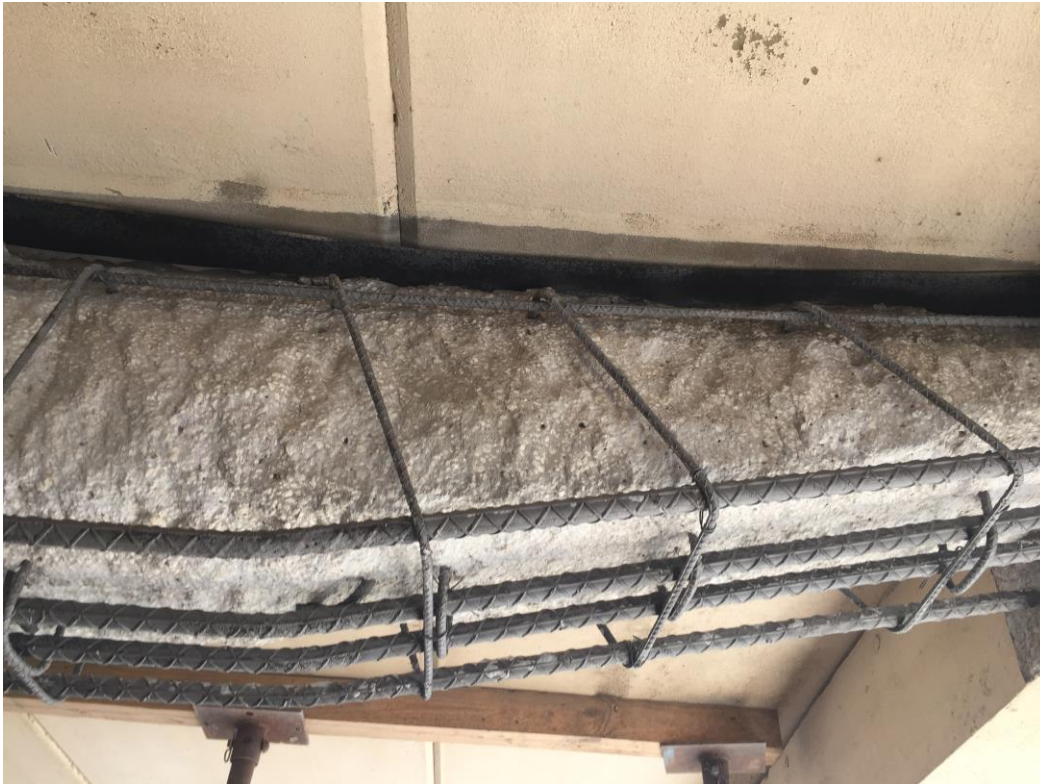
Picture 2: Typical beam excavation

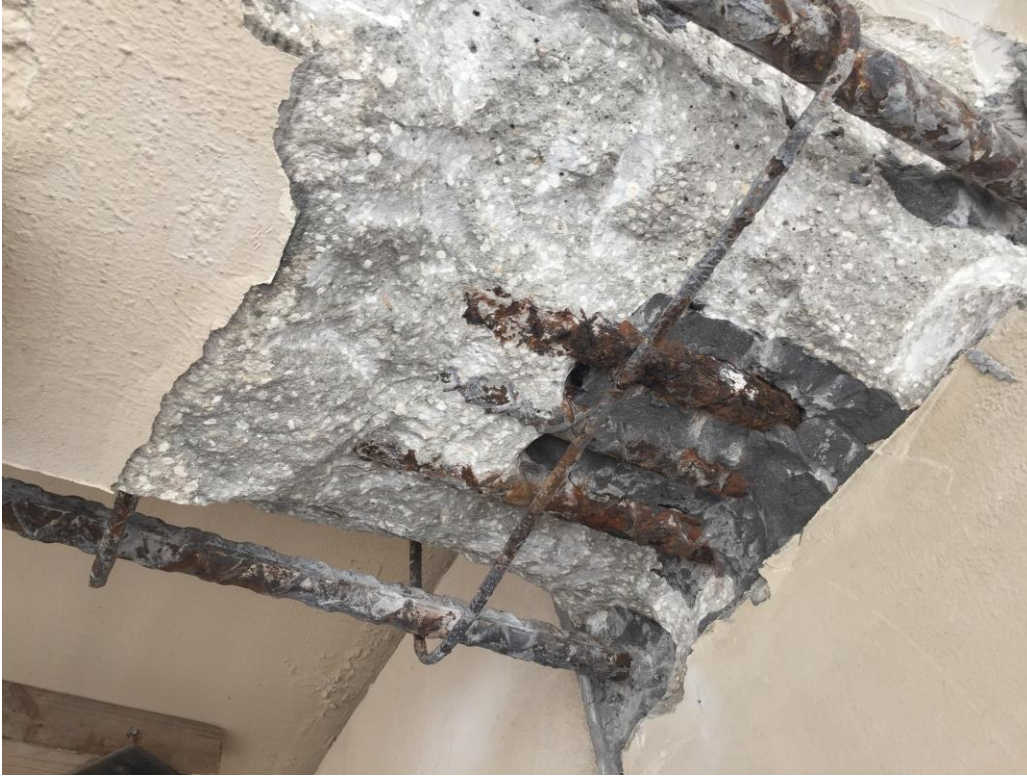
Concrete demolition continues on the beam and columns on the bottom side of the parking garage (See Photos 3-4).

Picture 3: In-progress excavation

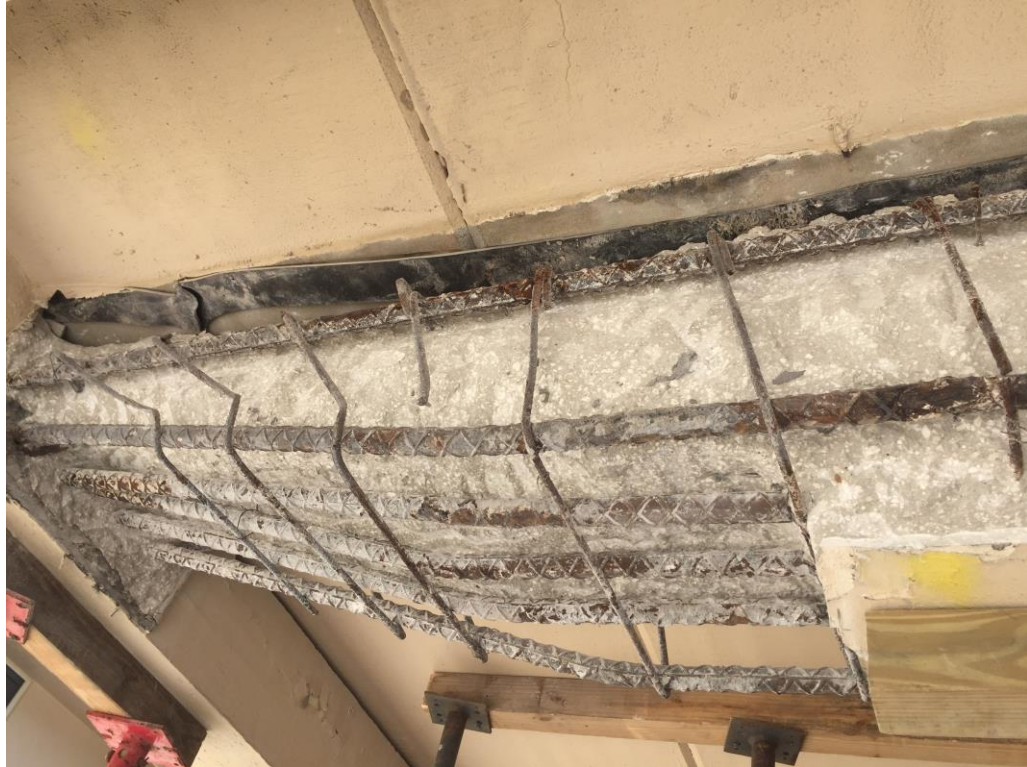
Picture 4: In-progress excavation

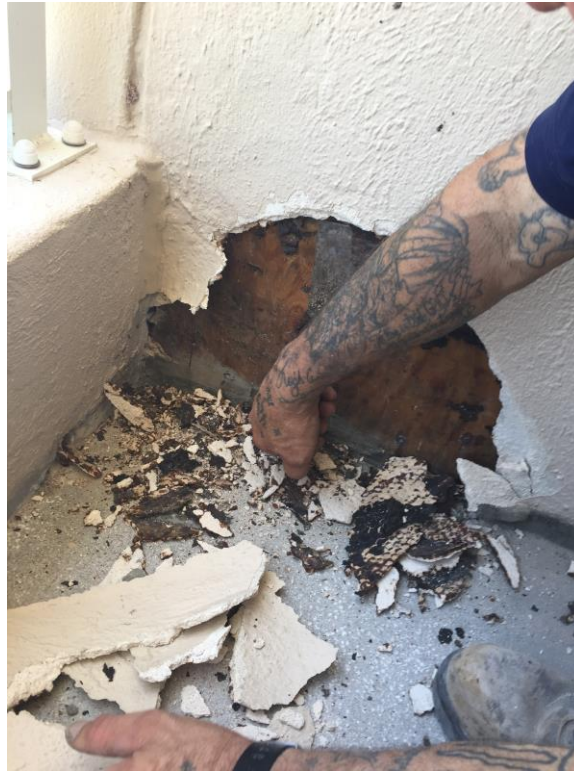
The Foreman and Engineer inspected the balcony of Unit 709. The wire lath was exposed at the base of the wall and was corroded (See Photo 5). The Engineer and Foreman discussed proper repair procedure.

Picture 5: Unit 709 with corroded lath in stucco
