UNITED ENGINEERING CONSULTANTS, INC.

FIELD OVSERVATION REPORT PERMIT # BLDC-000287-2020

Report No. 21	Page 1 of 1
Project:	Southpoint Condominium	Inspection For:	Restoration Project
Day/Date:	Monday, July 20, 2020	Job No.	19-1086
Location:	4453 S. Atlantic Ave, Ponce Inlet	Engineer:	Timothy J. Snook, P.E.
Contractor:	ACE Enterprises, LLC	Project Foreman:	Wes Swaim
Subcontractor:	Gulfstream Glass (3)	Inspector:	Timothy J. Snook, P.E.
Weather:	87 Degrees @ 10:25 A.M. Sunny	Light Breeze	20% Chance of Rain
Workforce Total:	13		
Activities:	Concrete demo, sandblasting, window installation

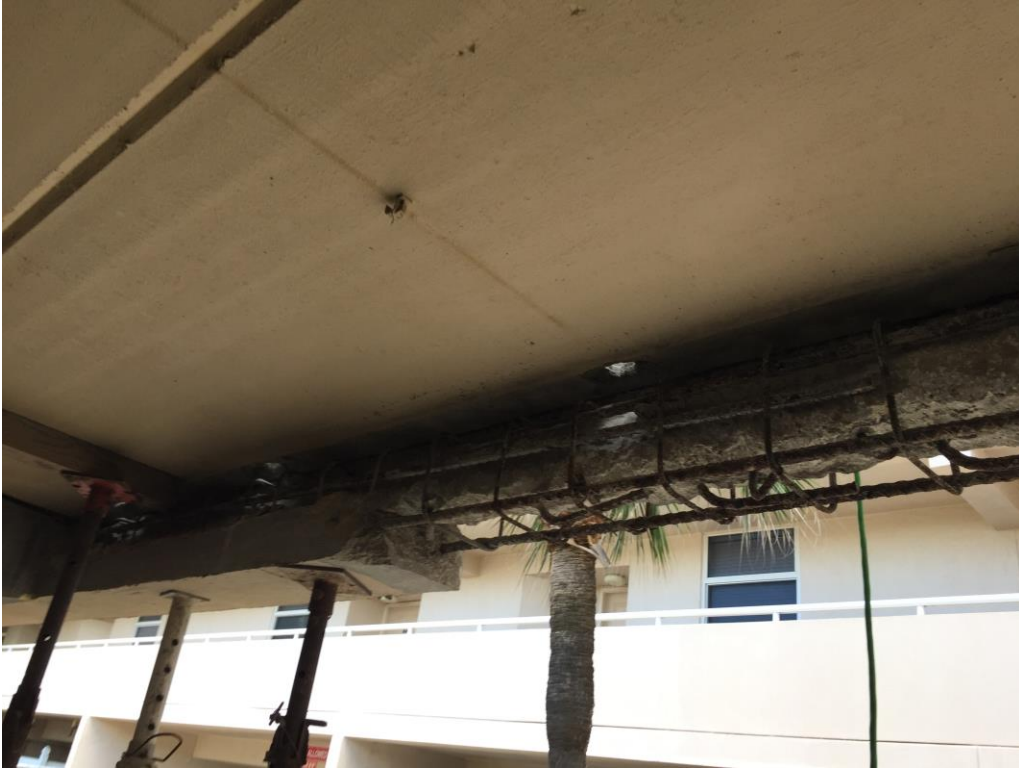
The Engineer was on-site to inspect two beam repairs and one column repair in the parking garage (See Photos 1-4). All excavations conformed to ICRI standards. Sandblasting the steel is underway. Supplemental steel was installed as directed. The excavations were approved to be cast.

Picture 1: Approved beam excavation

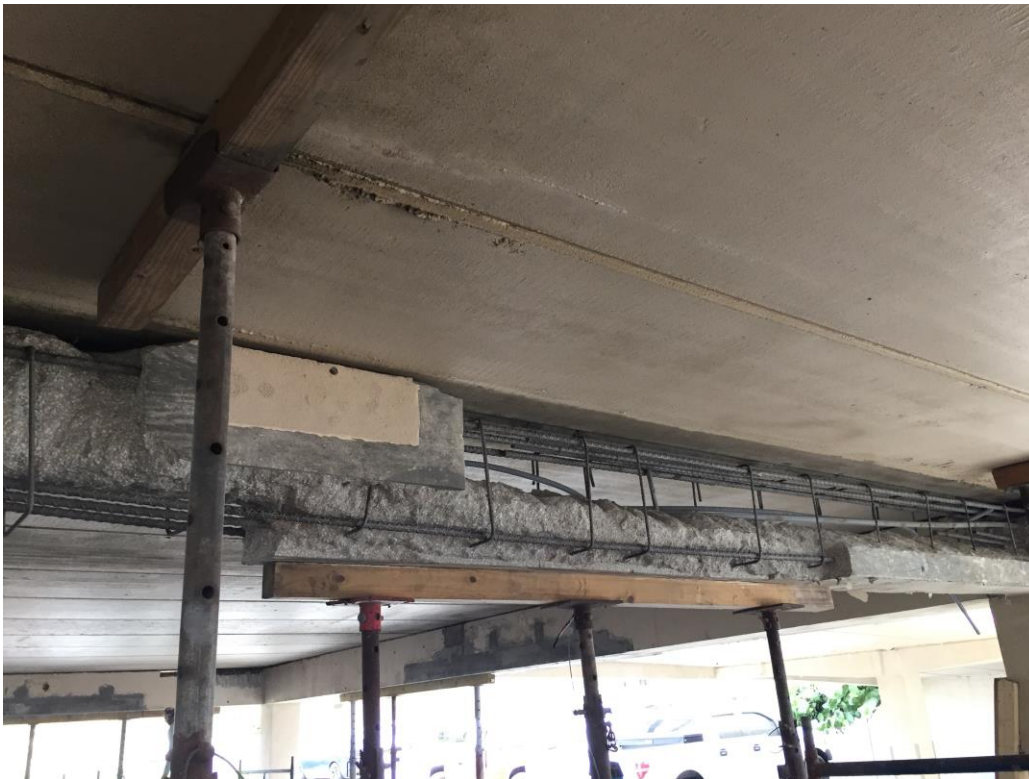
Picture 2: Approved beam excavation

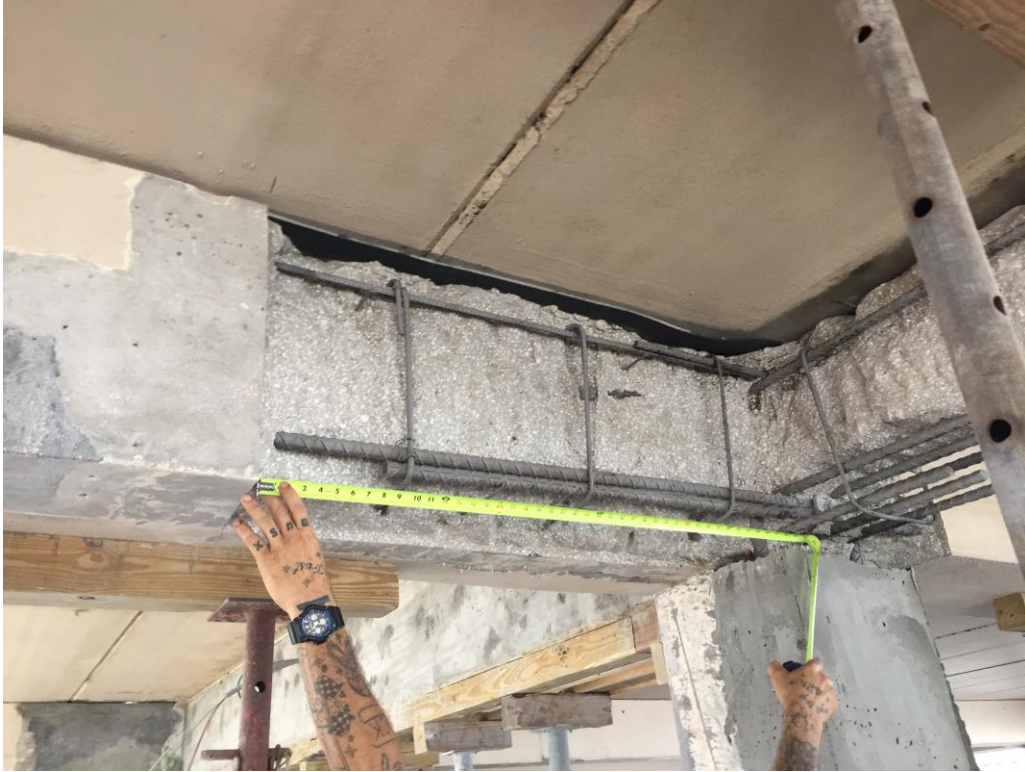
Picture 3: Approved beam excavation

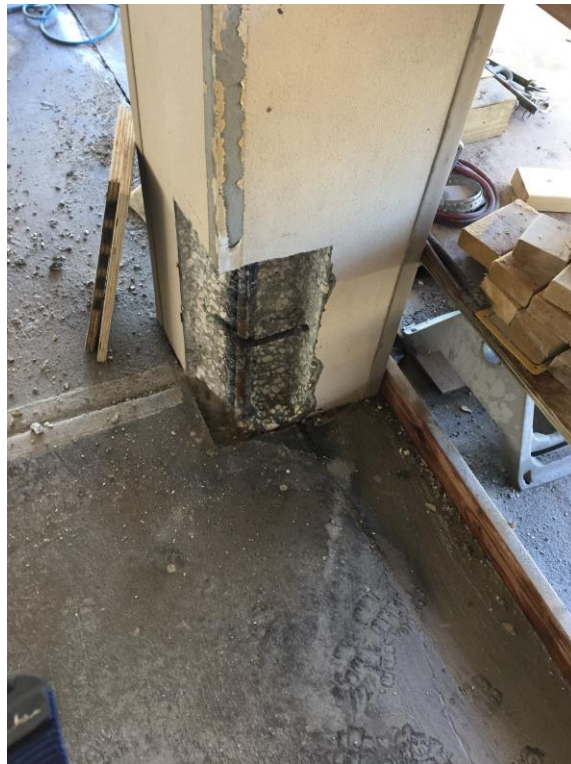
Picture 4: Approved column excavation

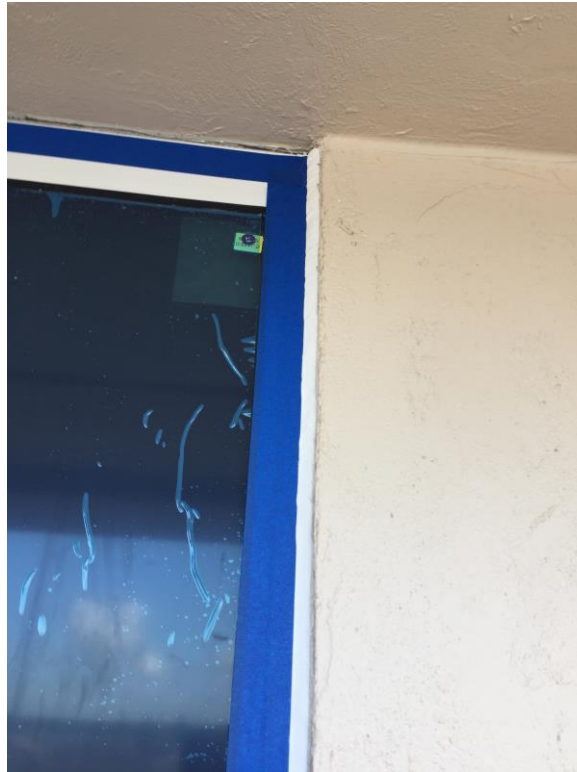
Gulfstream glass continues installing walkway windows on the 4th floor (See Photos 5-6). The substrates were inspected on units 408 and 409 and no issues were found. Perimeter sealants continue to be neatly tooled and compressed. Engineer observed caulking application over fastener heads.

Picture 5: Typical caulking application

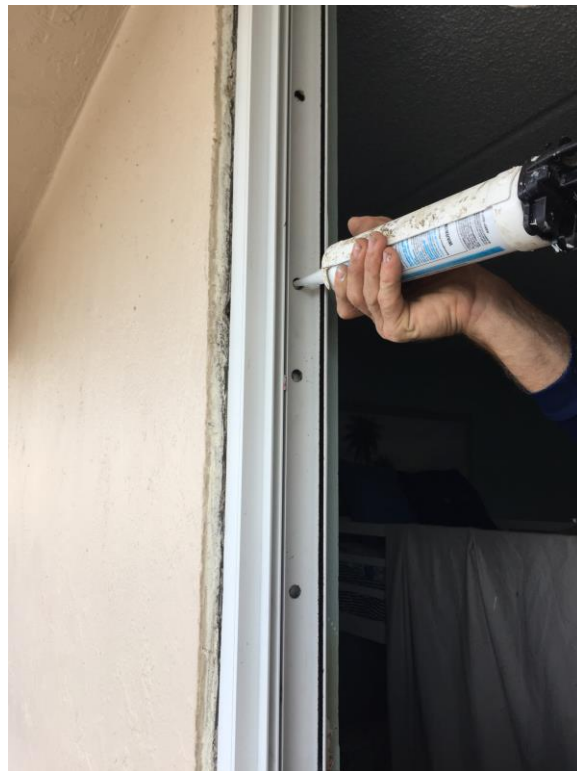
Picture 6: In-progress caulking of fastener heads
