FIELD OVSERVATION REPORT PERMIT # BLDC-000287-2020

Report No. 22	Page 1 of 1
Project:	Southpoint Condominium	Inspection For:	Restoration Project
Day/Date:	Wednesday, July 22, 2020	Job No.	19-1086
Location:	4453 S. Atlantic Ave, Ponce Inlet	Engineer:	Timothy J. Snook, P.E.
Contractor:	ACE Enterprises, LLC	Project Foreman:	Wes Swaim
Subcontractor:	Gulfstream Glass (3)	Inspector:	Timothy J. Snook, P.E.
Weather:	89 Degrees @ 12:45 A.M. Sunny	Light Breeze	40% Chance of Rain
Workforce Total:	20		
Activities:	Concrete demo, sandblasting, window installation, drywall repair, coating removal

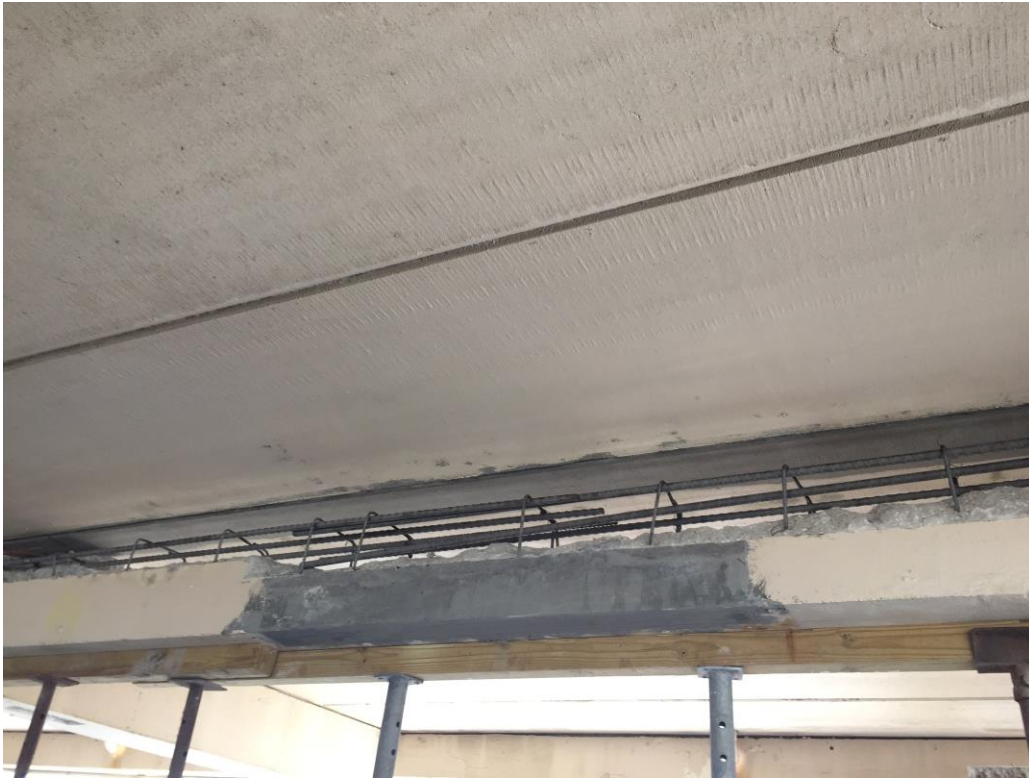
The Engineer was on-site to inspect two beam repairs in the parking garage (See Photo 1). All excavations conformed to ICRI standards. Sandblasting the steel was complete and all supplemental steel was installed as directed. The excavations were approved to be cast. Forming the previously approved excavations is in-progress (See Photo 2).

Picture 1: Approved beam excavation

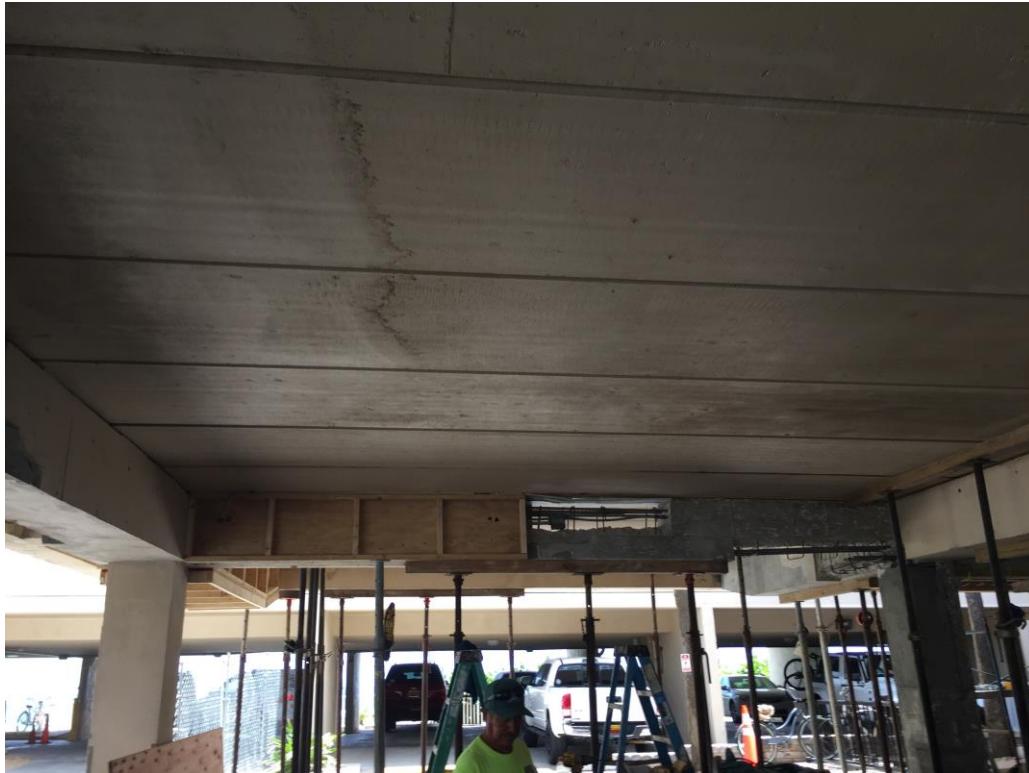
Picture 2: In-progress forming

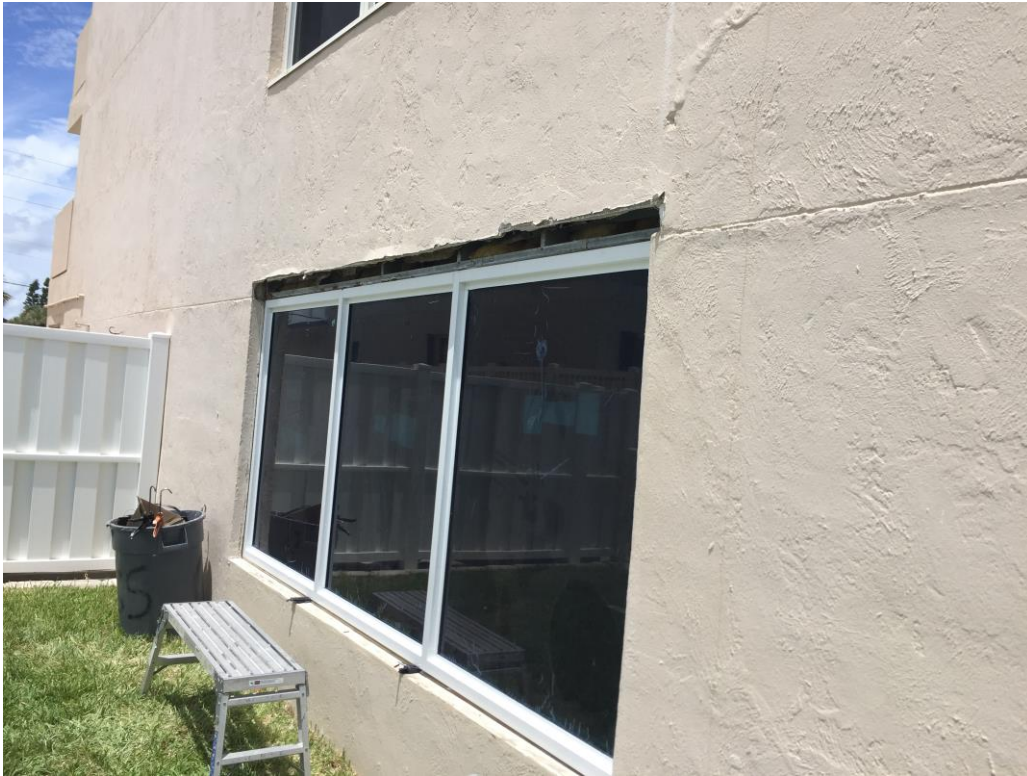
Gulfstream glass installed the South elevation community room window (See Photo 3). The existing stucco was over 2" thick at the header of the window. The Engineer directed the Contractor to build out the header with metal framing to allow for the proper application of stucco.

Picture 3: South elevation community room window in-progress installation

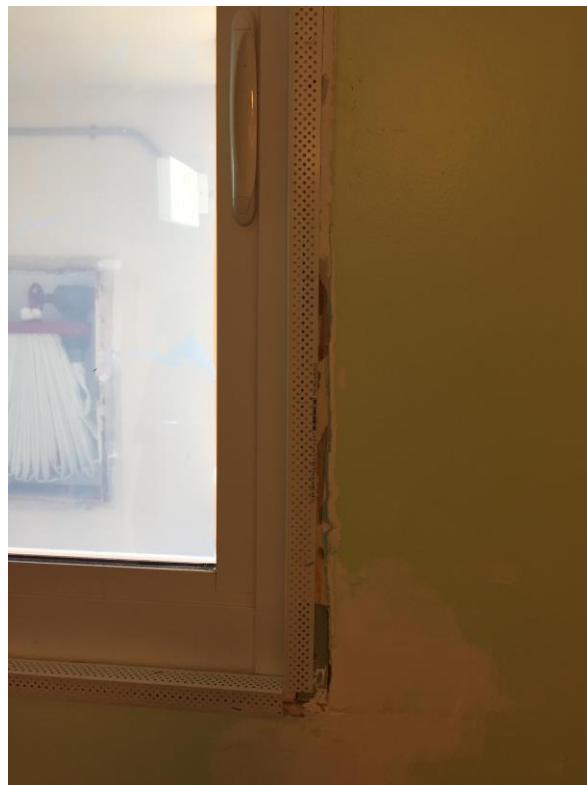
Drywall repair is in-progress around the interior of the walkway windows (See Photo 4).

Picture 4: In-progress drywall repair
