## FIELD OVSERVATION REPORT PERMIT # BLDC-000287-2020

Report No. 23	Page 1 of 1
Project:	Southpoint Condominium	Inspection For:	Restoration Project
Day/Date:	Monday, July 27, 2020	Job No.	19-1086
Location:	4453 S. Atlantic Ave, Ponce Inlet	Engineer:	Timothy J. Snook, P.E.
Contractor:	ACE Enterprises, LLC	Project Foreman:	Wes Swaim
Subcontractor:	N/A	Inspector:	Timothy J. Snook, P.E.
Weather:	93 Degrees @ 12:50 P.M. Sunny	Light Breeze 60	0% Chance of Rain
Workforce Total:	13		
Activities:	Concrete demo, forming repairs, stucco, drywall repair

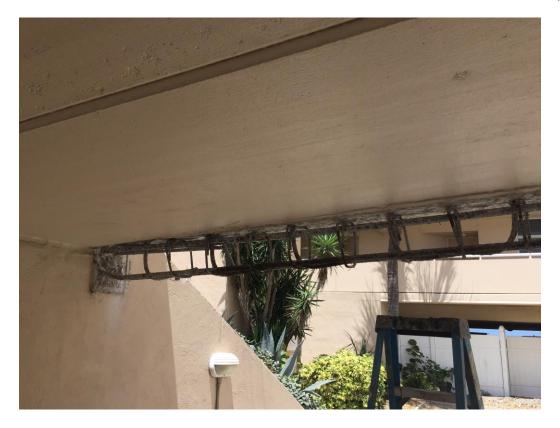
The Engineer was on-site to inspect four beam repairs on the North side of the parking garage (See Photos 1-2). All excavations conformed to ICRI standards. Sandblasting the steel is underway and all supplemental steel was installed as directed. The excavations were approved to be cast. Forming the previously approved excavations is in-progress.

Picture 1: Completed excavation prior to sandblasting

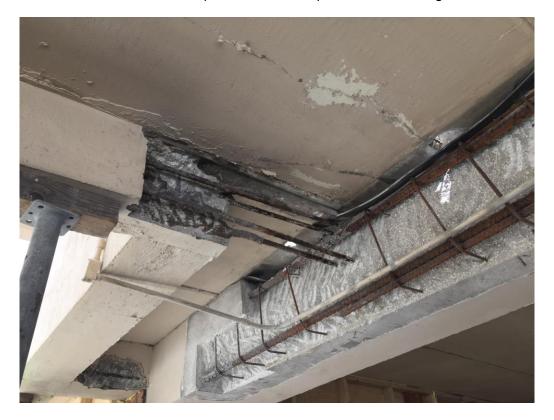
Picture 2: Completed excavation prior to sandblasting

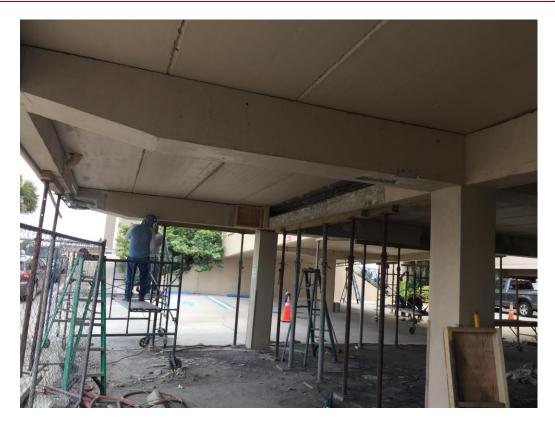
Concrete demolition continues on the North side of the parking garage (See Photo 3).

Picture 3: In-progress demolition

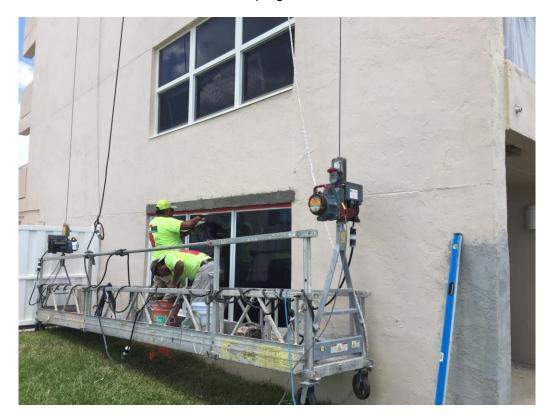
Stucco application is in-progress on the header of the ground floor South elevation window (See Photo 4).

Picture 4: In-progress stucco application
