## FIELD OVSERVATION REPORT PERMIT # BLDC-000287-2020

Report No. 27	Page 1 of 1
Project:	Southpoint Condominium	Inspection For:	Restoration Project
Day/Date:	Monday, August 10, 2020	Job No.	19-1086
Location:	4453 S. Atlantic Ave, Ponce Inlet	Engineer:	Timothy J. Snook, P.E.
Contractor:	ACE Enterprises, LLC	Project Foreman:	Wes Swaim
Subcontractor:	GAR (3)	Inspector:	Timothy J. Snook, P.E.
Weather:	92 Degrees @ 1:00 P.M.	Sunny	Light Breeze 20% Chance of Rain
Workforce Total:	18		
Activities:	Concrete demo, forming repairs, window installation

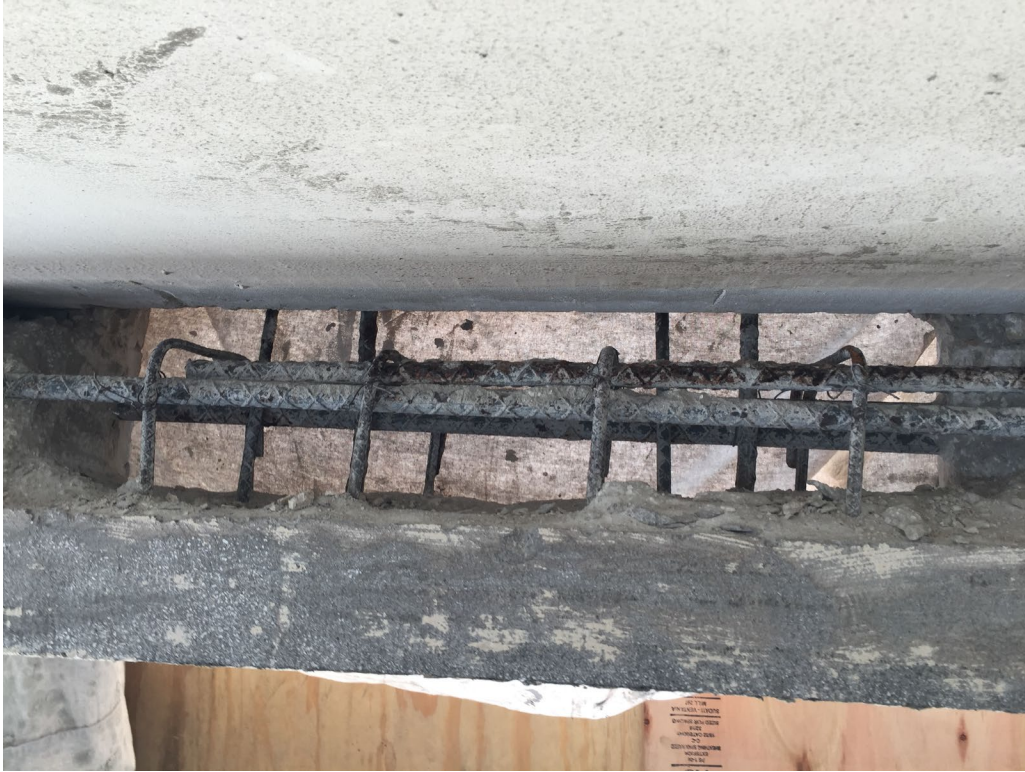
The Engineer was on-site to inspect miscellaneous beam and column repairs in the parking garage (See Photos 1-4). All excavations conformed to ICRI standards. Sandblasting the steel was underway. All supplemental steel was installed as directed. The excavations were approved to be cast. Forming the approved excavations is in-progress.

Picture 1: Completed excavation, sandblasting in-progress

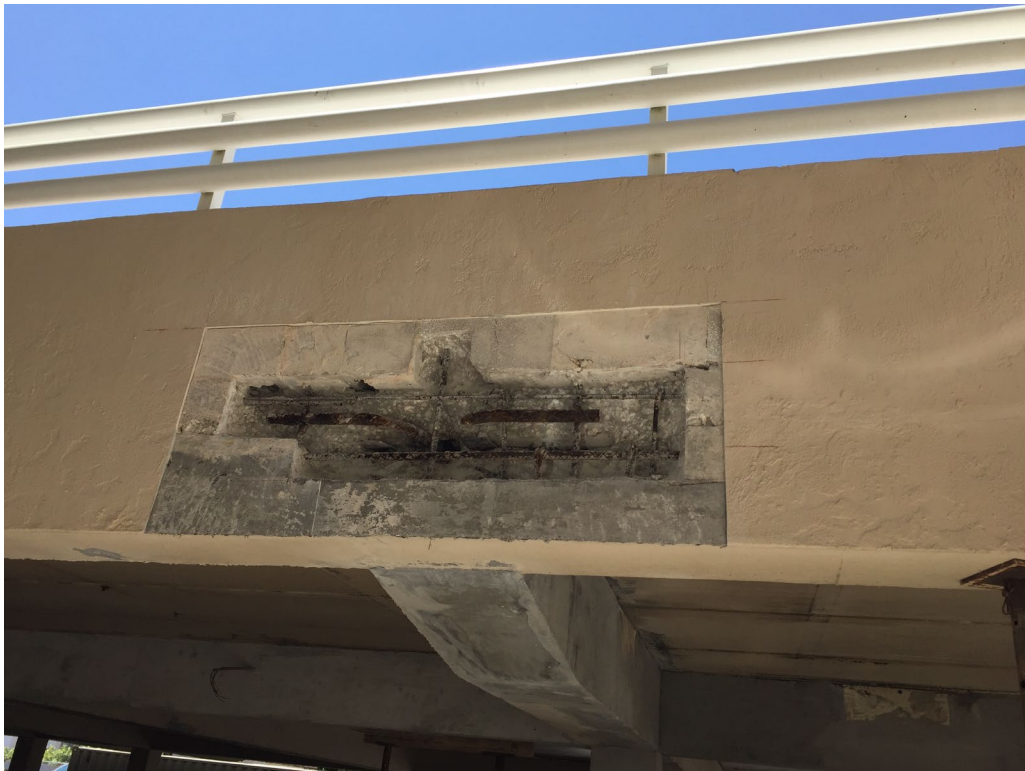
Picture 2: Completed excavation

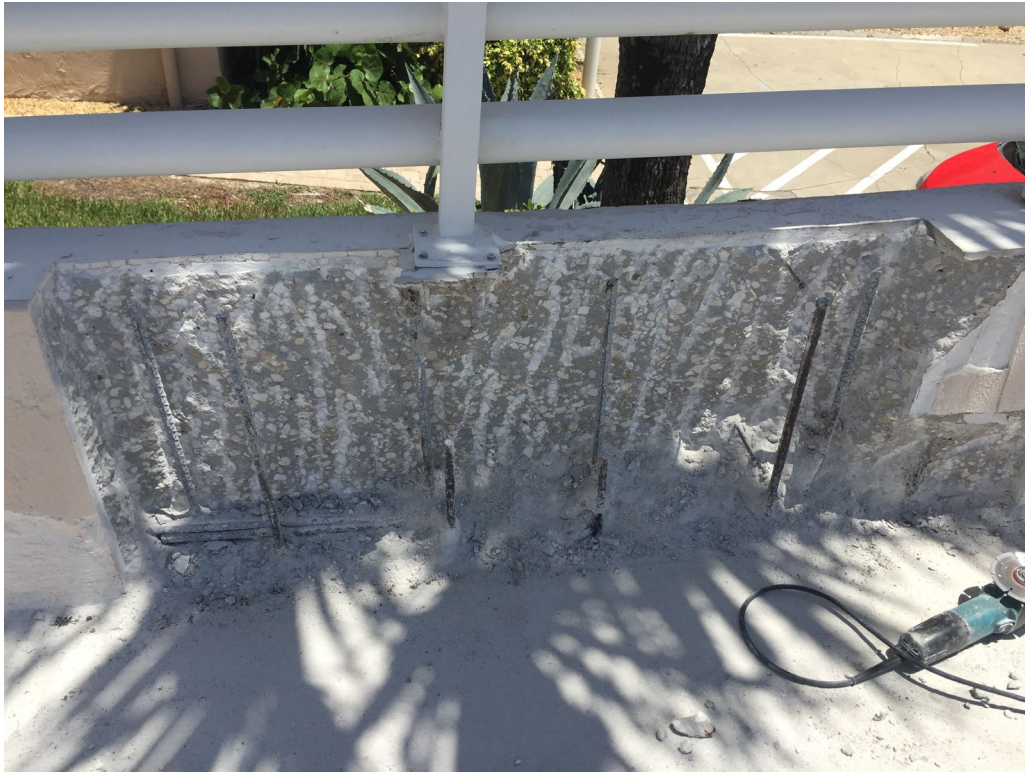
Picture 3: In-progress excavation on knee wall

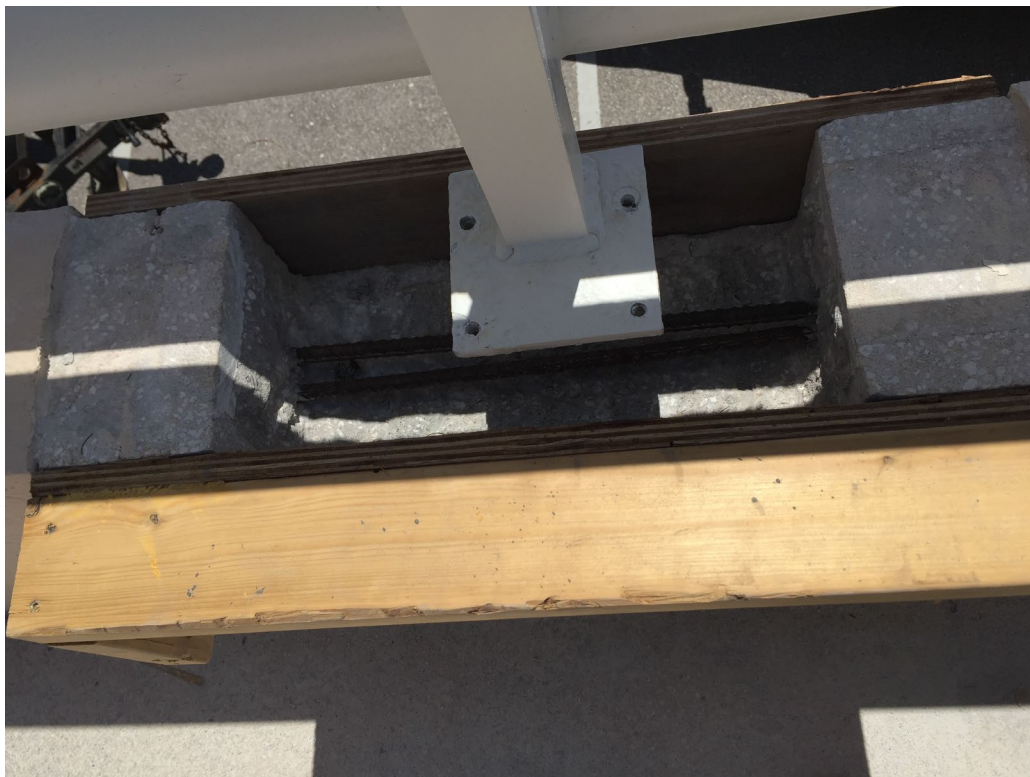
Picture 4: Completed excavation on knee wall
