FIELD OVSERVATION REPORT PERMIT # BLDC-000287-2020

Report No. 39	Page 1 of 1
Project:	Southpoint Condominium	Inspection For:	Restoration Project
Day/Date:	Wednesday, September 16, 2020	Job No.	19-1086
Location:	4453 S. Atlantic Ave, Ponce Inlet	Engineer:	Timothy J. Snook, P.E.
Contractor:	ACE Enterprises, LLC	Project Foreman:	Wes Swaim
Subcontractor:	Gulfstream Glass (5)	Inspector:	Timothy J. Snook, P.E.
Weather:	82 Degrees @ 8:20 A.M. Overcast	Light Breeze	60% Chance of Rain
Workforce Total:	13		
Activities:	Concrete placement, painting, rout and seal cracks, window installation

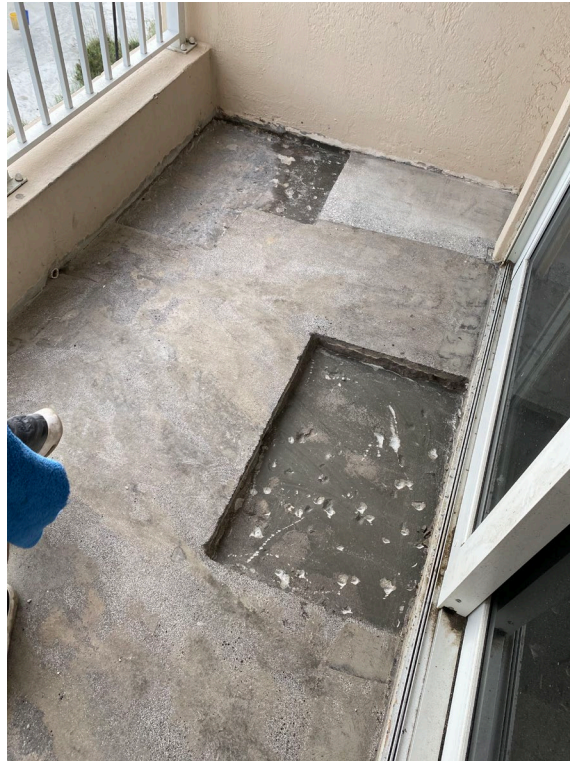
Concrete demolition has been completed on the 07 and 08 stack balconies (See Photos 1-2). The Engineer was on-site to inspect the completed repairs. The excavations conformed to ICRI standards. No supplemental steel was needed. The excavations were approved to be cast. After removing the topping on Unit 108, a crack could be seen in the precast panel (See Photos 3-4). The crack radiates through the panel and can be seen on the underside of the panel. This will need to be repaired full depth. The approved excavations will be cast starting today.

Picture 1: Typical topping repair

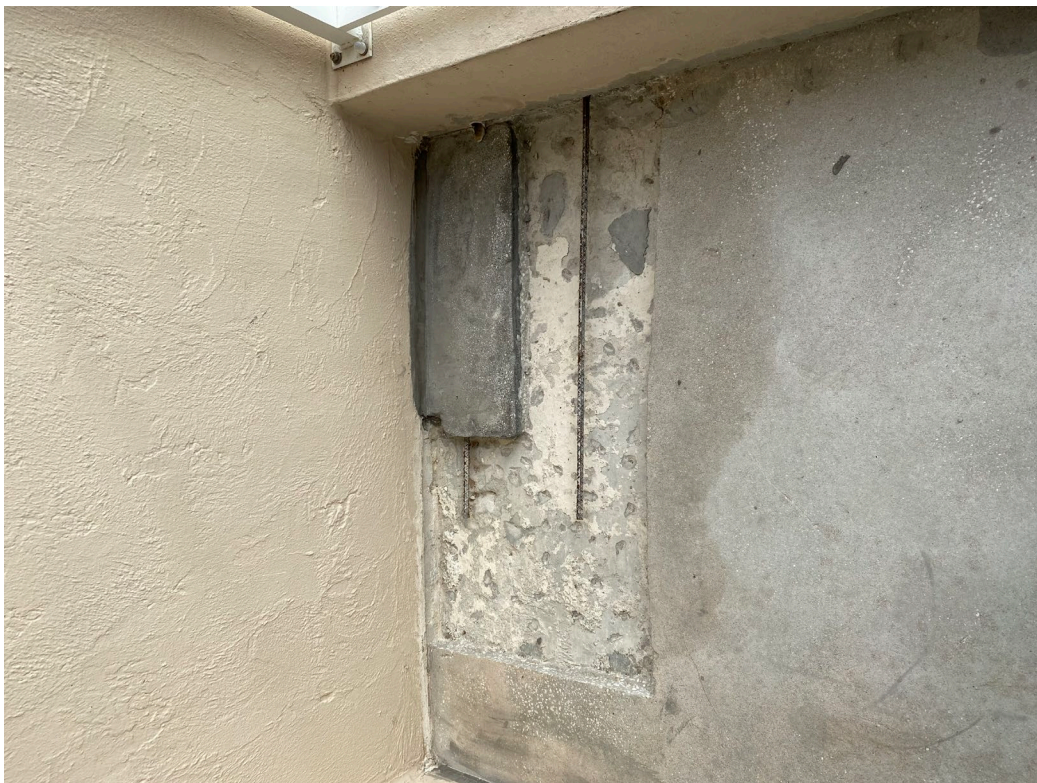
Picture 2: Typical topping repair

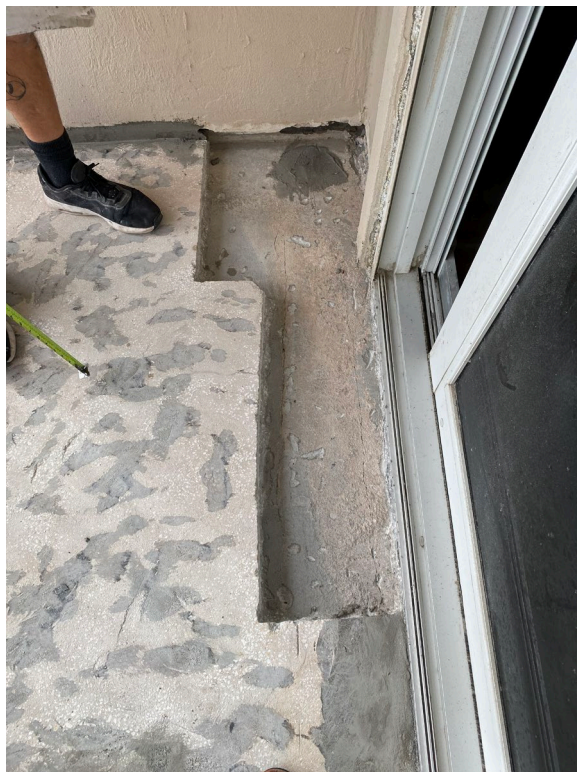
Picture 3: Cracks in the precast panel of Unit 108

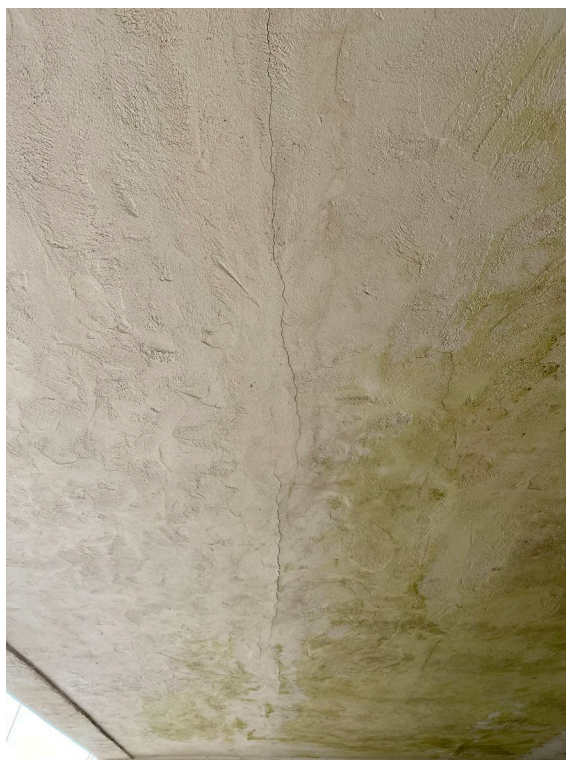
Picture 4: Crack in the bottom of the precast panel of Unit 108

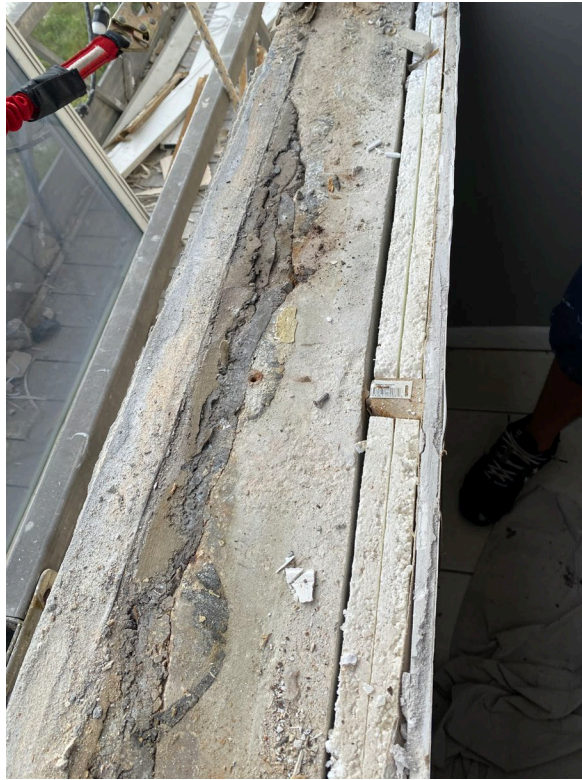
Installation of the East window on Unit 310 is in-progress. A concrete spall was found in the sill which requires repair prior to window installation (See Photo 5). The North jamb is constructed of metal framing which is corroded through and will require supplementation (See Photo 6).

Picture 5: Crack in window sill of Unit 310

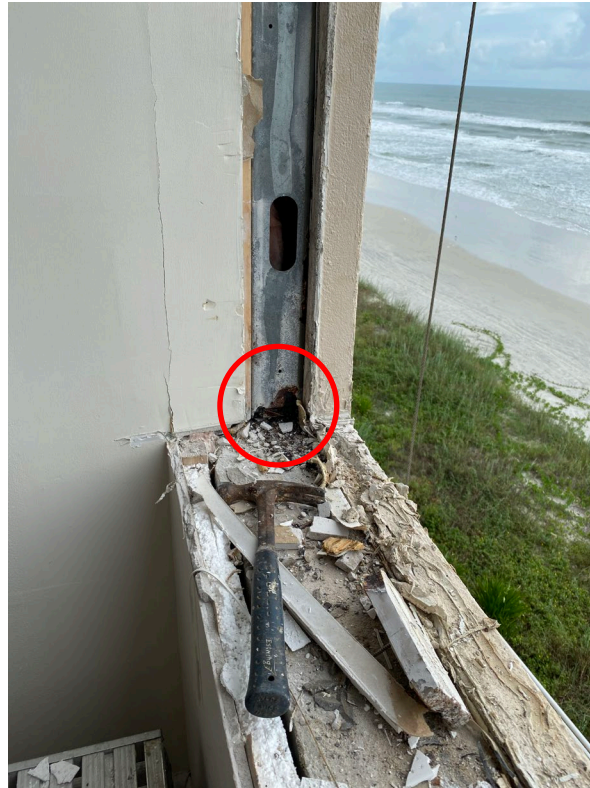
Picture 6: Metal stud corroded at bottom
