# UNITED ENGINEERING CONSULTANTS, INC.

## FIELD OVSERVATION REPORT PERMIT # BLDC-000287-2020

Report No. 41	Page 1 of 1
Project:	Southpoint Condominium	Inspection For:	Restoration Project
Day/Date:	Wednesday, September 23, 2020	Job No.	19-1086
Location:	4453 S. Atlantic Ave, Ponce Inlet	Engineer:	Timothy J. Snook, P.E.
Contractor:	ACE Enterprises, LLC	Project Foreman:	Wes Swaim
Subcontractor:	Gulfstream Glass (4)	Inspector:	Timothy J. Snook, P.E.
Weather:	85 Degrees @ 2:00 P.M. Sunny	Light Breeze	0% Chance of Rain
Workforce Total:	13		
Activities:	Concrete demo, window installation, stucco repair

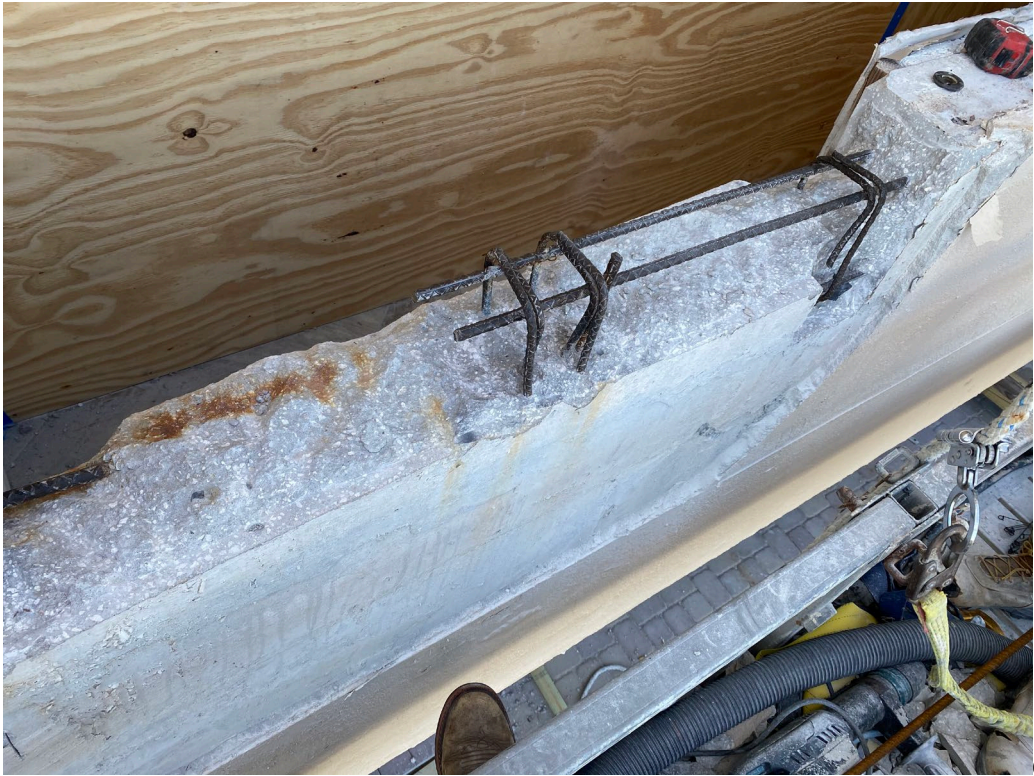
The Engineer was on-site to inspect the concrete repair at the window sill of Unit 110 East window and the jamb of the 7<sup>th</sup> floor South stairwell door (See Photos 1-2). The excavations conformed to ICRI standards. The steel was cleaned and supplemental steel was installed as directed. The excavations were approved to be cast.

Picture 1: In-progress repair at Unit 110 prior to steel supplementation

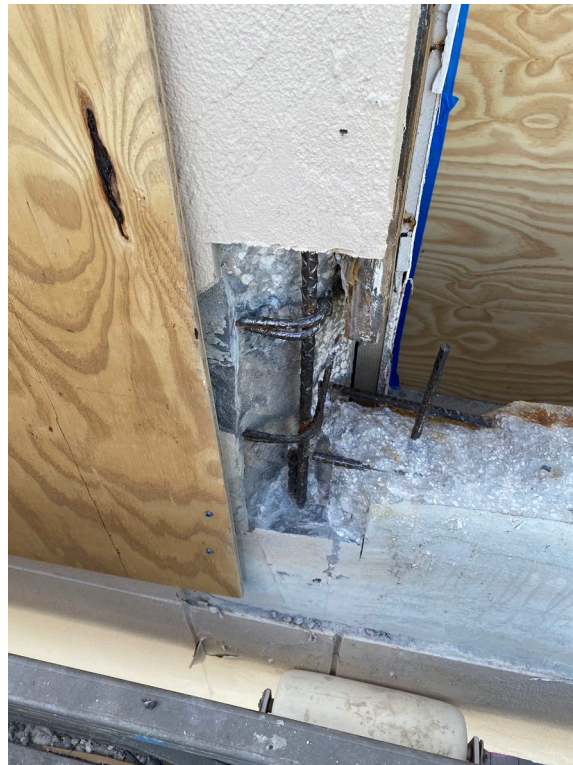
Picture 2: In-progress repair at Unit 110 prior to steel supplementation

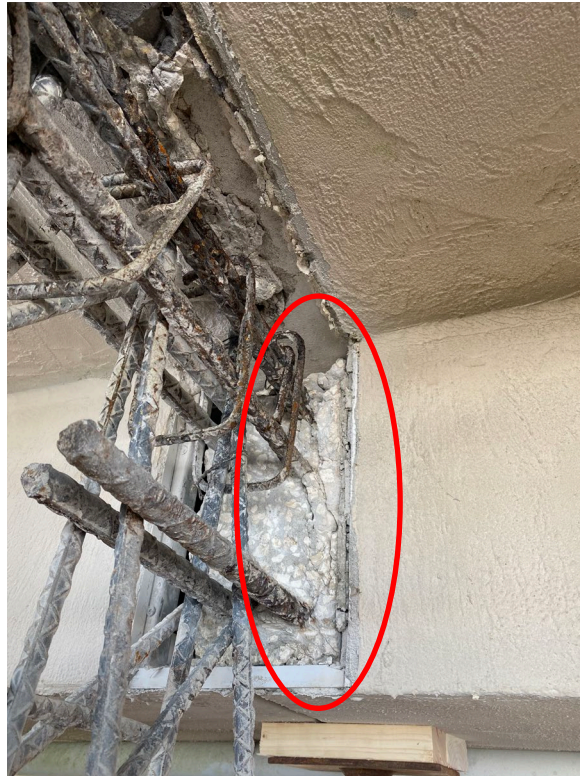
Concrete demolition continues on the walls in the parking garage below the building and at South stairwell doors (See Photo 3-5). After removal of the 7<sup>th</sup> floor stairwell door, more concrete damage was found at the header of the door (See Photo 6).

Picture 3: Cracked concrete at beam going above garage soffit

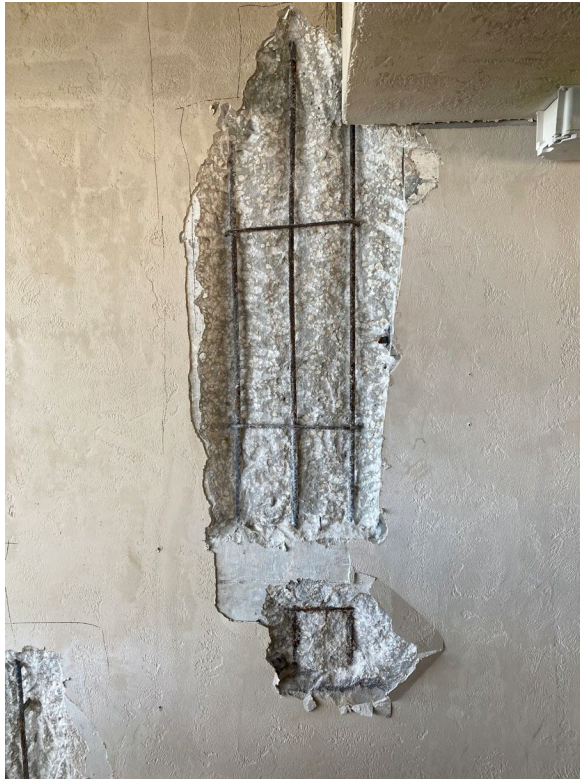
Picture 4: In-progress demolition in garage

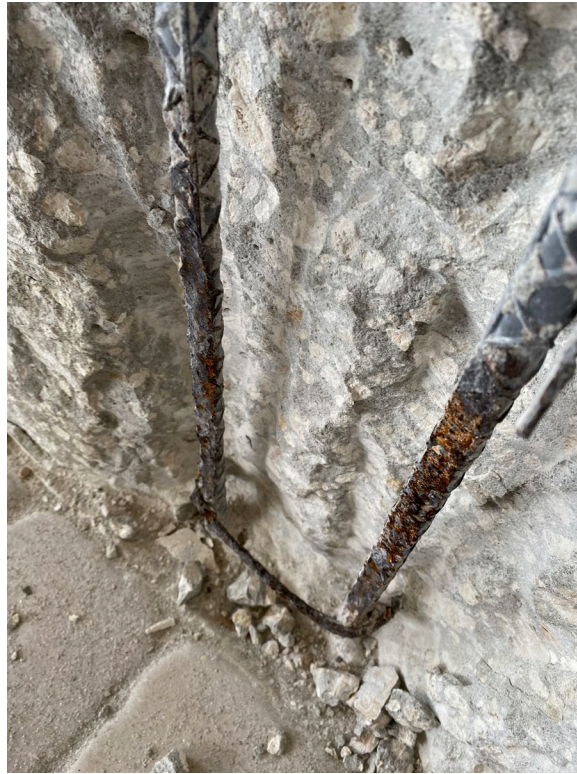
Picture 5: Typical corroded and necked down reinforcing steel in garage

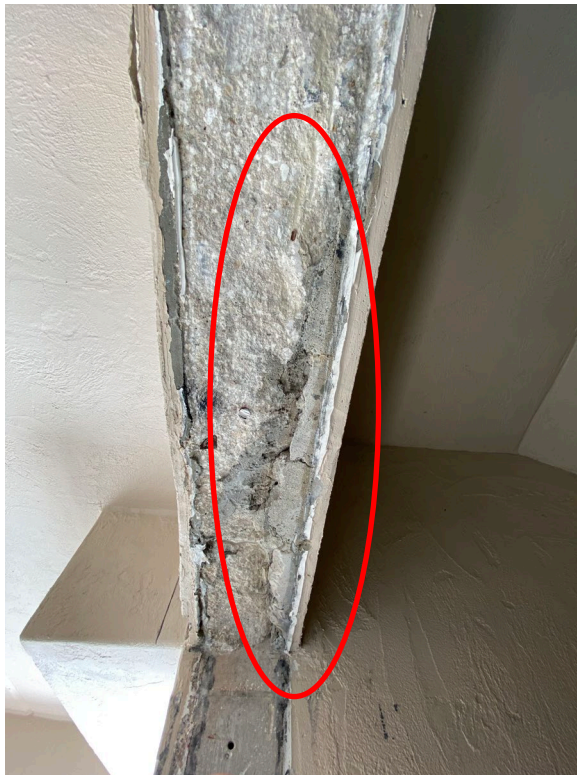
Picture 6: Cracked concrete in header of 7<sup>th</sup> floor stairwell door
