# UNITED ENGINEERING CONSULTANTS, INC.

## FIELD OVSERVATION REPORT PERMIT # BLDC-000287-2020

Report No. 42	Page 1 of 1
Project:	Southpoint Condominium	Inspection For:	Restoration Project
Day/Date:	Friday, September 25, 2020	Job No.	19-1086
Location:	4453 S. Atlantic Ave, Ponce Inlet	Engineer:	Timothy J. Snook, P.E.
Contractor:	ACE Enterprises, LLC	Project Foreman:	Wes Swaim
Subcontractor:	Gulfstream Glass (4)	Inspector:	Timothy J. Snook, P.E.
Weather:	84 Degrees @ 10:20 A.M. Sunny	Light Breeze	0% Chance of Rain
Workforce Total:	15		
Activities:	Concrete repair, window installation, stucco repair

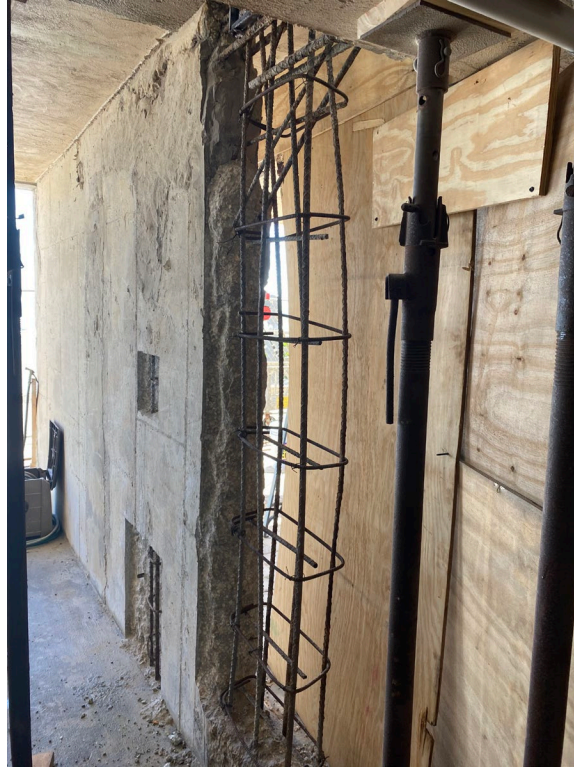
The Engineer was on-site to inspect miscellaneous concrete repairs on the load bearing walls in the garage and the jamb of the 4<sup>th</sup> floor stairwell door (See Photos 1-4). The excavations conformed to ICRI standards. Sandblasting the steel was underway. Supplemental steel was installed as directed. The excavations were approved to be cast. Forming of the excavations is in-progress.

Picture 1: Concrete repair on walls in garage

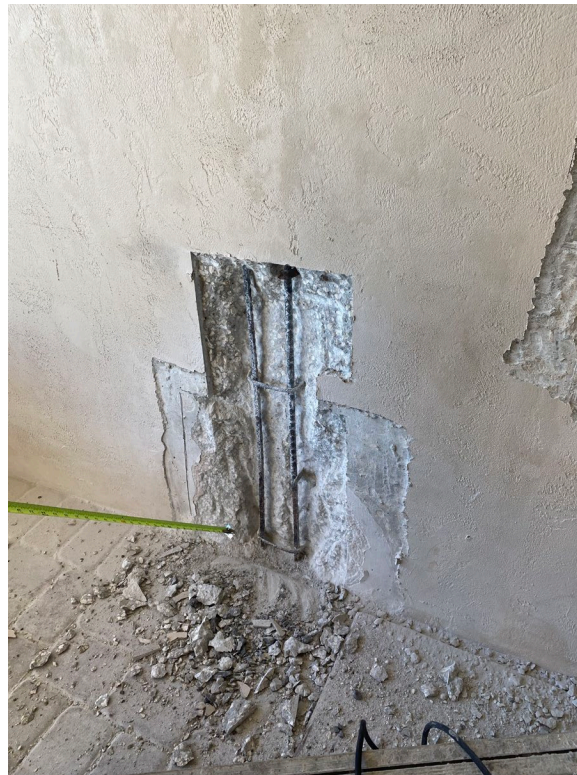
Picture 2: Concrete repair on walls in garage

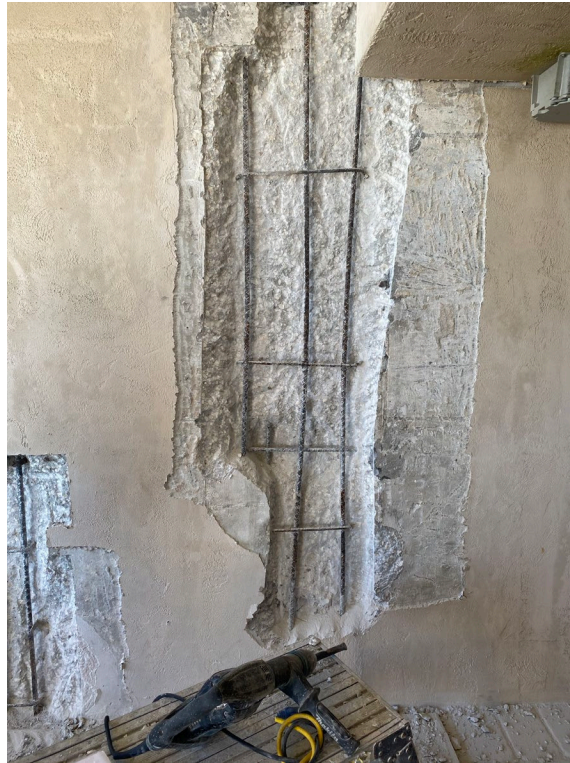
Picture 3: Concrete repair on walls in garage

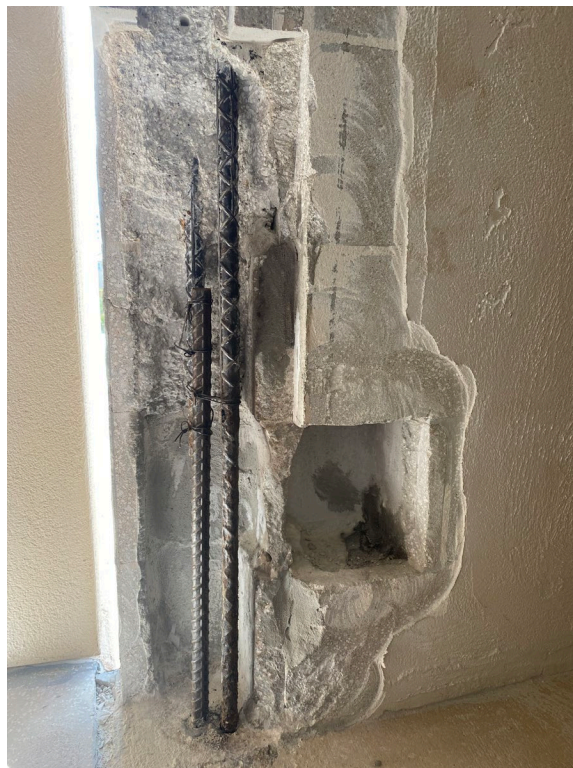
Picture 4: 4<sup>th</sup> floor stairwell jamb repair
