# UNITED ENGINEERING CONSULTANTS, INC.

## FIELD OVSERVATION REPORT PERMIT # BLDC-000287-2020

Report No. 43	Page 1 of 1
Project:	Southpoint Condominium	Inspection For:	Restoration Project
Day/Date:	Wednesday, September 30, 2020	Job No.	19-1086
Location:	4453 S. Atlantic Ave, Ponce Inlet	Engineer:	Timothy J. Snook, P.E.
Contractor:	ACE Enterprises, LLC	Project Foreman:	Wes Swaim
Subcontractor:	Gulfstream Glass (4)	Inspector:	Timothy J. Snook, P.E.
Weather:	71 Degrees @ 9:50 A.M.	Sunny	Light Breeze 0% Chance of Rain
Workforce Total:	14		
Activities:	Concrete repair, window installation, stucco repair

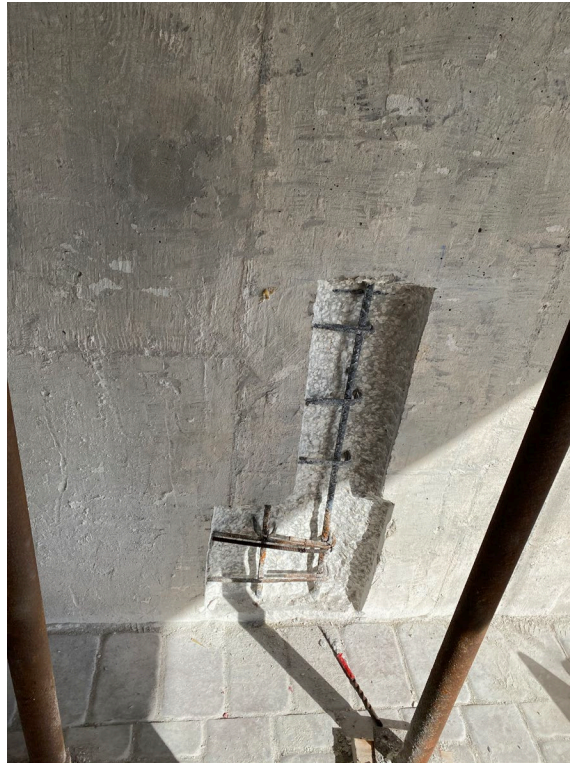
The Engineer was on-site to inspect miscellaneous concrete repairs (See Photo 1). The excavations conformed to ICRI standards. Supplemental steel was installed as directed. The excavations were approved to be cast.

Picture 1: Typical wall repair

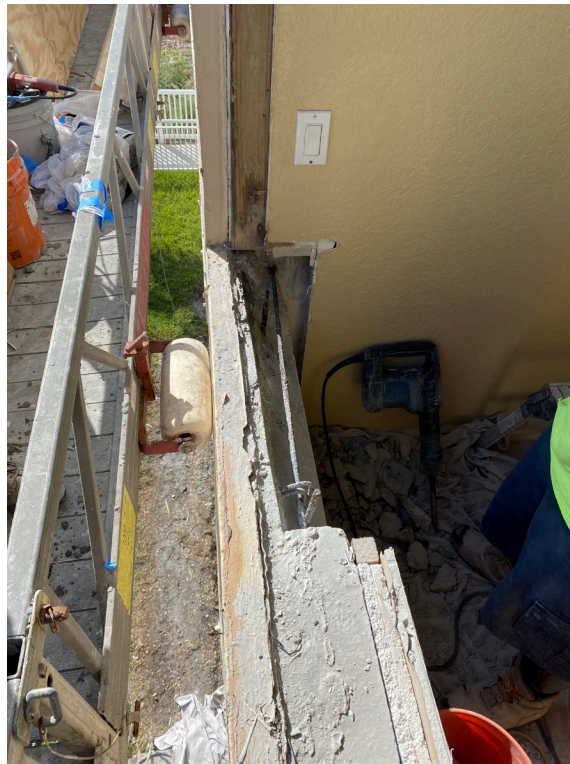
Gulfstream removed the window of Unit 210 yesterday. There was concrete damage on the South side of the window sill (See Photo 2). A hardwall barrier has been installed on the interior of the unit. The Engineer provided direction for steel supplementation. Concrete demolition is in-progress.

Picture 2: In-progress concrete repair at Unit 210 window sill

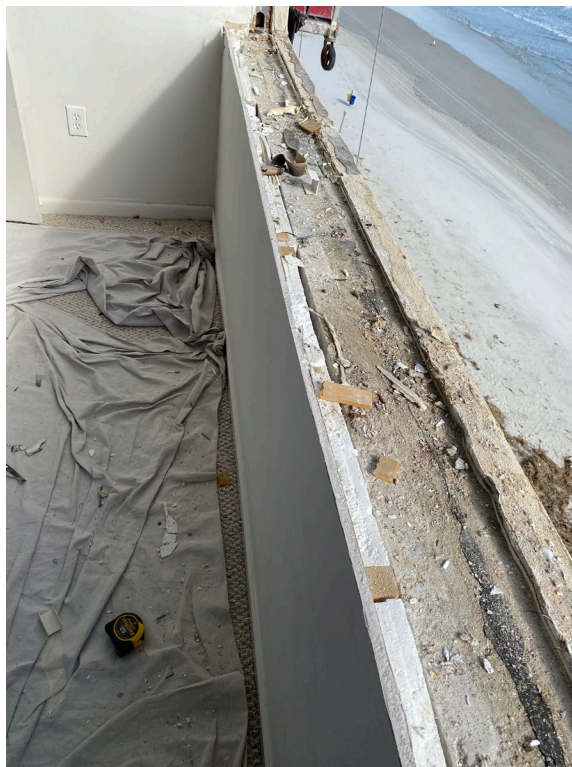
The East window in Unit 509 and 509 is being replaced today. The Engineer inspected the substrate and found no damage (See Photos 3-4). The windows will be installed today.

Picture 3: Window sill of Unit 508

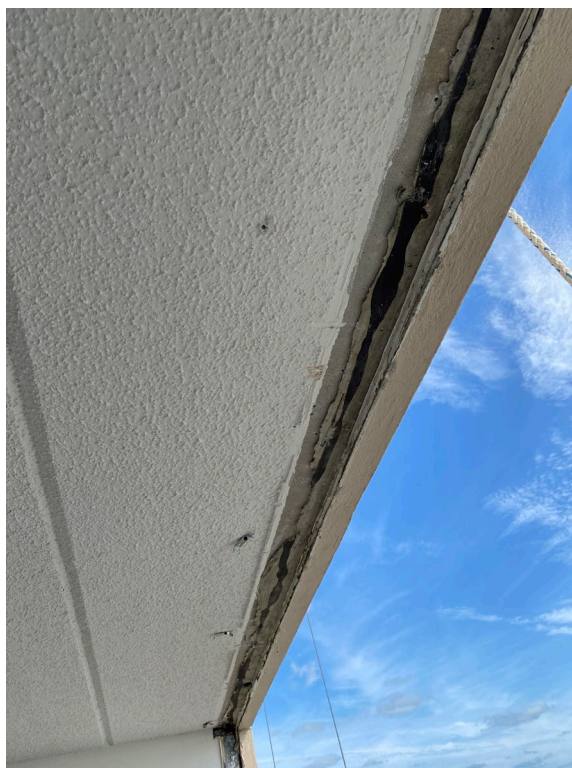
Picture 4: Header of Unit 508

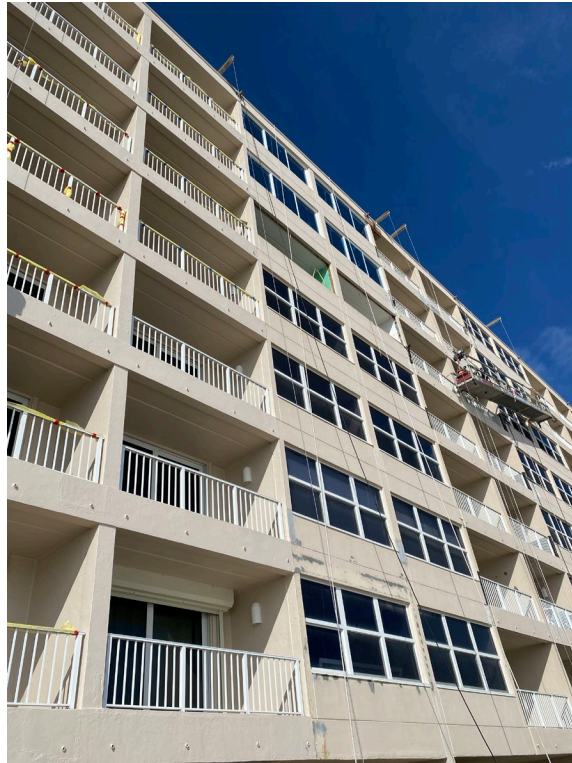
Picture 5: In-progress work on the 08/09 stack

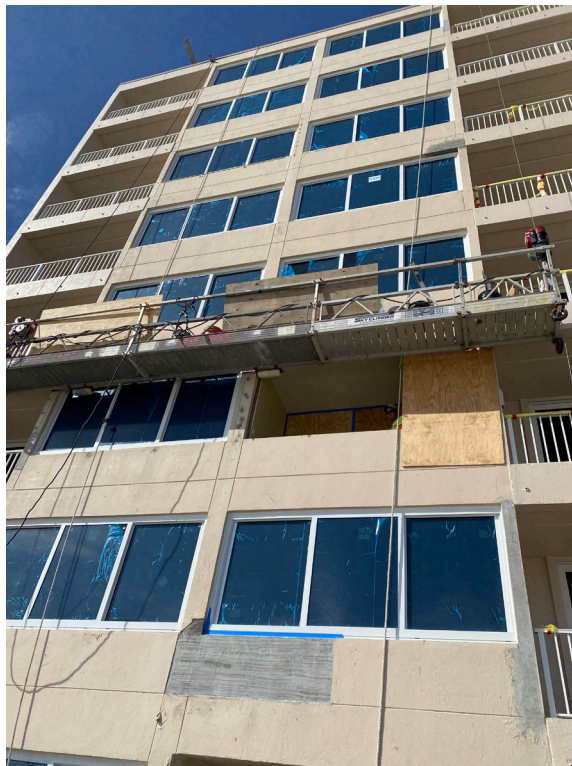
Stucco repair continues on the 07/08 stack balconies and the 10/11 stack window drop.

Picture 6: In-progress work on the 10/11 stack
