# UNITED ENGINEERING CONSULTANTS, INC.

## FIELD OBSERVATION REPORT PERMIT # BLDC-000287-2020

Report No. 68	Page 1 of 1
Project:	Southpoint Condominium	Inspection For:	Restoration Project
Day/Date:	Wednesday, December 23, 2020	Job No.	19-1086
Location:	4453 S. Atlantic Ave, Ponce Inlet	Engineer:	Timothy J. Snook, P.E.
Contractor:	ACE Enterprises, LLC	Project Foreman:	Wes Swaim
Subcontractor:	Gulfstream Glass (6)	Inspector:	Timothy J. Snook, P.E.
Weather:	53 Degrees @ 7:55 A.M. Sunny Light Breeze 0% Chance of Rain		
Workforce Total:	19		
Activities:	Concrete repair, punch out, painting, deck coating removal, window installation

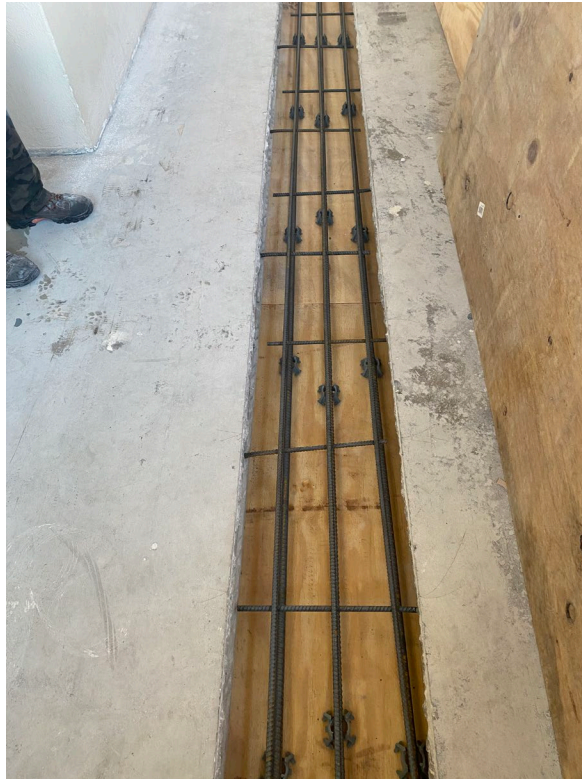
Concrete demolition continues on the 04 and 05 stack balconies. The Engineer was on-site to inspect the full depth excavation on the North half of the 7<sup>th</sup> floor walkways (See Photo 1). The excavation conformed to ICRI standards. The supplemental steel was installed as directed. The excavation was formed. Casting of the excavation was approved. It will be cast today.

Picture 1: 7<sup>th</sup> floor North walkway full depth repair

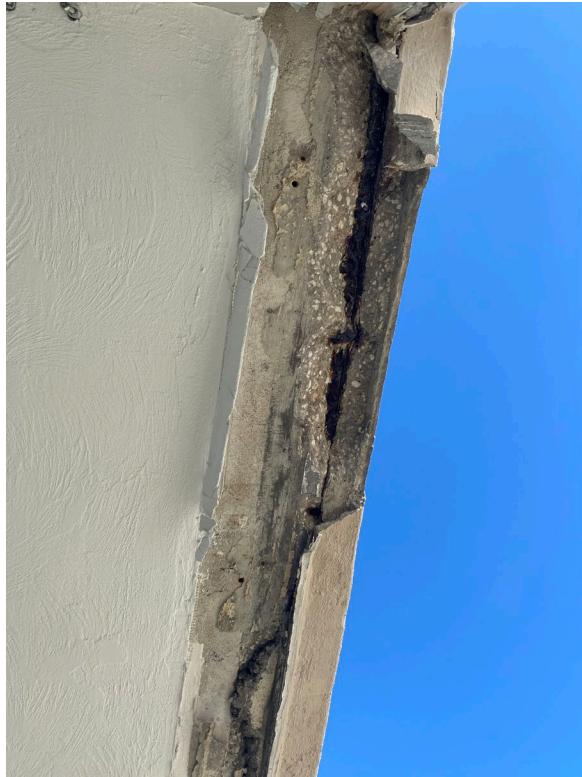
Window installation continues today on the 4<sup>th</sup> floor of the 06 stack East facing windows. When the window was removed, header spalls were found (See Photos 2-3). The Contractor will board the unit and make the repairs prior to window installation. Gulfstream switched gears and began installing walkway windows on the 2<sup>nd</sup> floor.

Picture 2: Unit 406 header spall

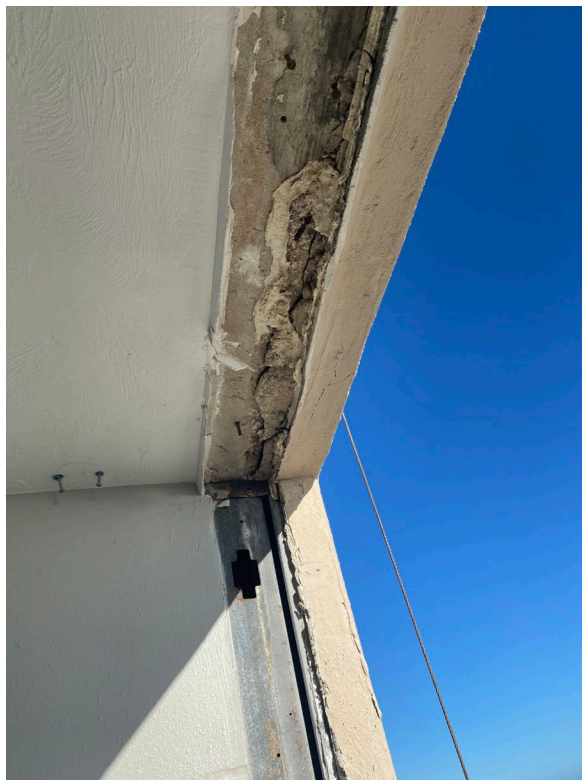
Picture 3: Unit 406 header spall
