FIELD OVSERVATION REPORT PERMIT # BLDC-000287-2020

Report No. 40	Page 1 of 1
Project:	Southpoint Condominium	Inspection For:	Restoration Project
Day/Date:	Tuesday, September 22, 2020	Job No.	19-1086
Location:	4453 S. Atlantic Ave, Ponce Inlet	Engineer:	Timothy J. Snook, P.E.
Contractor:	ACE Enterprises, LLC	Project Foreman:	Wes Swaim
Subcontractor:	Gulfstream Glass (4)	Inspector:	Timothy J. Snook, P.E.
Weather:	83 Degrees @ 11:15 A.M. Overcast	Light Breeze	20% Chance of Rain
Workforce Total:	13		
Activities:	Concrete demo, rout and seal cracks, window installation, stucco repair, stairwell door removal

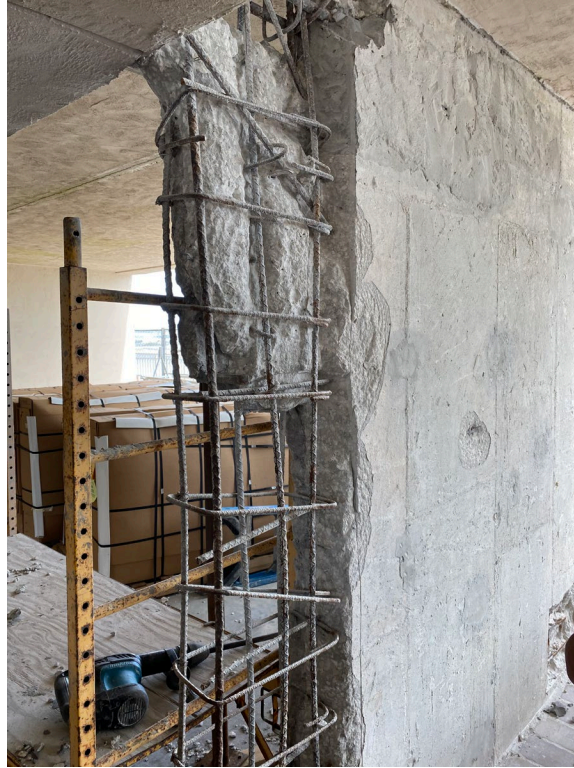
Concrete demolition is in-progress on the walls in the parking garage below the building (See Photo 1). The Engineer was on-site to inspect the completed repairs thus far. The excavations conformed to ICRI standards. The Engineer directed the installation of supplemental stirrups. The excavations were approved to be cast after steel supplementation.

Picture 1: In-progress concrete demo

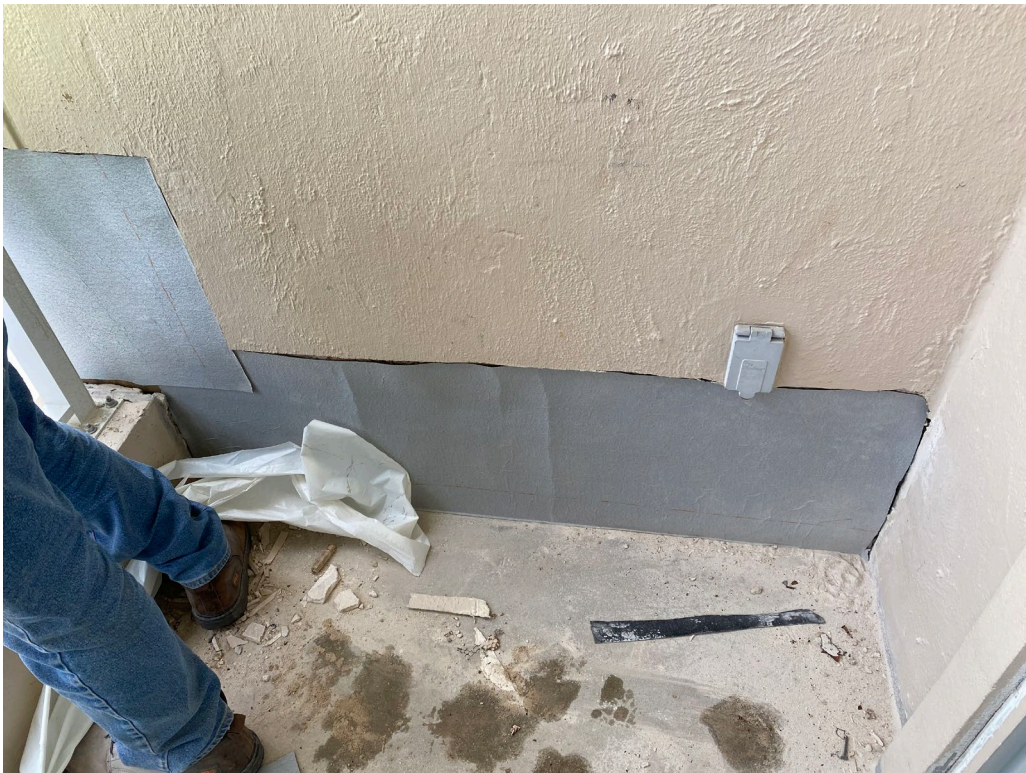
Stucco repair is in-progress on the 07 stack balconies (See Photo 2).

Picture 2: In-progress stucco repair on balcony

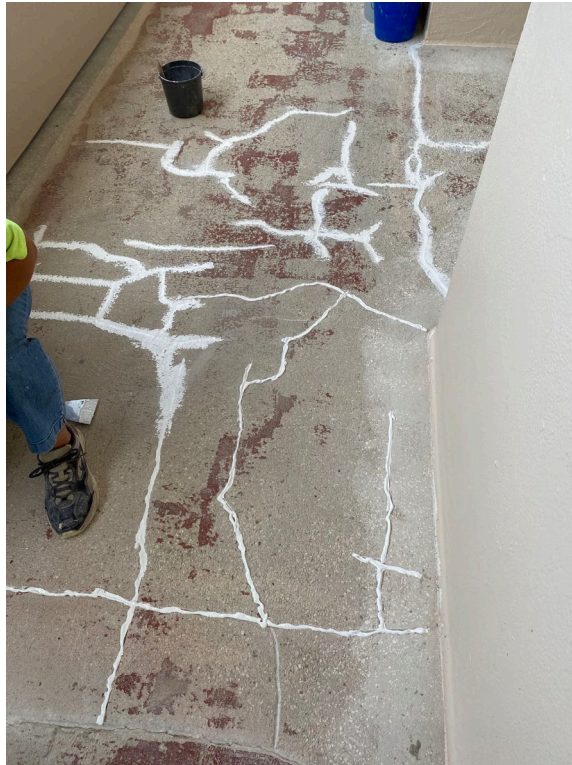
Routing and sealing cracks on the walkways continues (See Photo 3).

Picture 3: In-progress routing and sealing

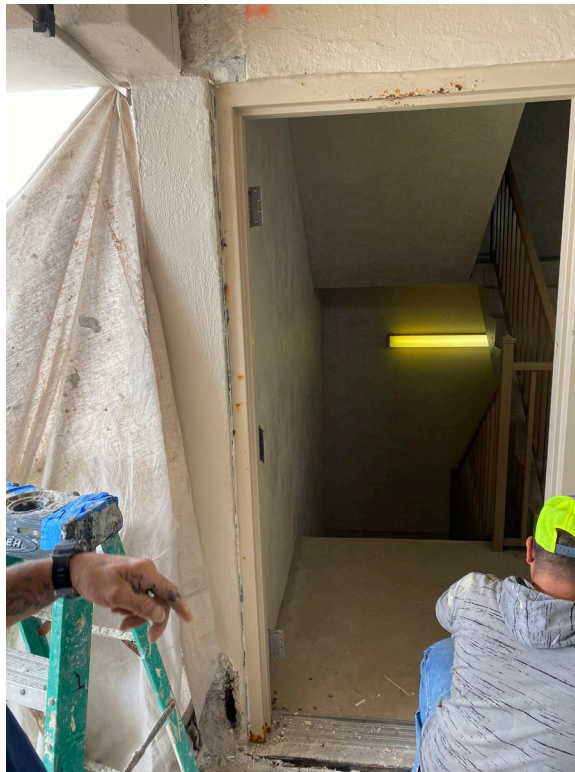
The 7th floor South stairwell door is being removed (See Photo 4). Any associated concrete repair will be made at this time.

Picture 4: In-progress stairwell door removal
