# **SOUTHPOINT CONDOMINIUM**

## **Project Summary**

### **Week #40**

#### **February 3rd through February 7th, 2014**

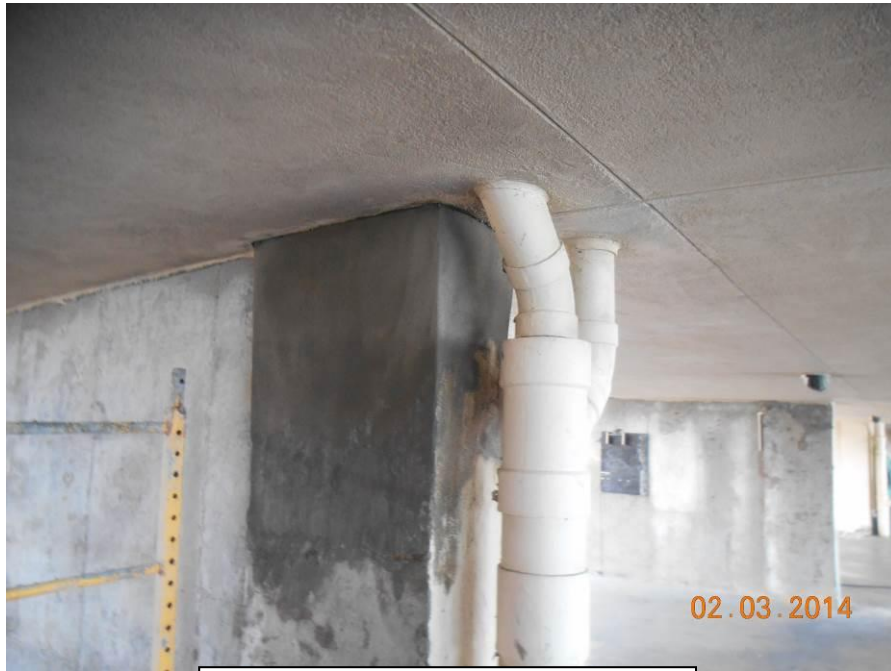
Patching mortar repair finished on east parking garage bay shearwall.

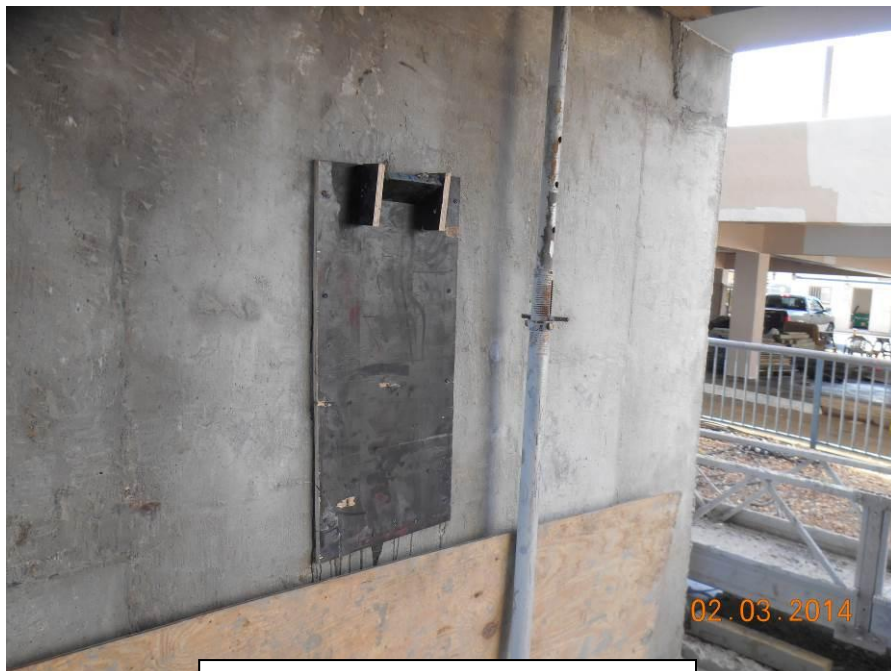
Concrete spall excavated with form built on east parking garage shearwall.

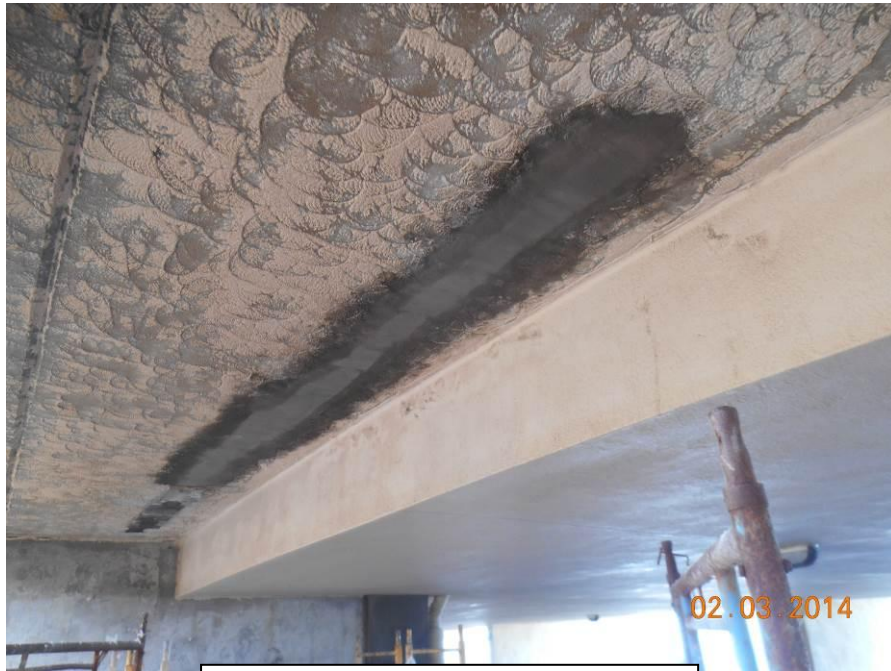
Patching mortar repair completed on east parking garage hollow-core ceiling panel.

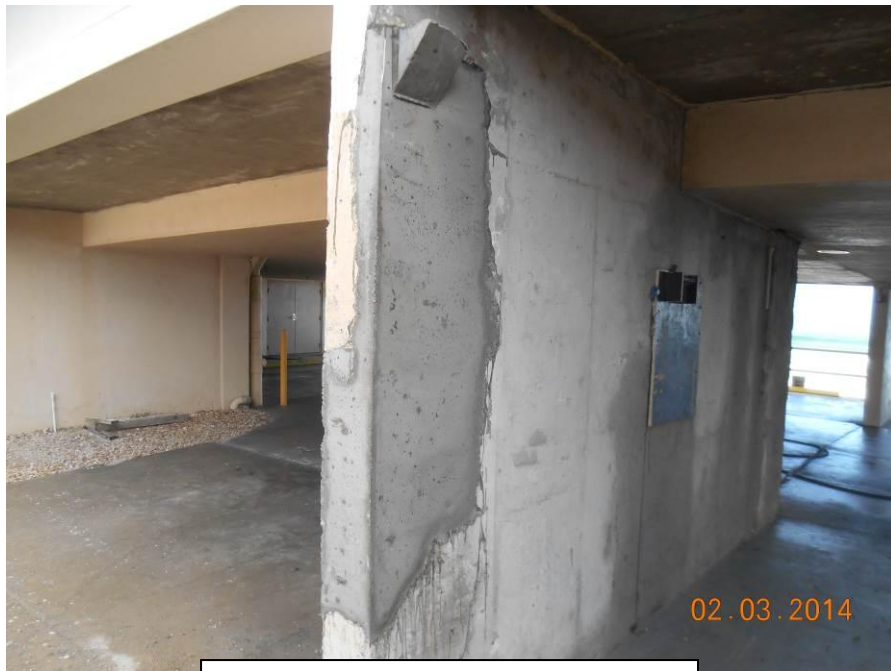
East parking garage concrete spall cast back with form removed.

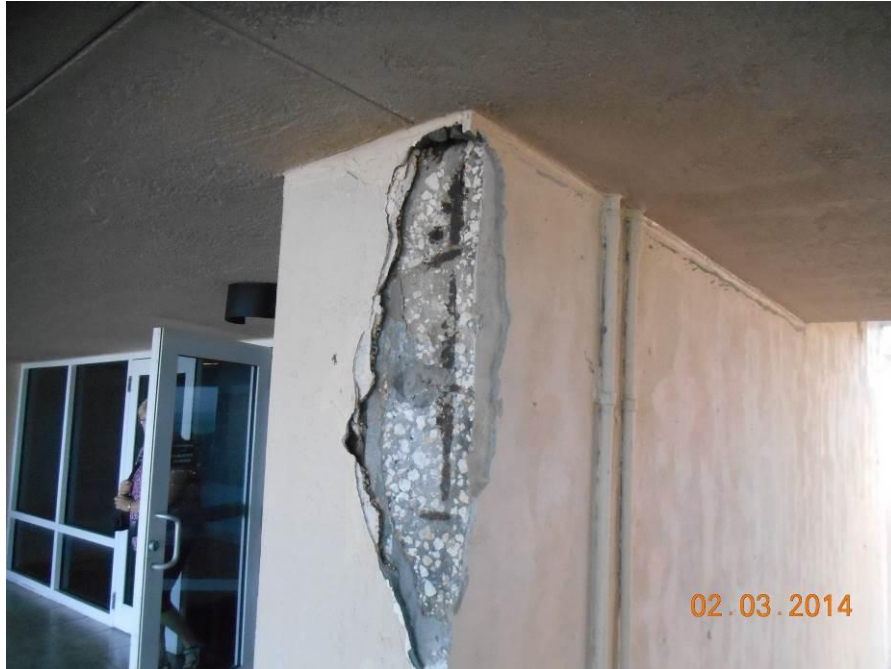
Concrete spalls requiring excavation  
on the east parking garage shearwalls.
